Turbochargers NR24/R and NR26/R
Modification of the compressor wheel seat and labyrinth
ring for engines with impulse-pressure supercharging

Cus 177 • 03/00

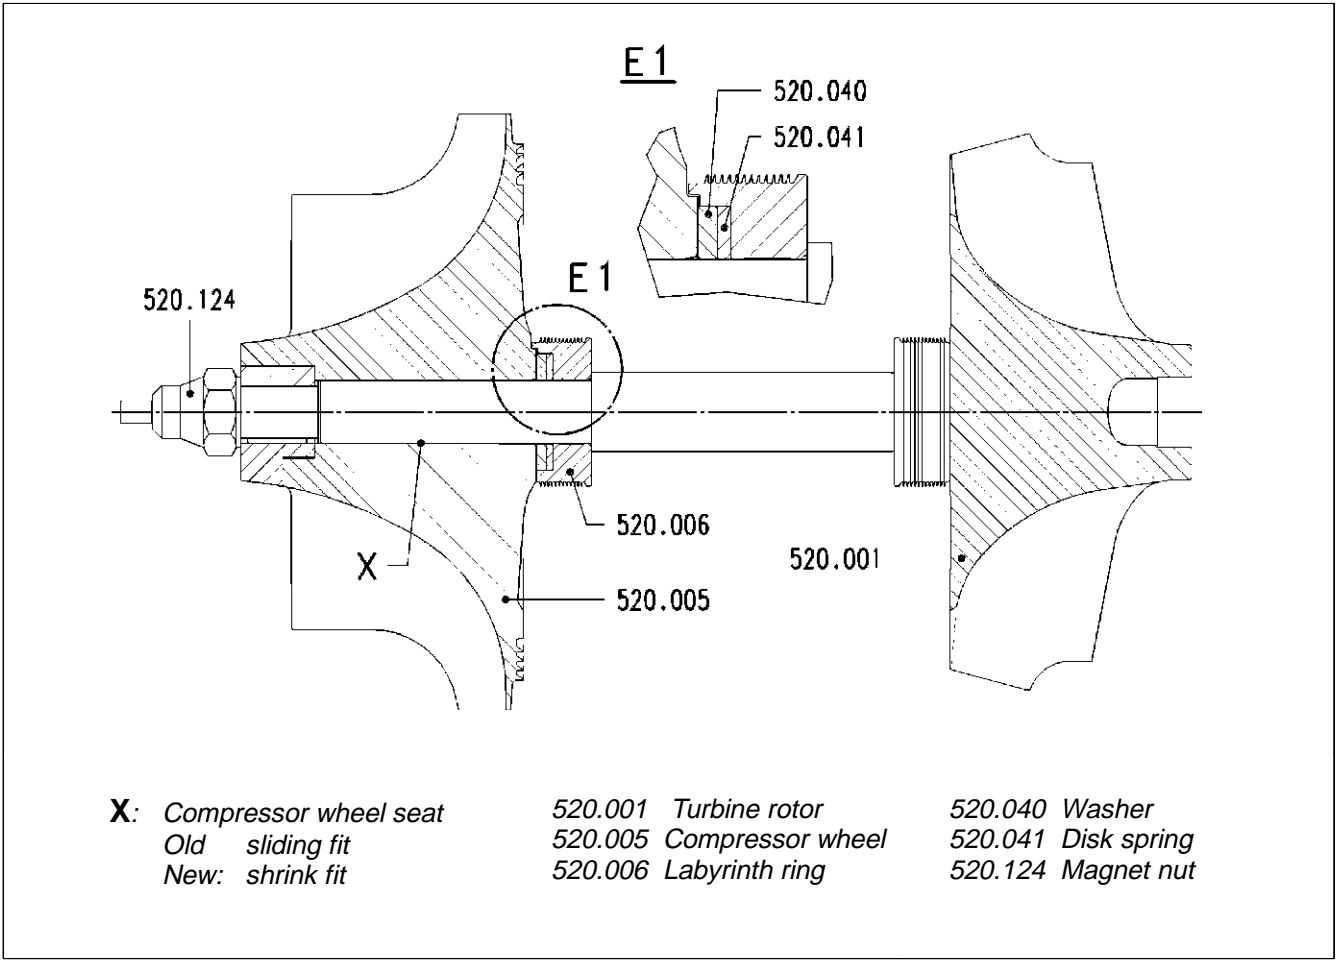
Figure 1. Modified rotor

Reasons for the modification	The high stresses on the rotor from the pulsating exhaust gas in engines with impulse-pressure supercharging caused damage to turbochargers of sizes NR24/R and NR26/R; in some cases, this led to failure of the turbocharger after a relatively short operating period.
Type of damage	On the damaged parts, fretting corrosion was found on the compressor wheel, axially on the contact surface between the rear of the compressor wheel and the labyrinth ring. The fretting corrosion observed on the axial contact surfaces enlarges the axial lubricating gap, so that the equilibrium of lube-oil supply to the bearings is disturbed. The result is insufficient lubrication of the bearing on the turbine side and excessive wear of the bearing bush, causing failure of the turbocharger.
Improvements	<p>In order to improve reliability, the seat of the compressor wheel and the labyrinth ring have been modified, and the tightening torque has been increased in the</p> <p style="text-align: center;">NR24/R from 120 Nm to 240 Nm, and in the NR26/R from 190 Nm to 350 Nm,</p> <p>by using a titanium or steel nut.</p> <p>By installing a disk spring (see Figure 1) as well, a constant pre-loading is provided, which prevents fretting corrosion in case of pulsating admission.</p>

Notes on installation	<p>Due to the alteration of the compressor wheel's seating from close sliding fit to shrink fit, the compressor wheel must be warmed up before installation or removal. To do this, heat the compressor wheel carefully and uniformly with a suitably adjusted flame in the vicinity of the hub between the blades to a temperature of 80°C.</p> <p>Before installation, the heating can also be done by means of a hot-plate. As soon as the warm compressor wheel has been mounted, tighten the magnet nut with the specified tightening torque. Since the compressor wheel shrinks axially while cooling, the tightening torque must be checked again when it is cold.</p>
Retrofitting	Turbochargers supplied previously can be retrofitted correspondingly.
