Sealing Air

PrimeServ Customer Information

No. 354 / October 2015

MAN Diesel & Turbo Turbochargers
NR12/S.

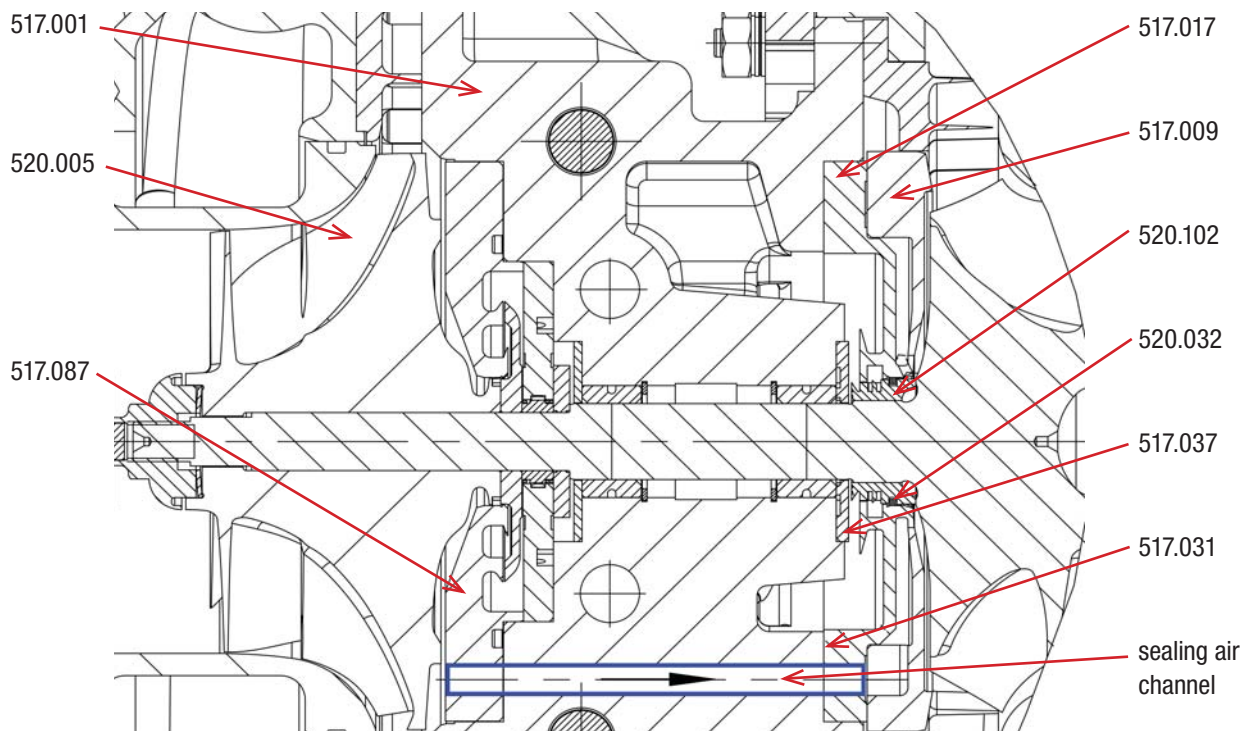
Figure sealing air design

In some cases NR12/S. turbochargers showed advanced wear on the turbine side sealing system. Especially on HFO-operated engines with e.g. insufficient cleaning of the turbocharger, exhaust gas deposits may enter the piston ring sealing area of the turbine rotor resulting in an excessive wear on the piston ring and the locating ring.

In order to avoid exhaust gas deposits on the piston ring (520.032) the following measure is applied:

Internal sealing air is led from the compressor wheel section (rear side of the compressor wheel 520.005) to the location of the turbine side piston ring area. The overpressure behind the turbine wheel prevents the entering of exhaust gas. Heavy contamination by exhaust gas deposits is no longer possible.

To ensure the proper function of the sealing air, the turbine side sealing cover (517.017) is new designed. The new sealing cover is thicker compared to the old one which means the existing gasket (517.031) is replaced by using a special liquid sealing (517.031). Never use the old design sealing cover in upgraded turbochargers!

NR12/S. turbochargers in operation can be upgraded by remachining of the bearing casing (517.001) in one of our workshops and exchanging the following components:

- 517.009 Cover disk
- 517.017 Sealing cover, turbine side
- 517.031 Liquid sealing
- 517.037 Cover
- 517.087 Sealing cover, compressor side
- 520.032 Piston ring
