Supplementary information regarding checking and replacing big-end bearings on medium-speed engines

Cus 190 • 02/02

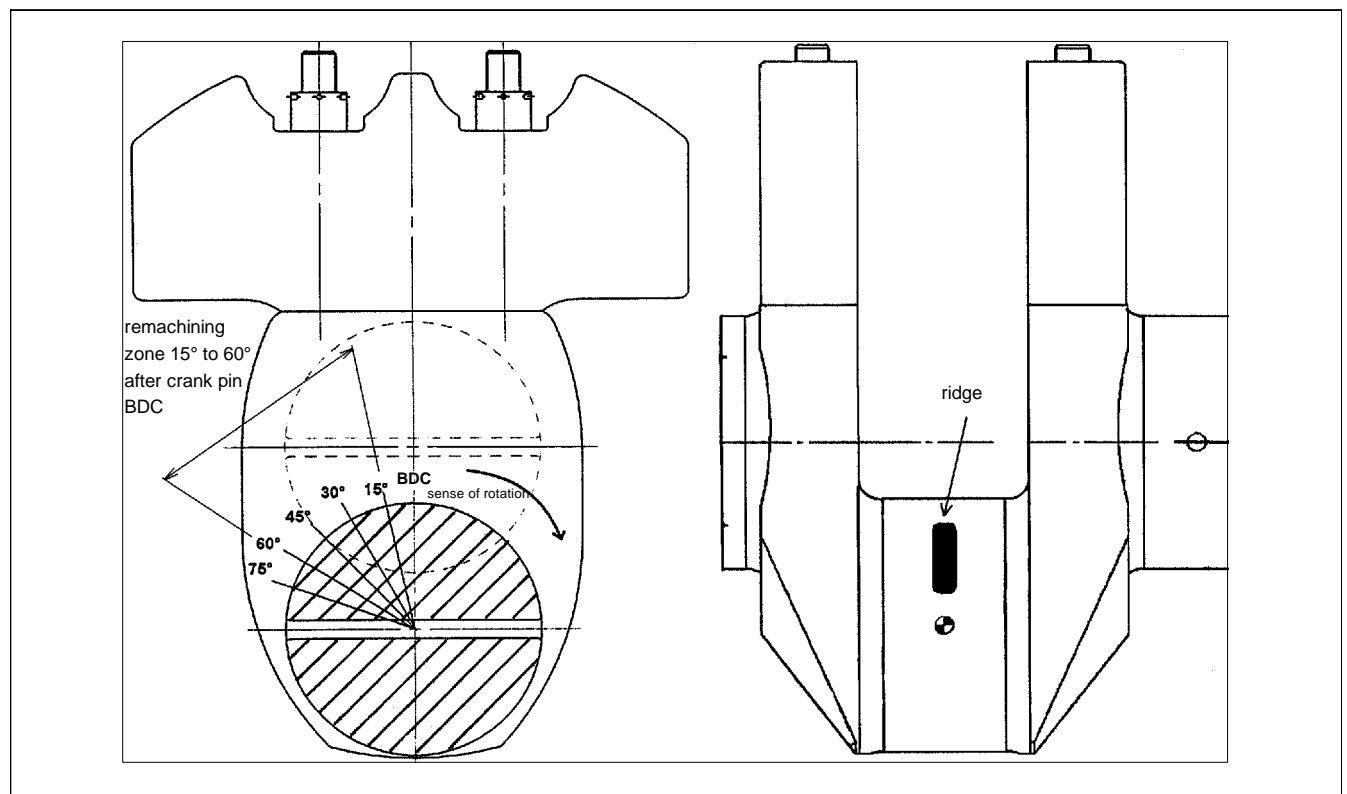
Depending on the sense of rotation, an unevenness, the so-called ridge, forms in the range between 15° and 60° after crank pin BDC. Reasons for this are, e.g., an increased contamination of the lubricating oil or an increased lubricating oil temperature. This ridge is harmless during normal engine operation. The actual material wear out in connection with this type of wear is within the range of a few 1/1000 mm.

Figure 1. Zone of the crank pin, in which the described wear may occur

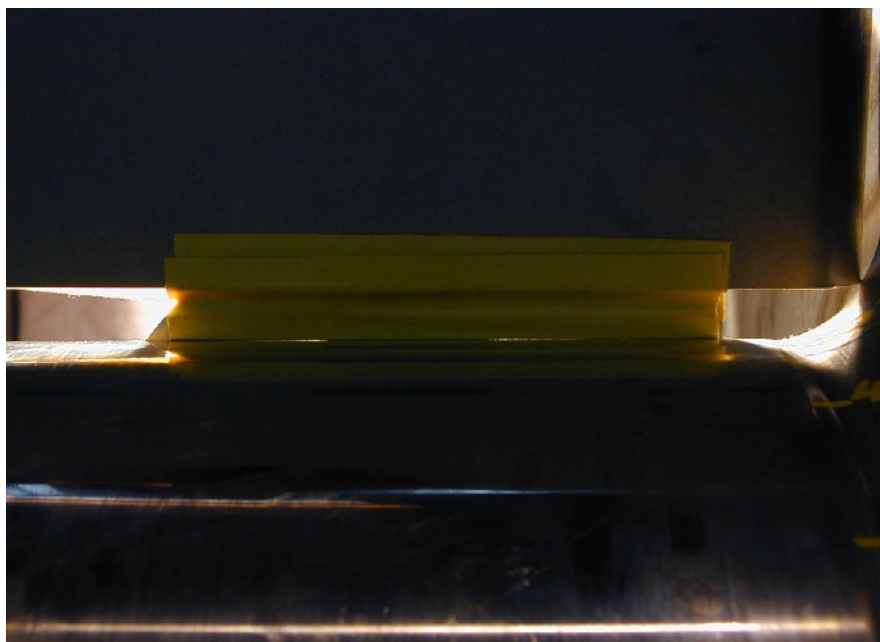
Figure 2. Photo not showing any ridge wear

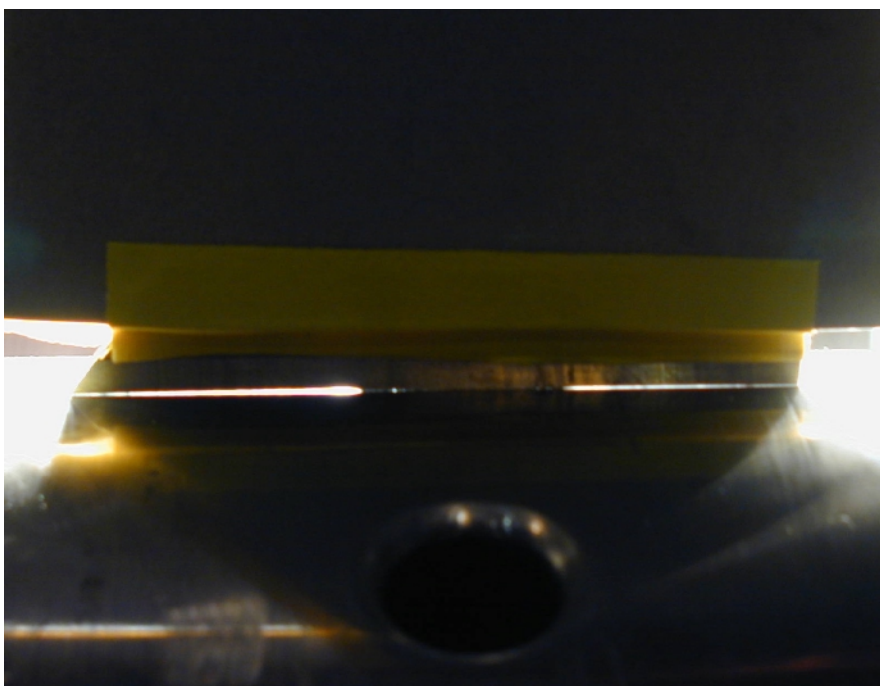
In special cases, however, such as, e.g., after installation of a new big-end bearing shell, this wear may lead to damage, as the existing unevenness on the crank pin may considerably hinder running-in of the bearing shells.

Figure 3. Photo with clearly visible ridge wear

1. With an uneven light gap prevailing, close all lubricating oil bores. Subsequently, mount the slipring in centred position on the big-end bearing running surface of the pin (the lubricating oil bore represents the centre of the running surface), in order to render reworking the ridge possible (the actual wear can be seen in the light gap).

2. Use emery cloth with a grain size of 400 and clamp it to the spring-loaded grinder clamp. Now, carry out approx. 10 double strokes in the zone between 15° and 60° after crank pin BDC.

3. If necessary, renew the grinding material and carry out another 10 double strokes. Afterwards, fix 30 µm polishing cloth.
4. With the polishing cloth fixed, carry out another 20 double strokes in the specified area and, if necessary, renew the grinding material.

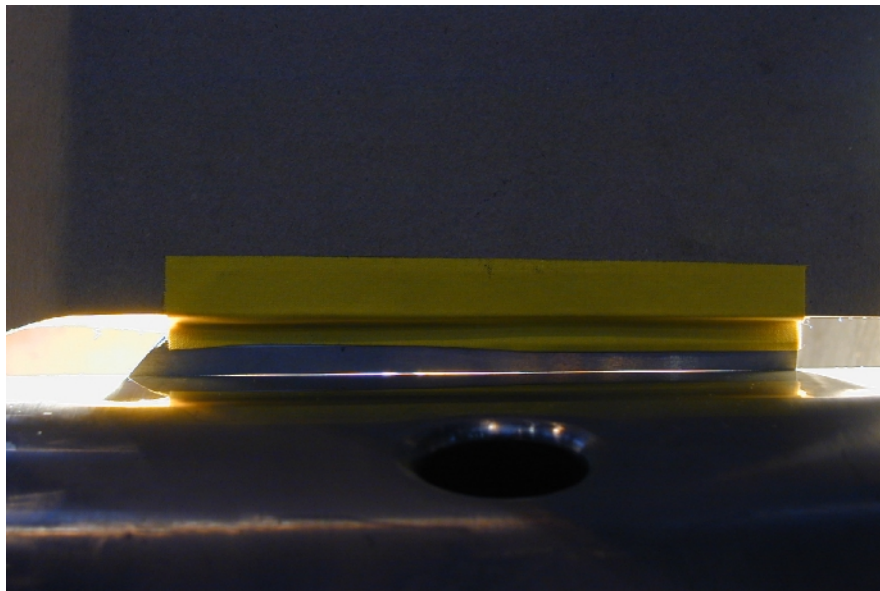
Figure 4. Successfully completed refinishing work on the crank pin

5. After completion of the refinishing work, dismount the slipring and check the result by means of a straight edge and a strong source of light.

6. In case a continuous light gap does not yet prevail and/or unevenness can still be recognised, the grinding process has to be continued using 30 μm polishing cloth, until a satisfactory result has been obtained.
7. Subsequently, smoothen the complete pin circumference over the whole width using 15 μm polishing cloth.
8. Clean the pin and open the lubricating oil bores.
