Turbine Cleaning

PrimeServ Customer Information
No. 367 / January 2017

MAN Diesel & Turbo SE
Turbochargers - all radial TC types
(NR- and TCR-series)

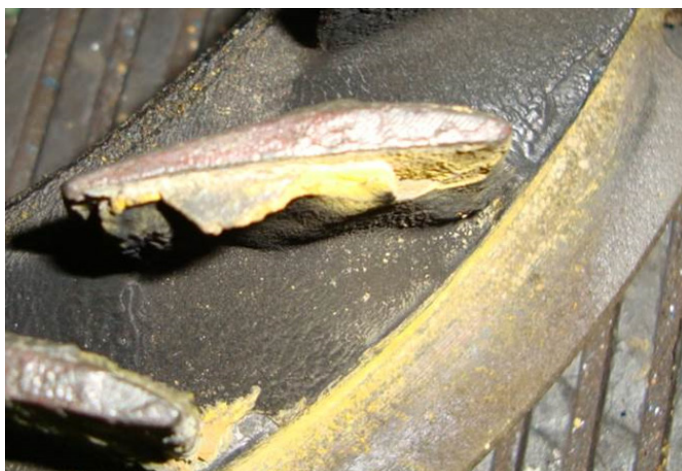
It is observed in some rare cases that turbochargers in the field are not adequately cleaned. In order to ensure a reliable and safe operation of the turbocharger the installation of a wet and dry cleaning device is necessary. Especially when the engine is operated with HFO, wet and dry cleaning is mandatory.

Figure 1: Heavily contaminated nozzle ring vane

The cleaning procedure must be carried out in accordance to the engine or turbocharger operating manual, further it's mandatory to check adjustments of the cleaning system as air / water pressures, pipe connections and installation.

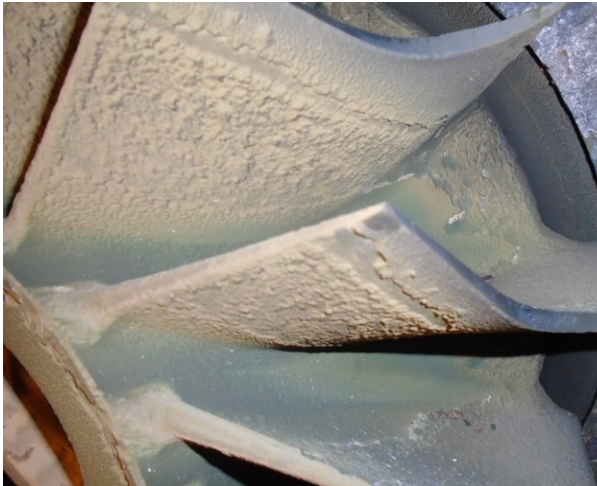
A high contamination level with deposits will cause an offset to the normal gas-flow parameters. This can cause on the one hand an increase of the temperature level before turbine or also surging, and on the other hand a significant increase of unfavorable excitation orders what may advance a severe damage of the turbocharger by causing fatigue on the turbine rotor vanes.

Figure 2: Inhomogenous fouling on turbine vanes

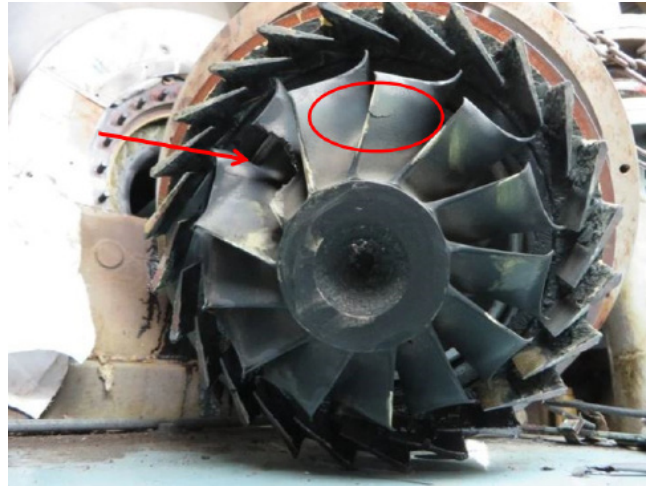
Figure 3: Cracks of turbine outlet vane
