# REL Test-Luna Air-leakage issue (Camera Lens)

- ❖ Failure symptom: Devices are failed at IPX2 station after REL Q-Sun Sunny.
- ❖ Detect station: IPX2
- ❖ Happen time: 2025/07/21
- ❖ How many: 2F/6T (FR: 33.33%) , DSN: GT54G002526500D9, GT54FJ02525400FD.

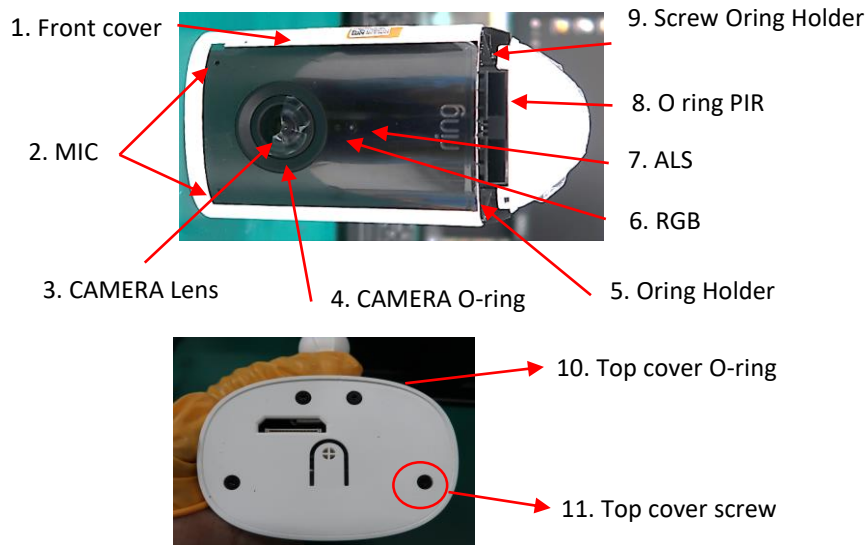
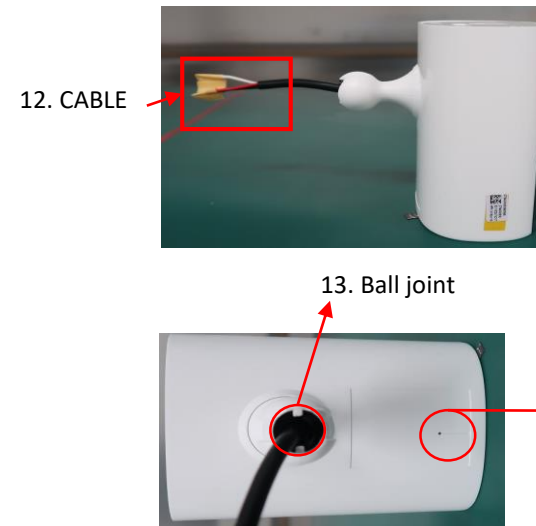
**Step 1:** Checking device cosmetic if have any abnormal → No scratches or breaks found on the outside of the device.

**Step 2:** Stick wooden tape to each possible air leakage location on the device to find out the exact air leakage location on the device.

- ❖ Only stick wooden tape and clay in turn to MIC/ALS/Camera/RGB/Vent position/Oring/Cable/Ball joint/Screw

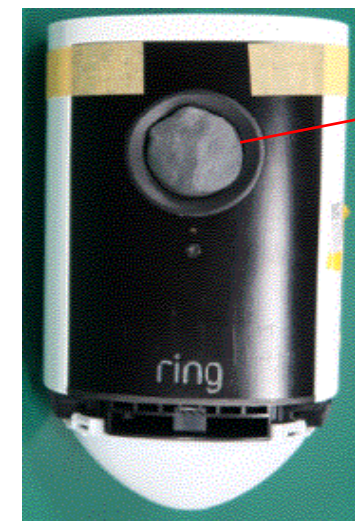
❖ Only fill Camera Lens position, re-test IPX2 is OK, the result showed table below

→ Only have air-leakage at Camera lens position

DSN	Leaking Position	IPX2 (IPX 2 < 200pa)	After fill Camera lens
GT54G002526500D9	CAMERA LENS	6230	105.1
GT54FJ02525400FD	CAMERA LENS	6126	65.14

Only fill  
Camera Lens

❖ **Suspected Cause:** The material used to seal the camera lens may not withstand the alternating **spray and sunlight exposure** conditions during the Q-SUN test.

1. SQE Coordinate with supplier for material review and improvement.
