REL Test-Luna Air-leakage issue (Holder speaker)

- ❖ Failure symptom: Device is failed at IPX2 station and has water inside of device, and SI saw water on the tray cover devices.
- ❖ Detect station: IPX2
- ❖ Happen time: 2025/07/21
- ❖ How many: 1F/6T (FR: 16.66%) , DSN: GT54G002526500DD.

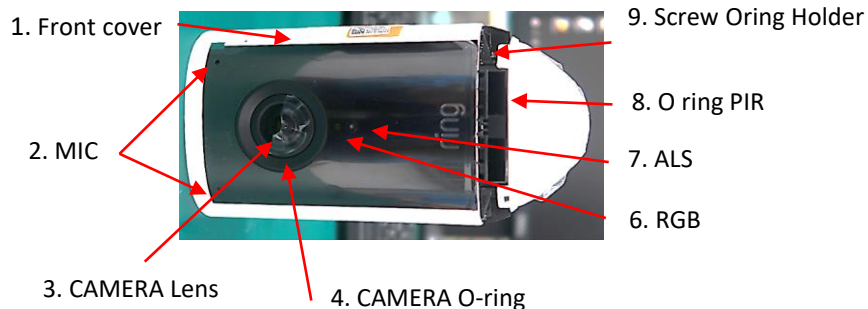
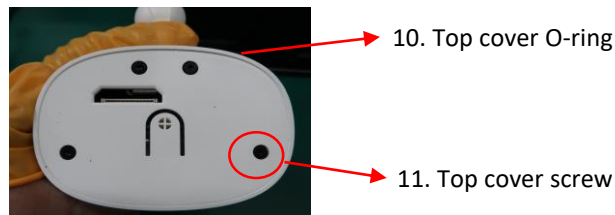
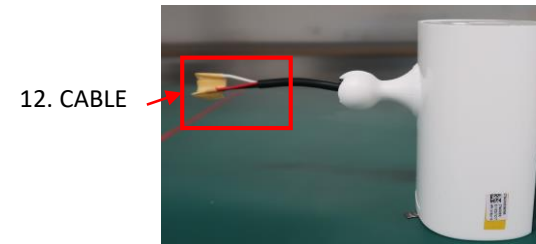
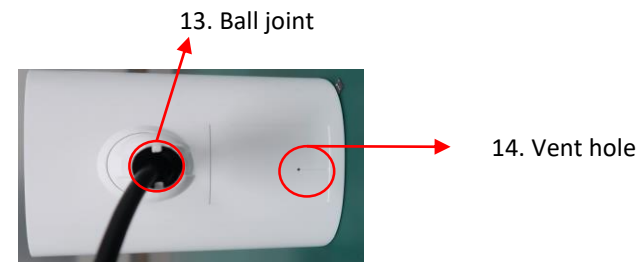
Step 2: Stick wooden tape to each possible air leakage location on the device to find out the exact air leakage location on the device.

- ❖ Only stick wooden tape and clay in turn to MIC/ALS/Camera/RGB/Vent position/Oring/Cable/Ball joint/Screw

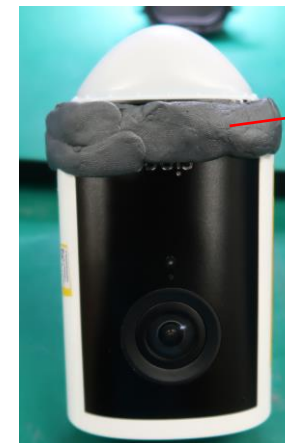
❖ Only fill Holder speaker position, re-test IPX2 is OK, the result showed table below

→ Only has air-leakage at Holder speaker position.

DSN	Leaking Position	IPX2 (IPX 2 < 200pa)	After fill Camera lens
GT54G002526500DD	CAMERA LENS	6230	156.1

Only fill
Holder
speaker

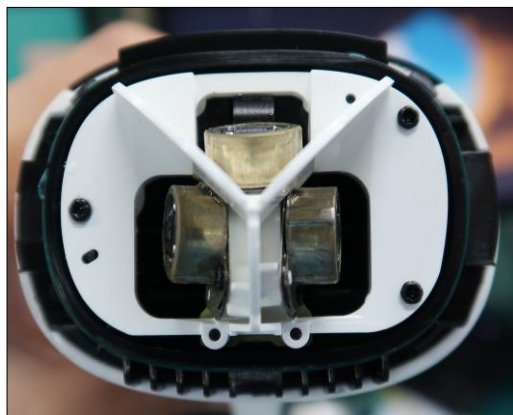
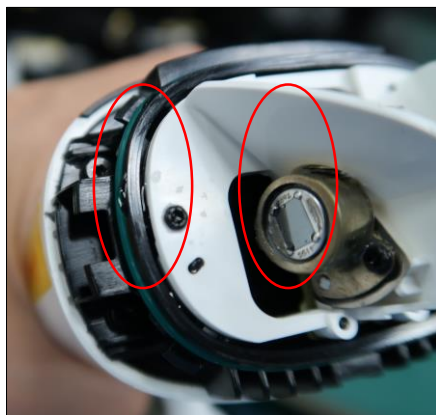
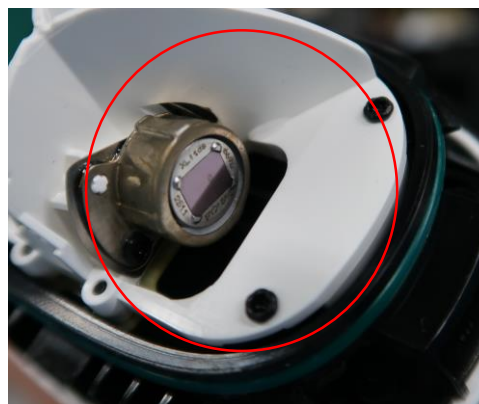
→ Found water on the device & holder speaker is cracked

There is water

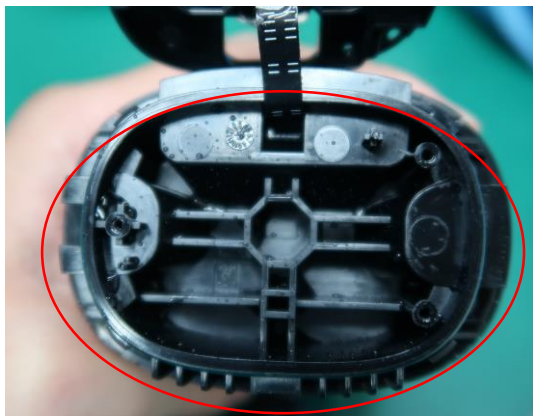
There is water

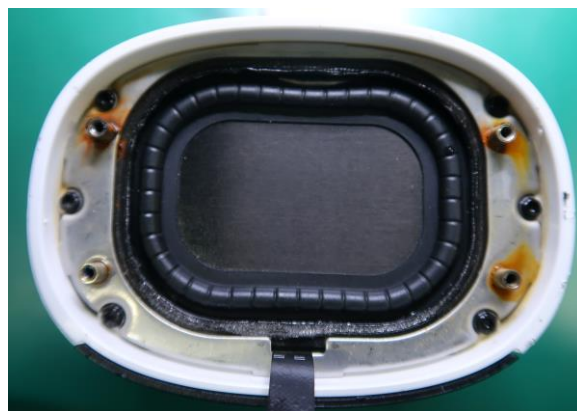
There is water

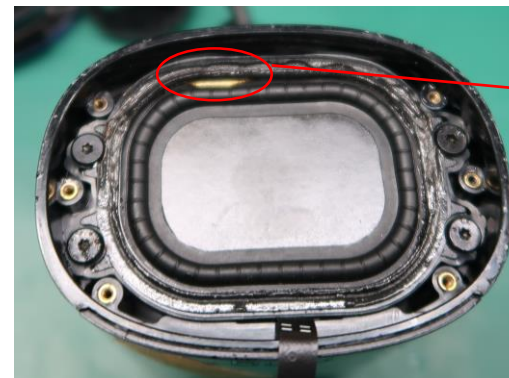
There is water & Holder speaker is crack

The holder speaker is cracked & ...

1. SQE contacted the PSA Speaker supplier to report the material quality condition not ensuring adhesion.

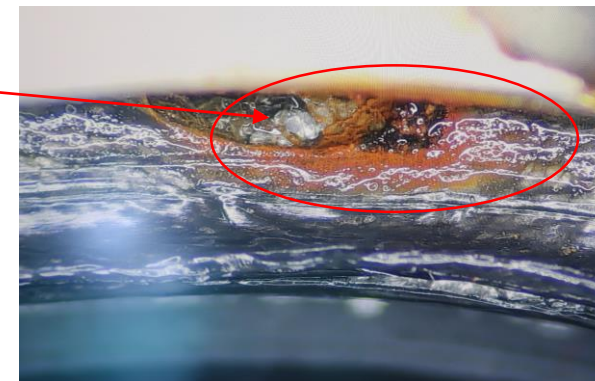
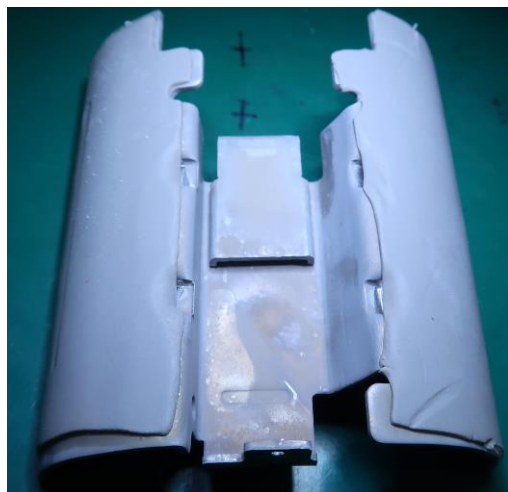
There is water

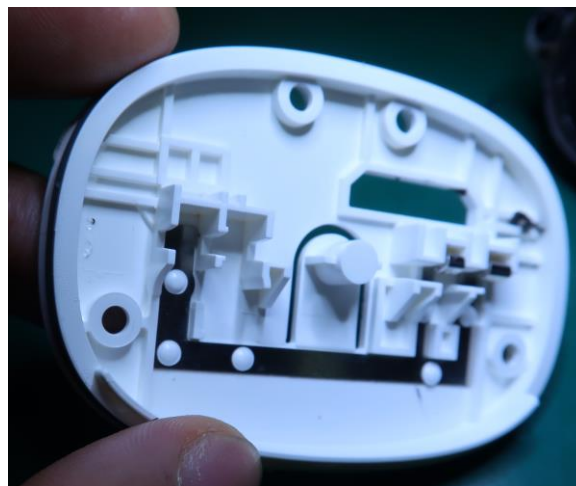
There is water

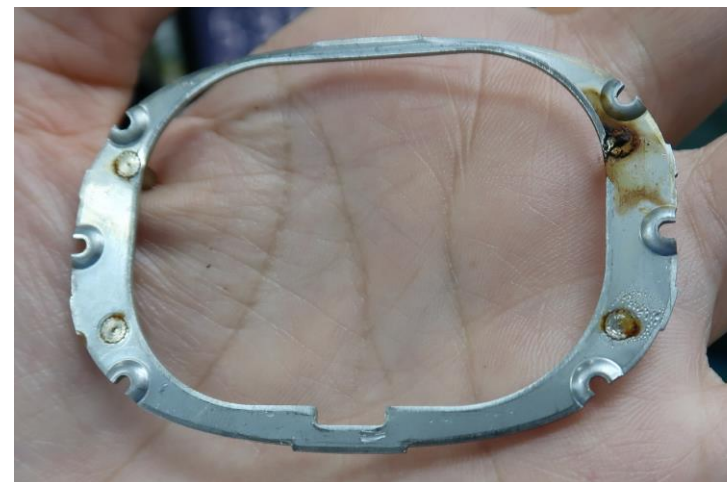
There is water

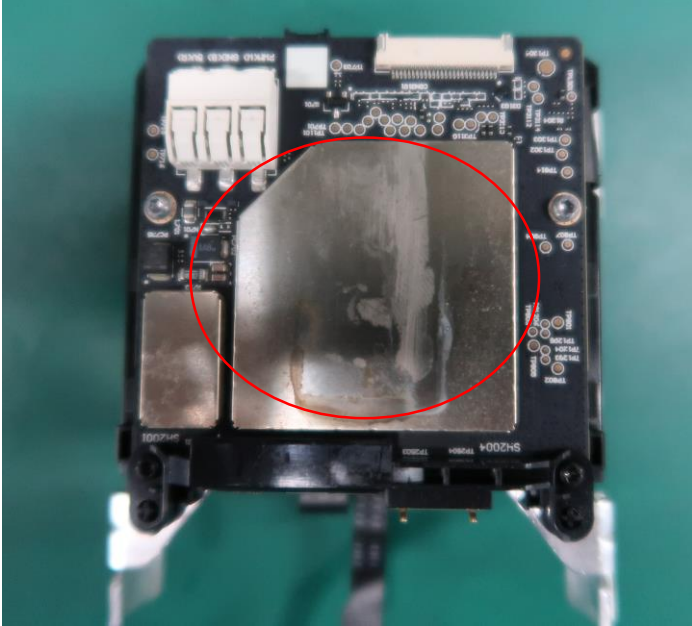
Signs of water
