## REL Test-Luna Air-leakage issue (ALS)

### << Failure description:

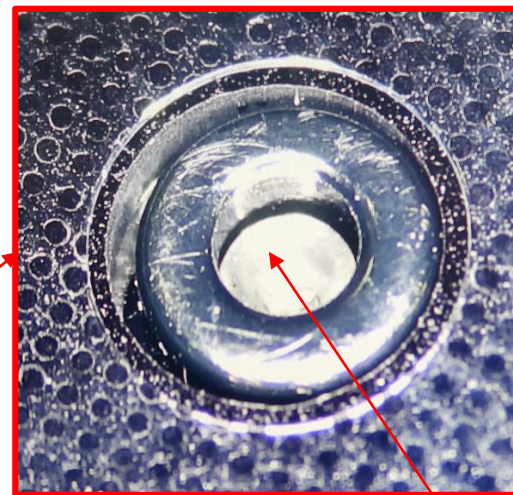
NG

ALS is lower than housing surface

→ ALS product appearance detected abnormal phenomenon.

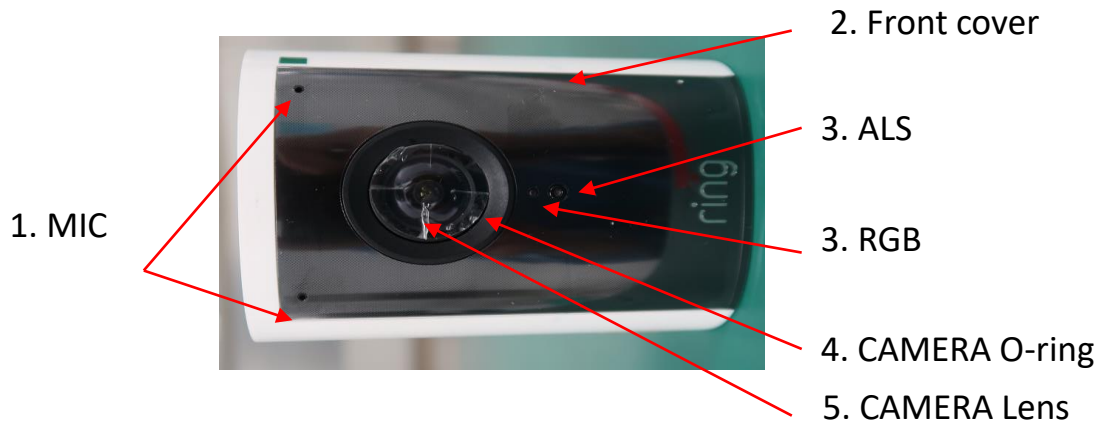
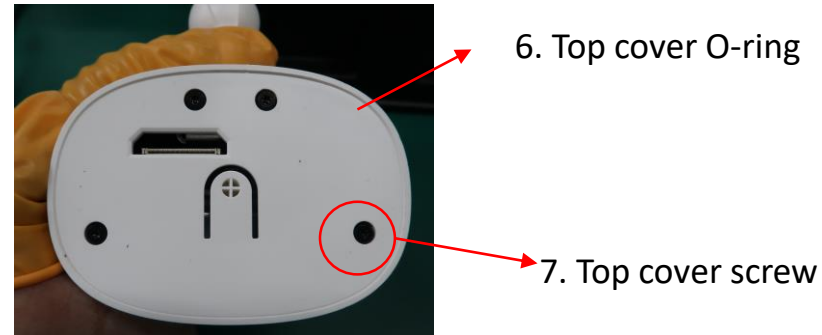
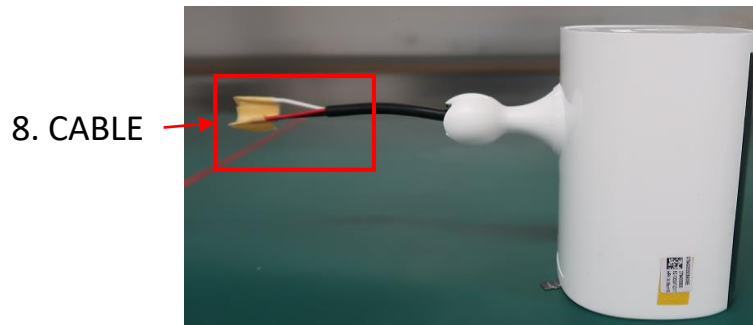
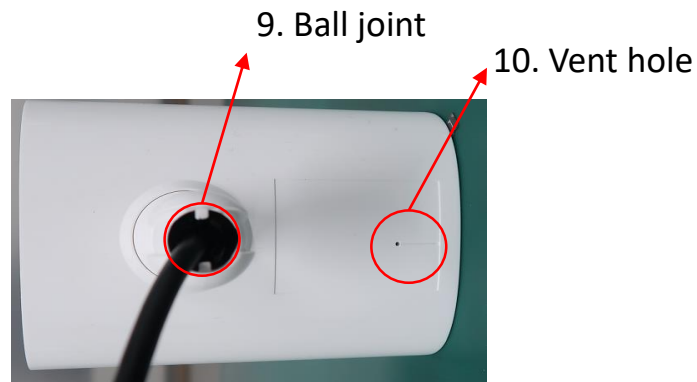
- ❖ Only stick wooden tape and clay in turn to MIC/ALS/Camera/RGB/Vent position/Ball joint → Re-test IPX1 failed
- ❖ Only fill ALS position, re-test IPX1 is OK, the result showed table below → **Only have air-leakage at ALS position**

DSN	Leaking Position	IPX1 (IPX 2 < 200pa)	IPX After stick tape (Pa)
GT54FJ02525400F9	ALS	4232	183

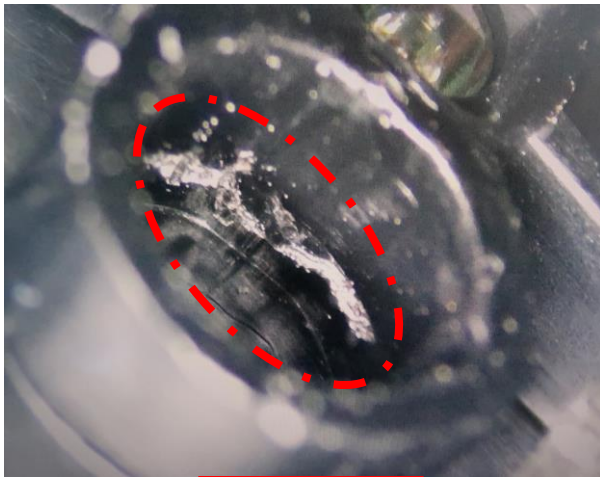
NG

- ❖ During inspection of the ALS cavity, a raised defect was **observed inside the hole**. This raised portion results in an uneven surface.

- ❖ The raised surface inside the ALS hole prevents tight bonding due to uneven terrain.
- ❖ REL Q-Sun testing exacerbates the issue by accelerating PSA degradation.
- ❖ These combined factors lead to poor adhesion performance in the final product.

1. SQE Coordinate with supplier for material review and improvement.

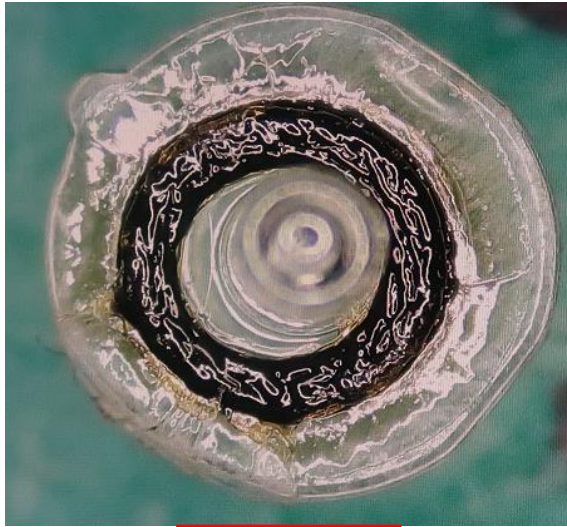
NG

- ❖ When ALS is assembled onto this uneven surface, proper adhesion is compromised. This issue becomes more critical after undergoing the REL Q-Sun test (sunlight and mist exposure)
  - ❖ which further degrades the adhesive properties of PSA
- As a result, the bonding becomes unreliable or fails entirely.
