High Rate In-situ Damage of Electronics Packages

Drop Tower shock tests of highly-instrumented electronics package

Alain Béliveau, Jonathan Hong
Applied Research Associates Inc.

Jacob Dodson, Michael Davies
Air Force Research Laboratory

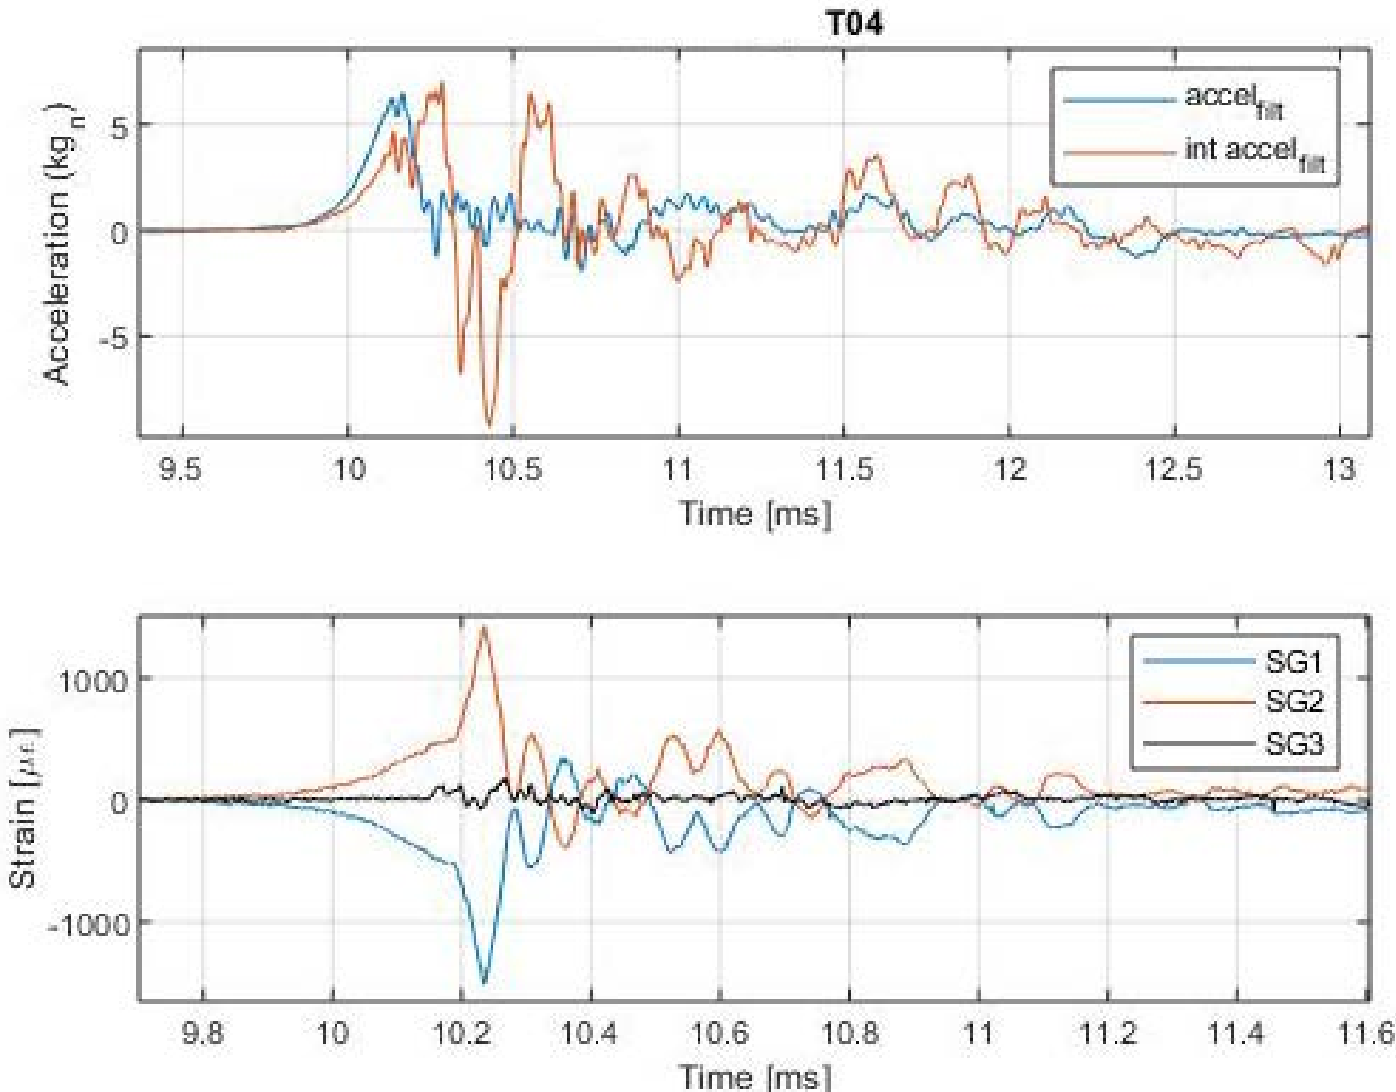
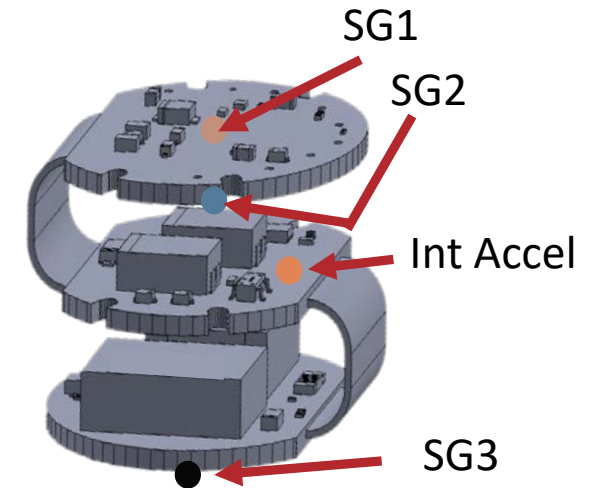
Results – 1st shock (T04)

The internal accelerometer profile is different than the fixture accelerometer and might reflect the oscillation of the board to which it is mounted.

The strain measurements of the gauges mounted on each side of the top board (SG1 & SG2) are almost a perfect reflection of each other as expected.

The strain gauge mounted on the bottom board does not display a lot of signal, perhaps because the larger components make the board stiffer.

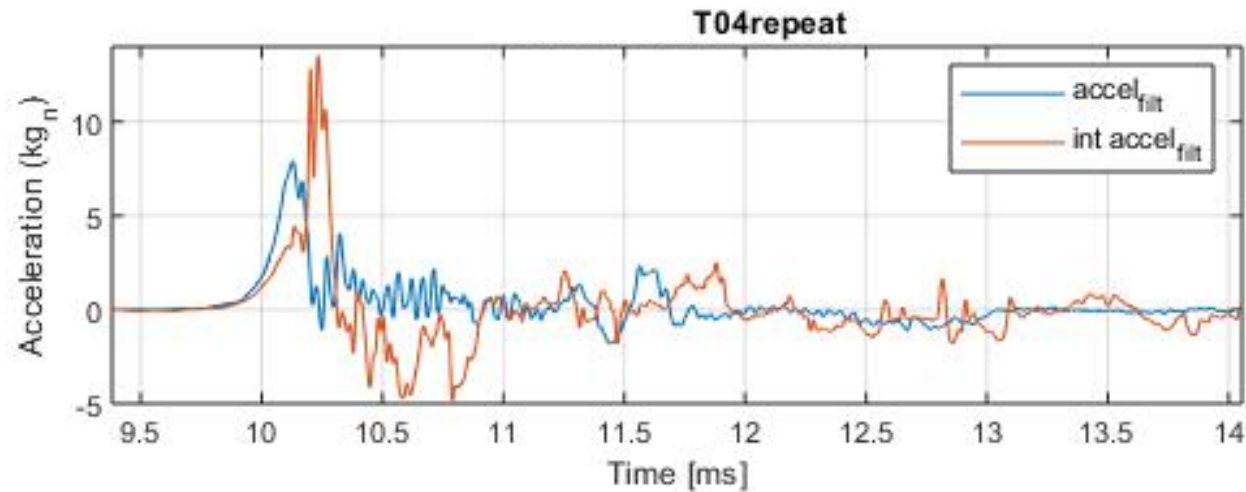
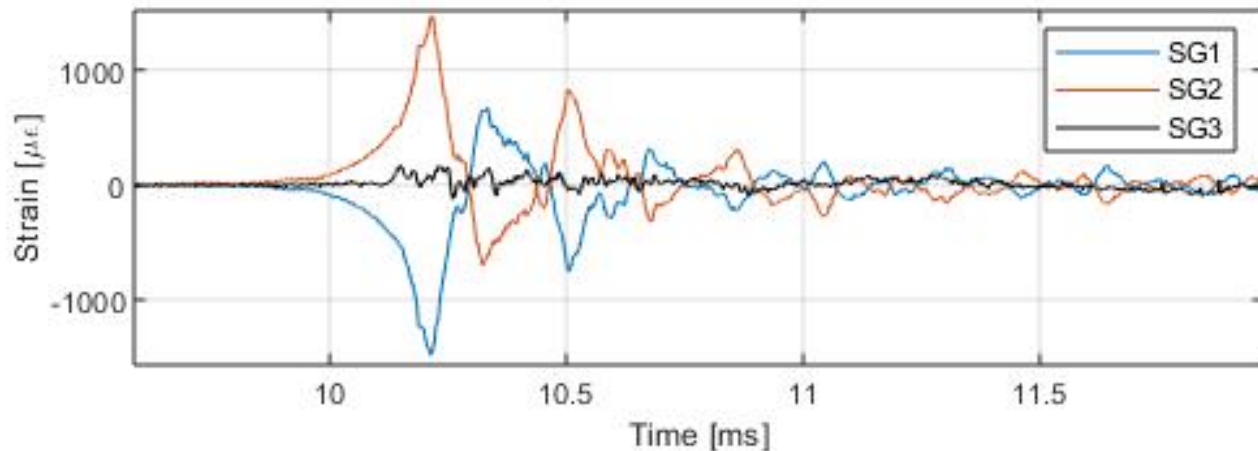
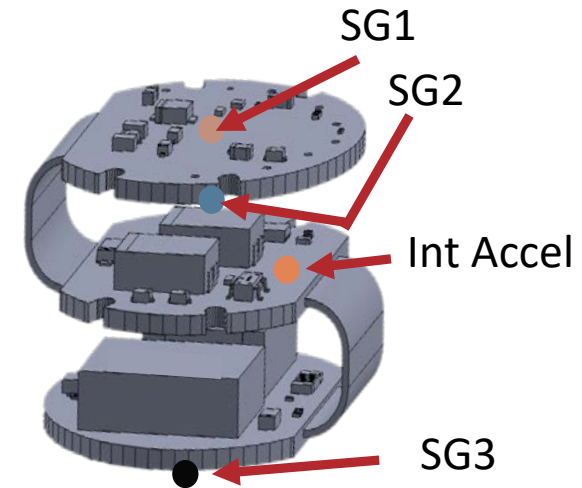
Results – 2nd shock (T04repeat)

Note the small difference on the fixture accelerometer between T04 and T04repeat (from $\sim 6.5kg$ to $7.95kg$ in peak value but with similar pulse shape) compared to the change on the internal accelerometer (very different shape!). Something changed!

The strain measurements are comparable in the two tests.

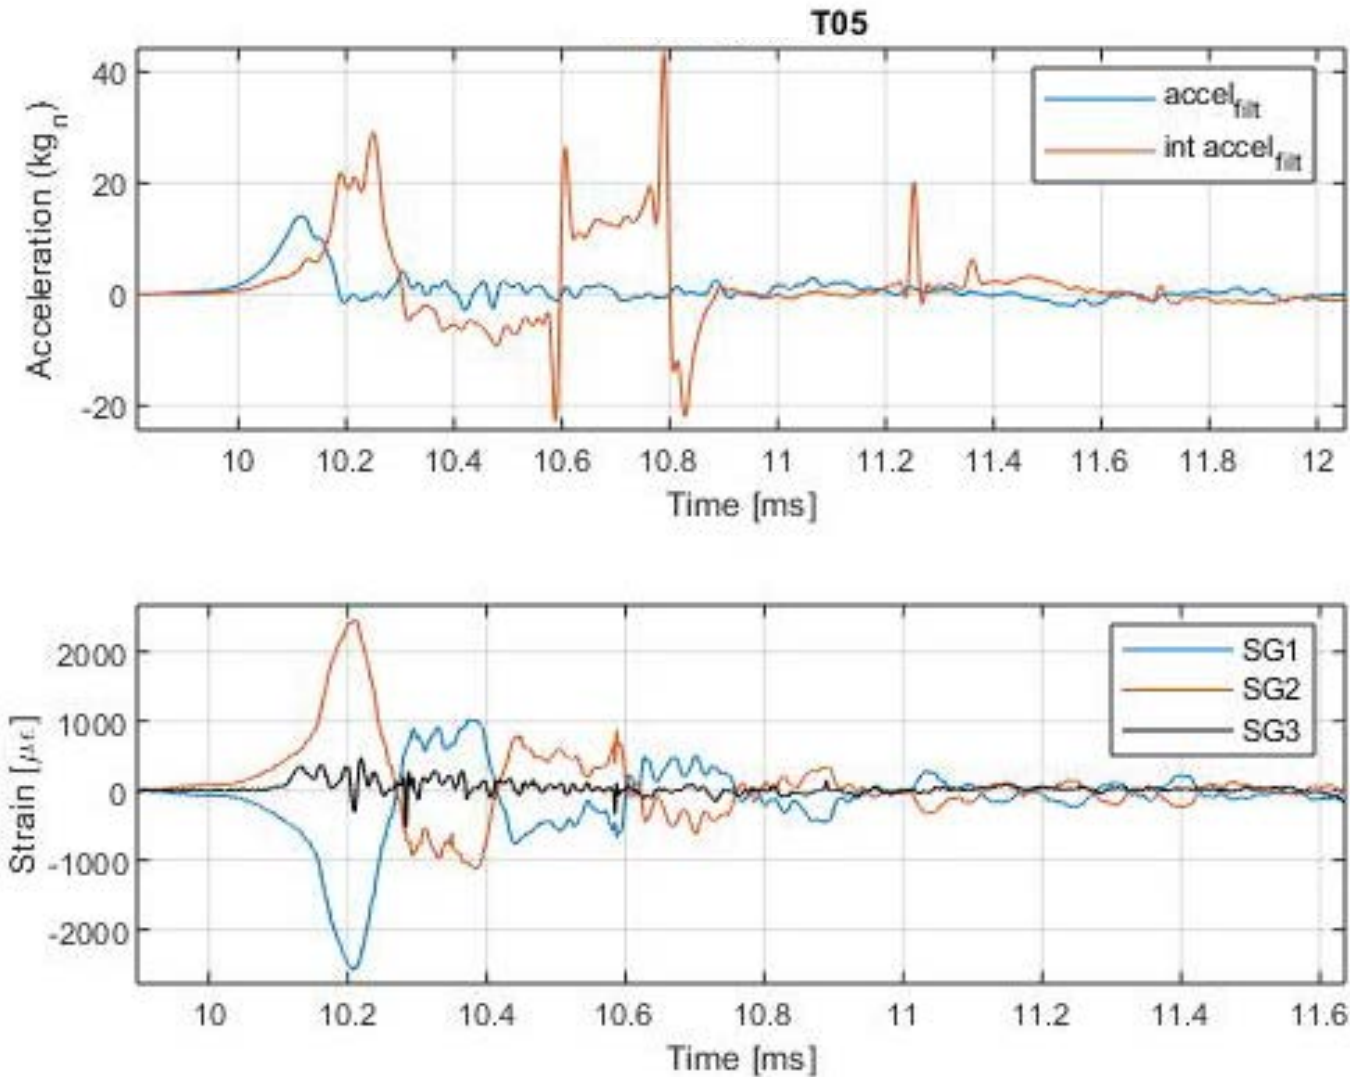
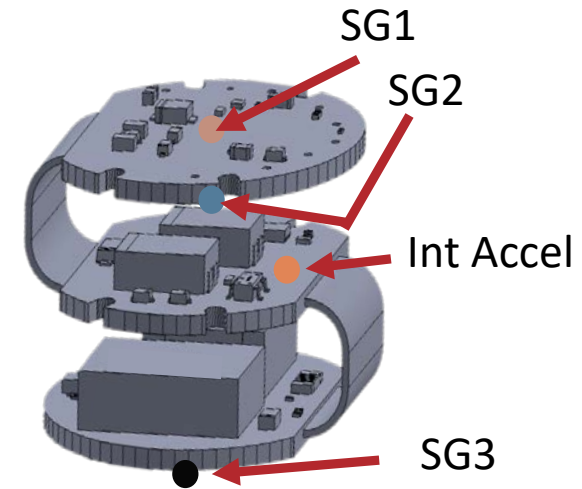
Results – 3rd shock (T05)

The fixture accelerometer response is much larger than the fixture accelerometer response. The abnormal behavior at 10.6 msec could be caused by the accelerometer de-bounding or the middle board changing boundary conditions.

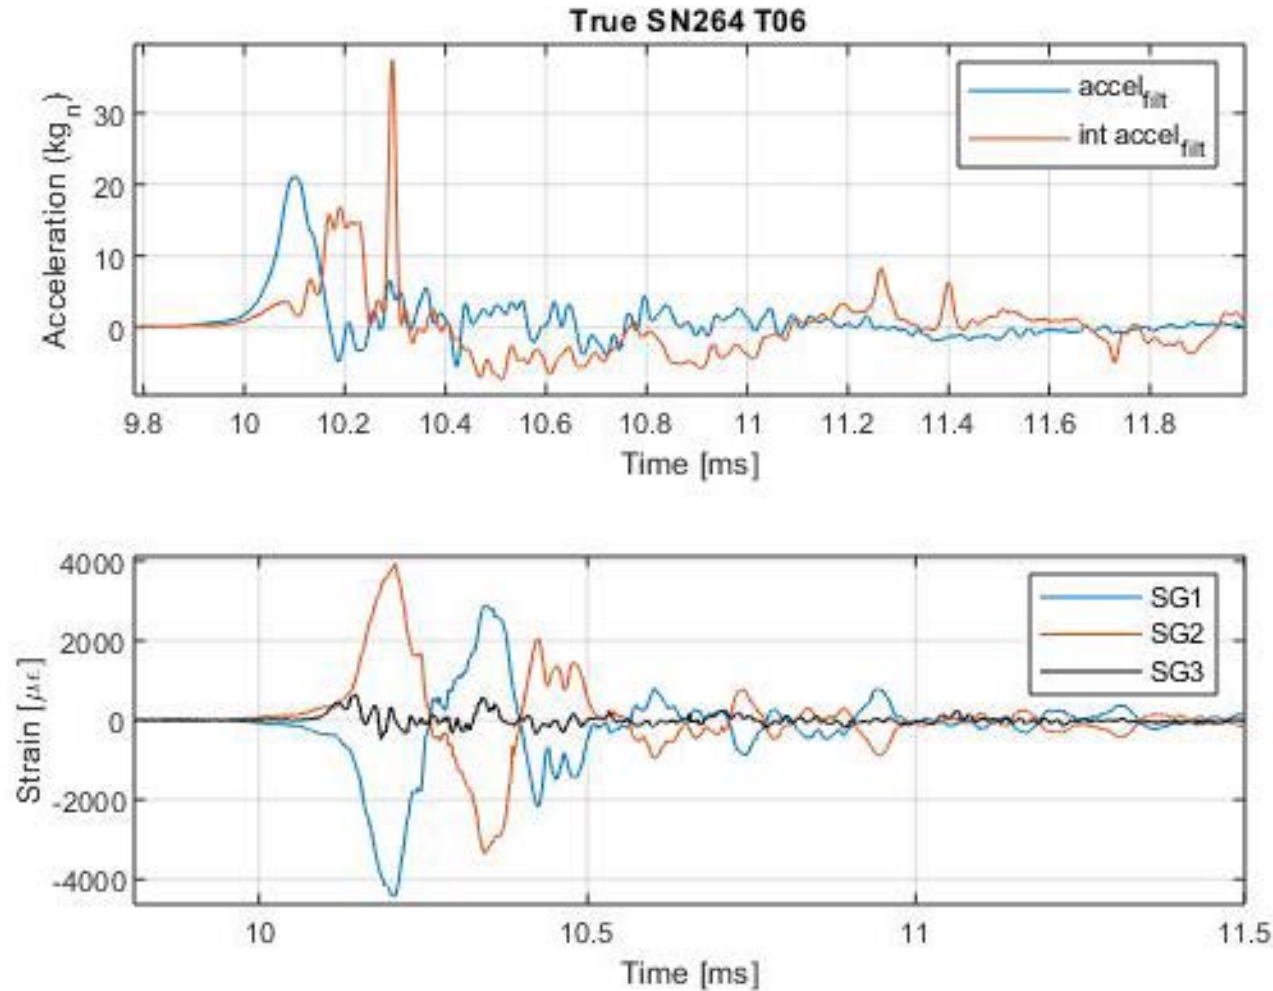
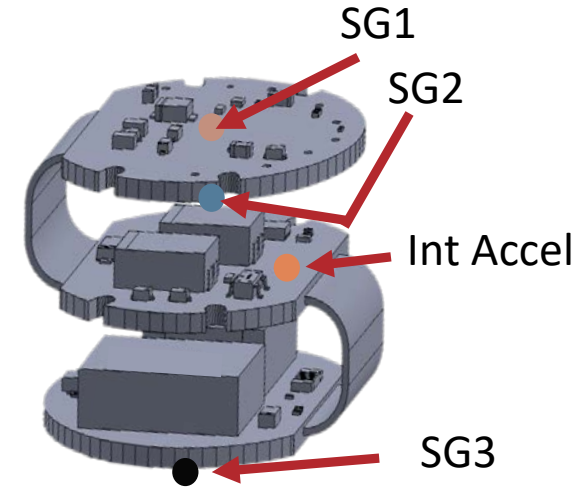
Results – 4th shock (T06)

The fixture accelerometer response is now smaller than the fixture accelerometer response!

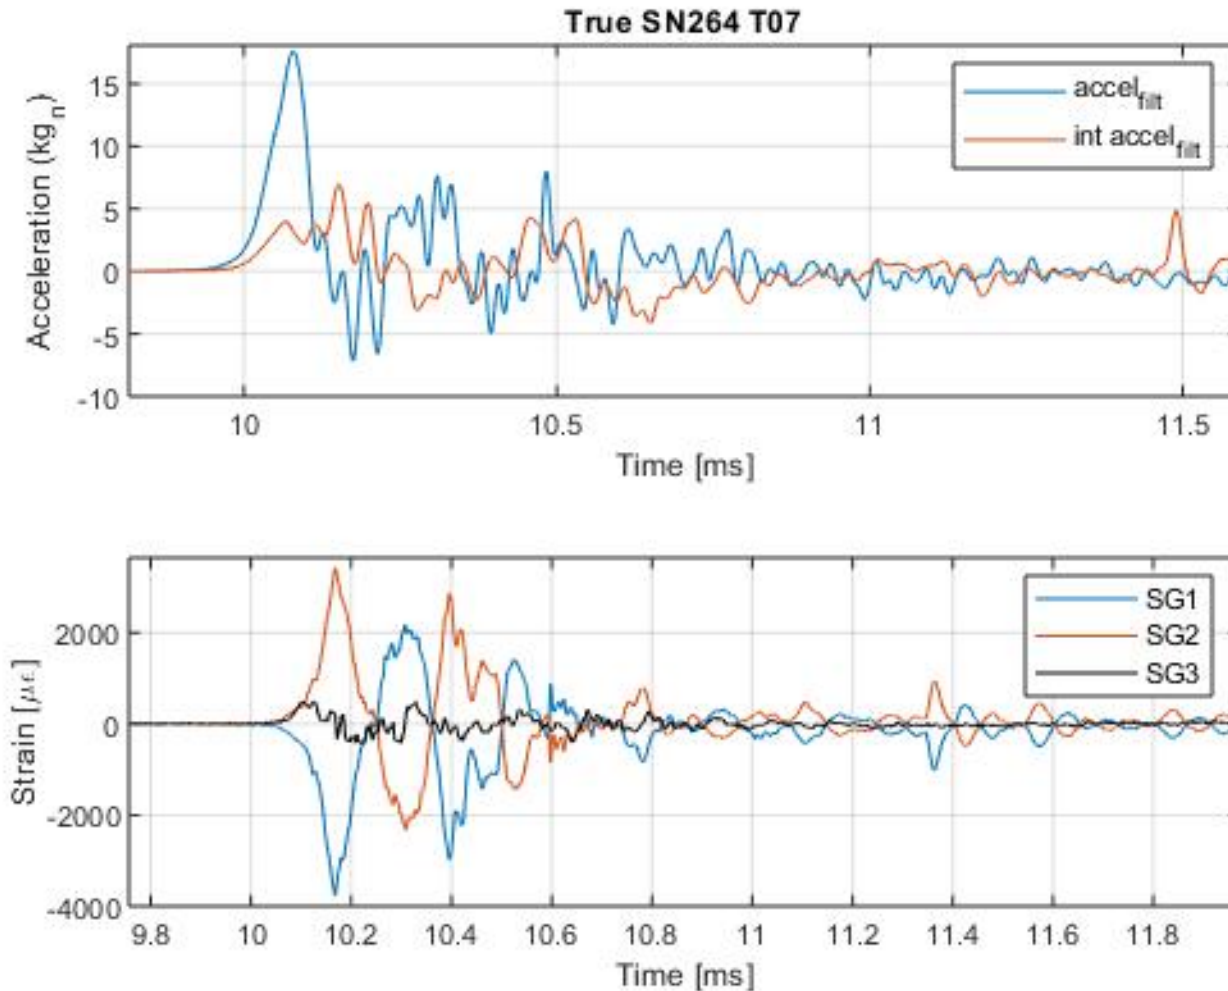
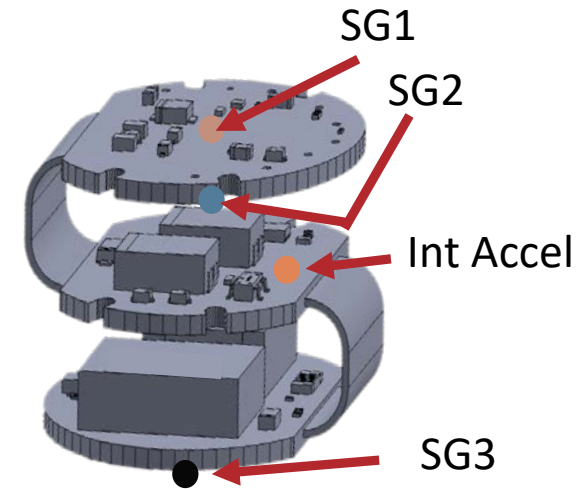
Results – 5th shock (T07)

The fixture accelerometer response does not correlate well with the fixture accelerometer response. Perhaps something has failed.

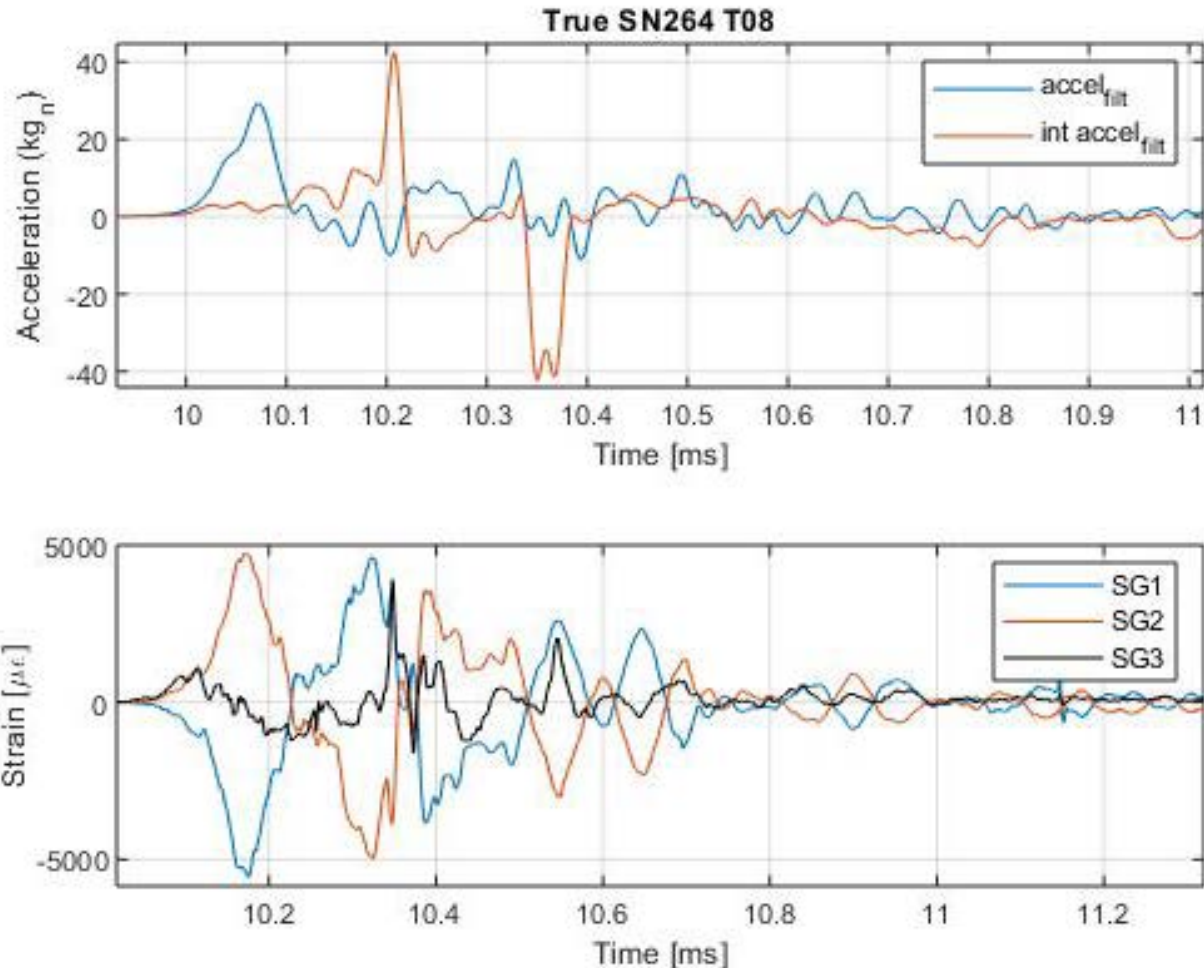
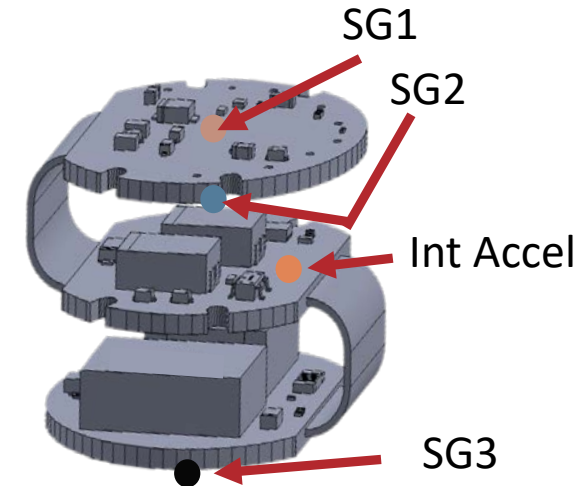
Results – 6th shock (T08)

The fixture accelerometer response does not correlate well with the fixture accelerometer response. Perhaps something has changed.

Strain gauges SG1 and SG2 are still producing reliable data. Strain gauge SG3 on the bottom board is exhibiting more output than before.

The electrical checkout performed after the shock test T08 revealed a unique behavior that indicated an change in the function of the electric components of the unit (See next slide).

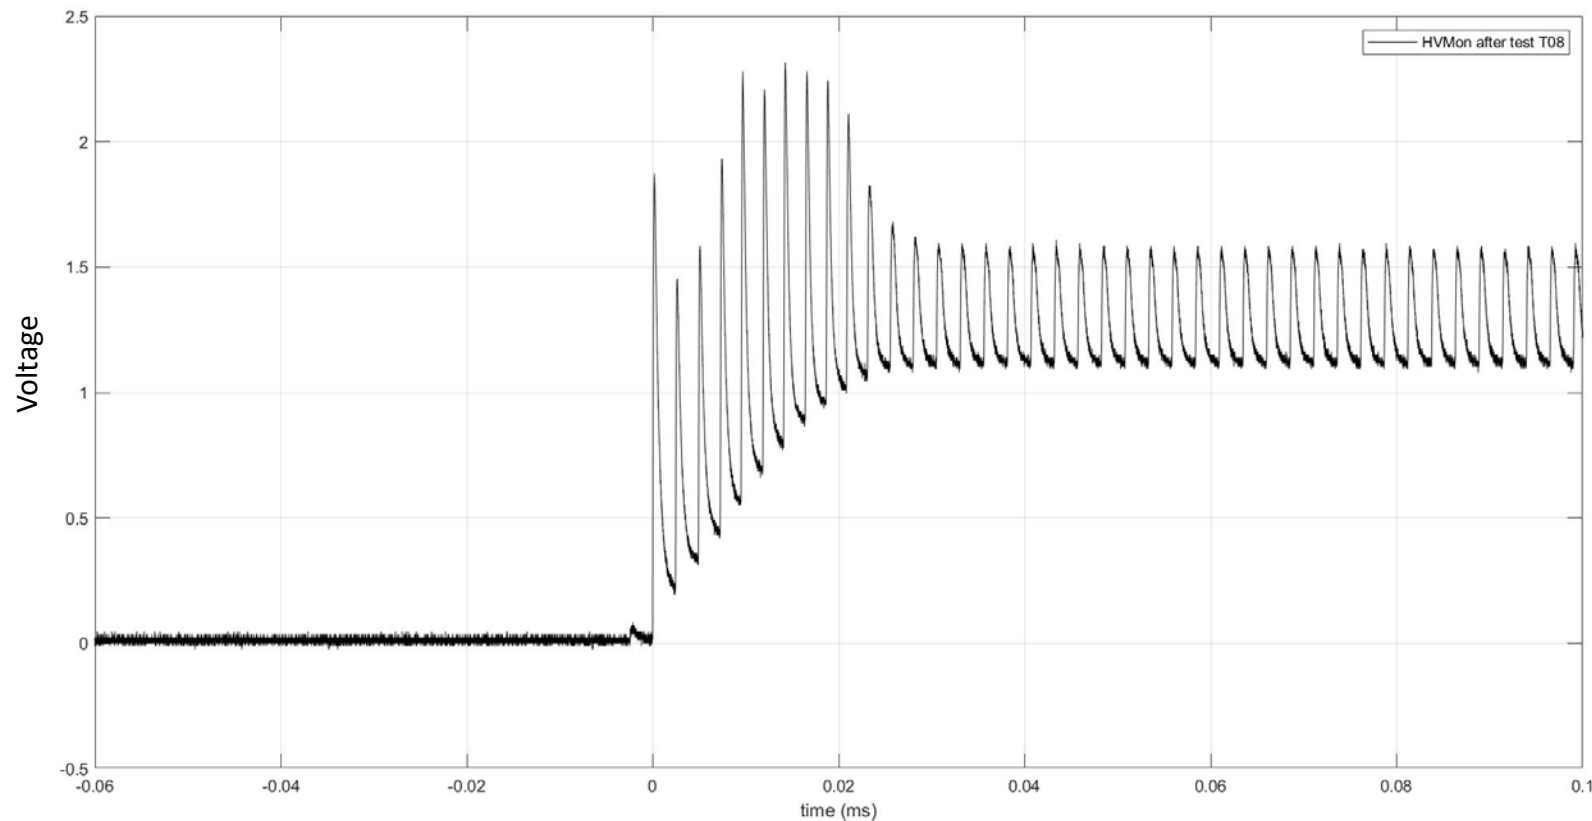
Results – Electrical Performance after T08 SN264 - Unpotted

After test T08, it was not possible to normally charge the capacitor. As seen in this figure, when Voltage is applied, the voltage displays a rise and a drop in the signal.

The behavior may relate to a malfunction in the switch or capacitor in the circuit located on the bottom board.
