Samsung HA SVC Guide Booklet

- 2023.05 -

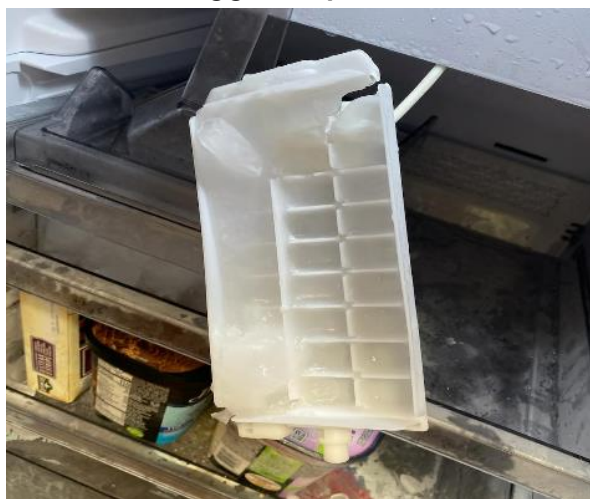
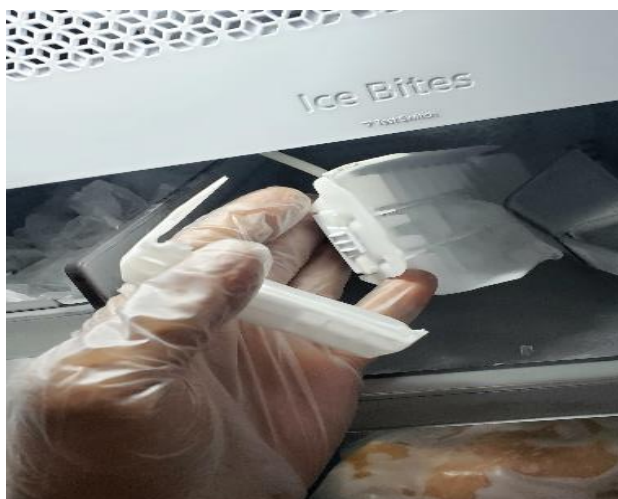
1. Ice Maker, nugget tray broken

Issue occurs due to frozen ice pipe, the tray collides with the frozen ice during harvest and breaks or is dislocated from motor drive.

- If the ice tray is damaged, not only the 'ice tray' but also the 'Ice pipe heater' must be replaced with the improved part.
 - Before improvement: DA97-21801A - Currently available and updated to Improved part
 - After improvement : [DA97-21801C](#) - Available once stock of revised part DA97-21801A is depleted
- Part Name : ASSY PIPE WATER ICE

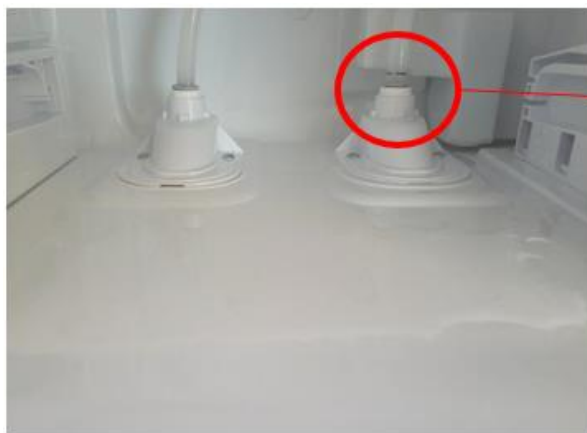
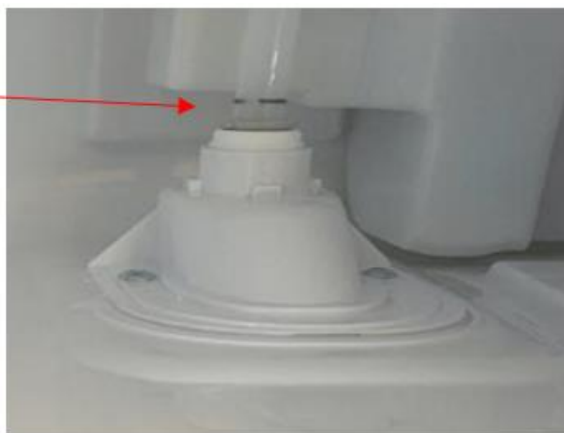
2. Water leakage on the fridge floor (hose is not inserted up to black line)

Important: When re-assembling the hose, you need to insert the hose fully into the pipe assembly

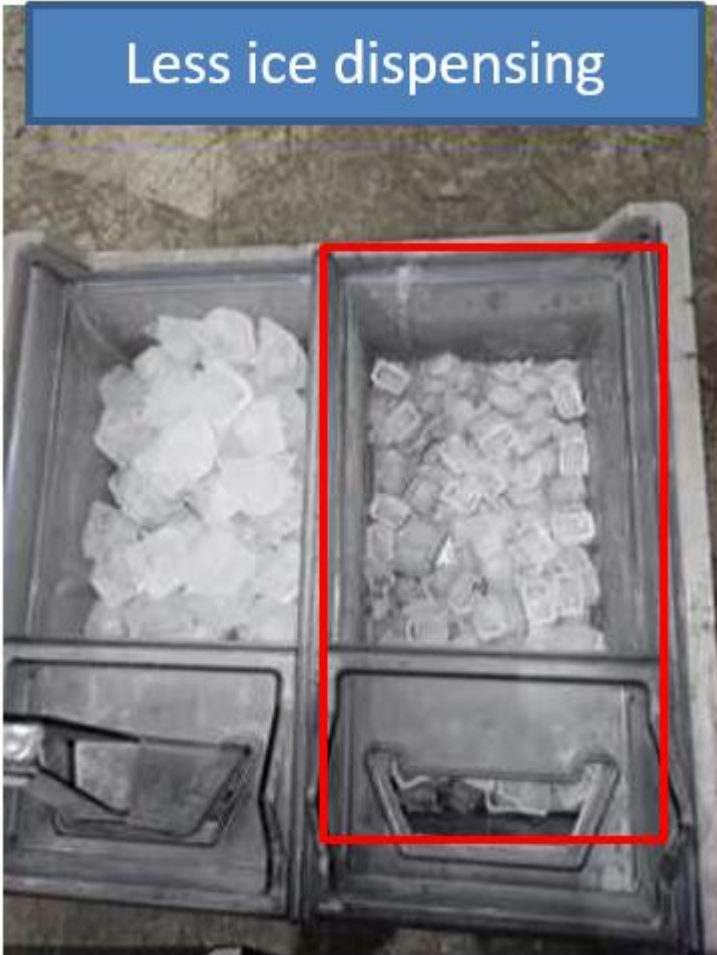
3. Ice is not dispensing (Bite side)

Less ice dispensing

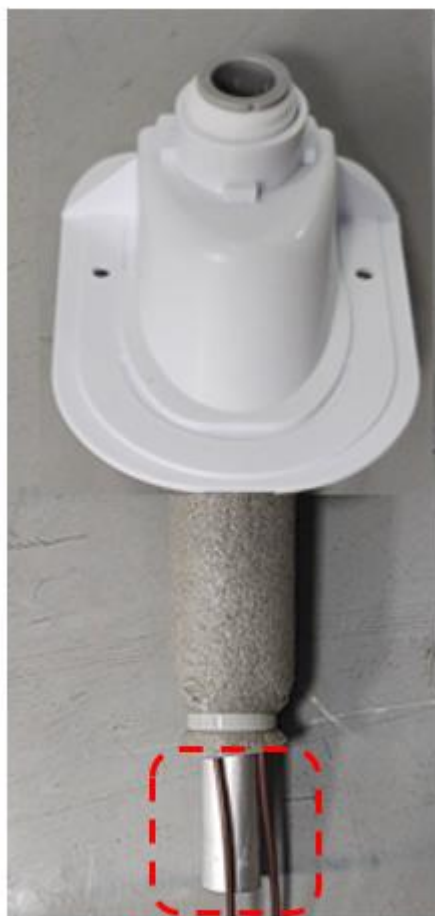
[Before]

Pipe exposure
length 30mm

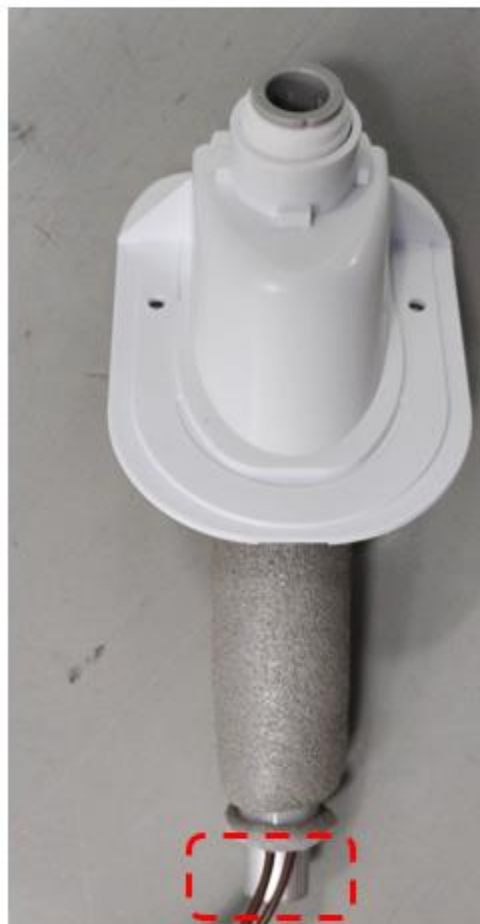
[Improved]

Pipe exposure
length 10mm

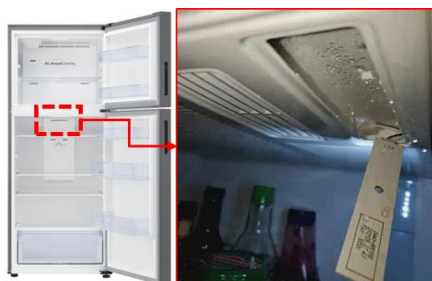
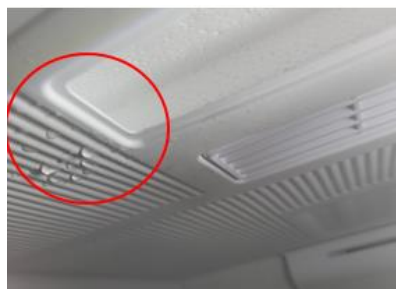
Water leaking from FF ceiling by the lamp which is caused by super cooling of the freezer when unit ice maker is set to on, but unit does not have ice maker present or is connected to water.

Under this condition the temperature of the freezer can achieve -24 C (-11.2 F)

This condition will cause condensation on the lower (fresh food) compartment

Turn off ice making function - the switch for ice maker control is located on the left rear side of the top table.

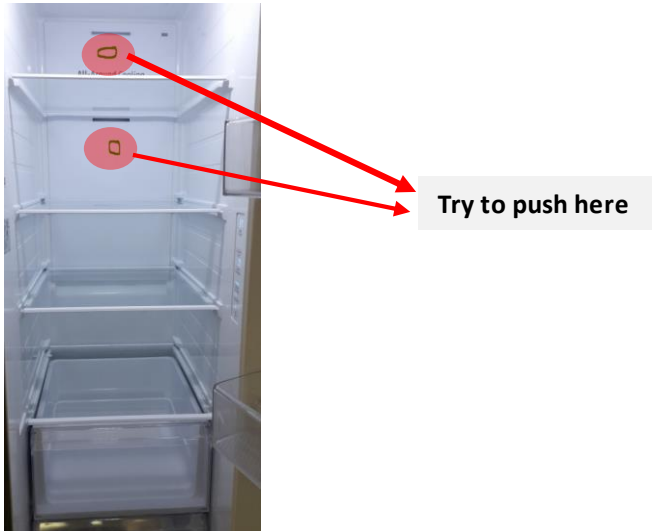
- Check if the evaporator cover is correctly assembled.
If the evaporator cover has movement when trying to push (there is a sound), this is a bad assembly.

- If a bad assembly of the evaporator cover is discovered, disassemble cover and reassemble to ensure the ribs are attached in the liner hooks.

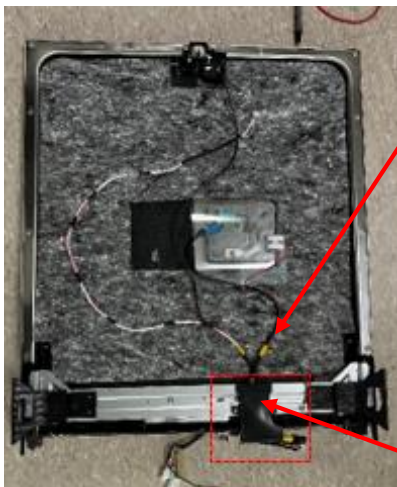
- Unit is not filling with water (4C error)
- Unit display PC & 7C error
- Ran Smart Install and received PC or 4C, or 7C
- **Three types(PC, 4C, 7C) of errors occur intermittently or alternately**
 . With the neutral wire connected to the water valve (4C), distributing motor (PC), and geared motor (7C), three errors can occur simultaneously or alternately.
- **The same error occurs even when the error-related parts are replaced.**

- Replace the wire harness (sub) that assembled in the inner door. (Below red arrow)
- Refer to the table below for Part No.

※ **Don't replace the Assy Door, Just replace the only wire harness sub**

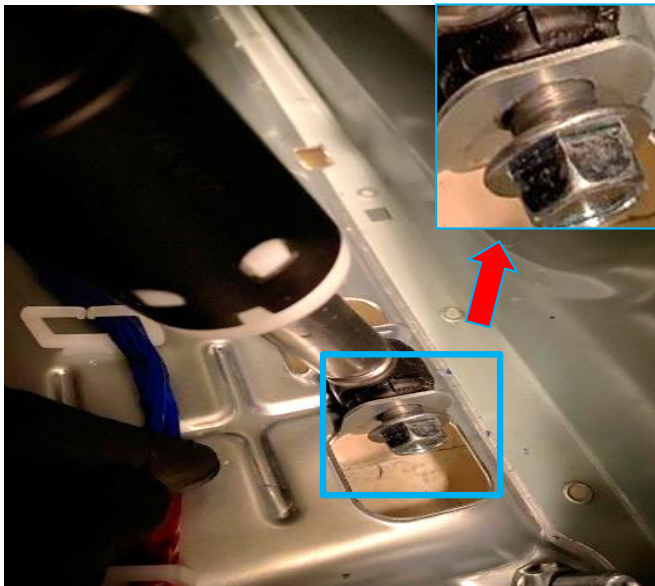
Vibration and knocking noises due to loose mechanical connection between the bottom frame tab and damper caused by stripped threads on the bottom mounting tab

Loose mechanical connection

1. Identify which damper is the source of the noise.
2. If a loose damper is identified, attempt to tighten the bolt to the bottom frame mounting tab.
 - a) If the bolt cannot be tightened, order and install **A/S ASSY-DAMPER KIT (DC82-01634A)**. The kit will include a new bolt and nut.
3. Remove the bottom bolt from the damper and insert the new bolt from the A/S ASSY-DAMPER KIT through the mounting tab and damper.
4. Install the nut on the back side of the bolt.
5. Secure the nut using a 15mm socket and ratchet. Use an impact drill with a 15 mm socket and tighten the nut until it is flush with the mounting tab.

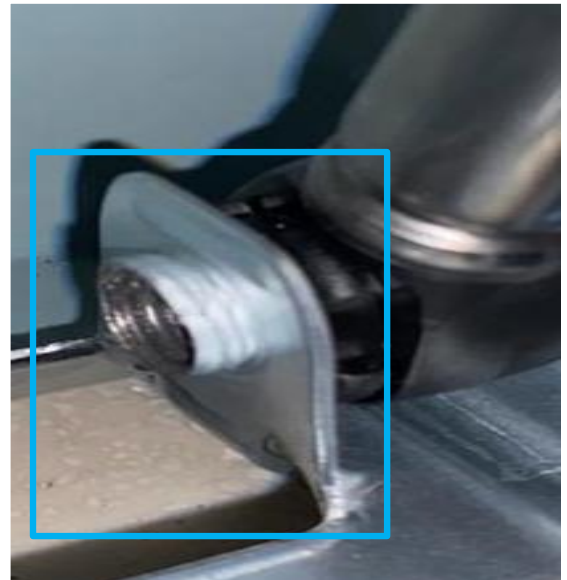
Back view of mounting tab w/ stripped thread
