Long-term monitoring of a damaged historic structure using a wireless sensor network

Esequiel Mesquita^{a,*}, António Arêde^a, Nuno Pinto^a, Paulo Antunes^b, Humberto Varum^a^a CONSTRUCT-LESE, Faculty of Engineering of University of Porto, Department of Civil Engineering, 4200-465 Porto, Portugal^b I3N & Department of Physic of the Aveiro University and Instituto de Telecomunicações, Campus de Santiago, 3810-193 Aveiro, Portugal

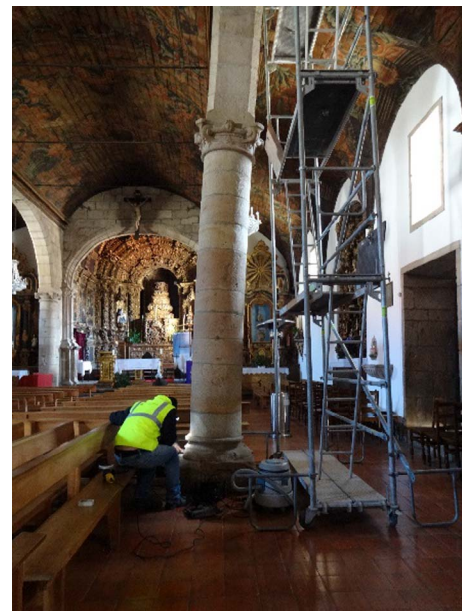
Fig. 2. Photograph of column 2, evidencing its inclination.

lateral right, as well on the main façade. The column 2 (Fig. 2) was assigned as the region with higher deformations, and hence densely instrumented. Column 2 is the main instrumented column presented in Fig. 5.

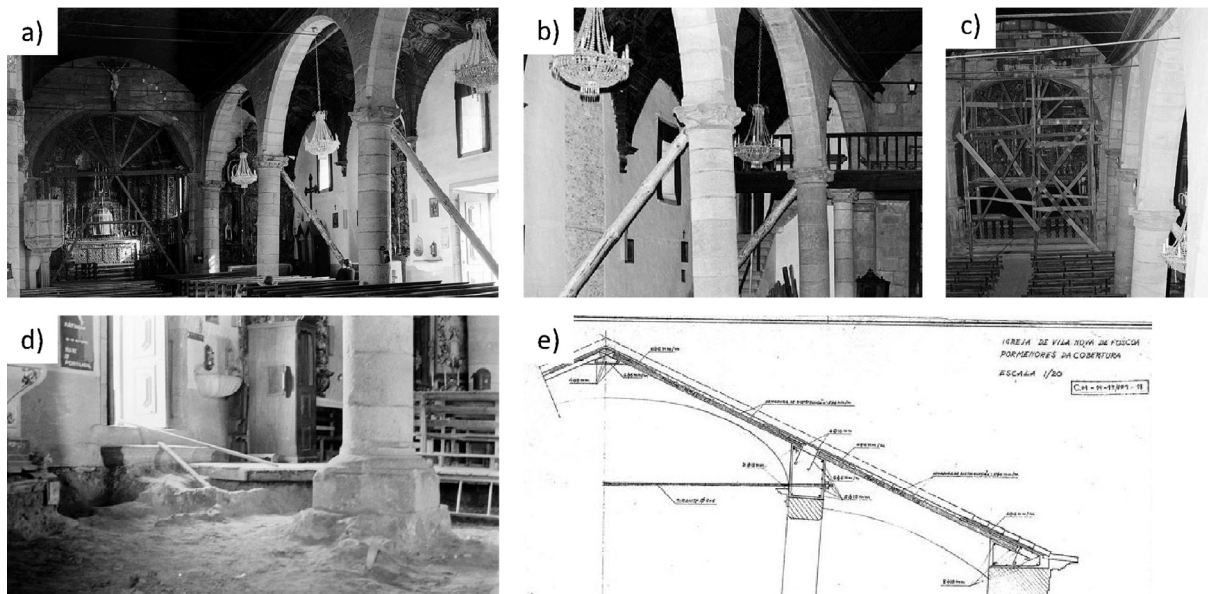
Fig. 4. Main interventions carried out on Foz Côa Church in the 1970s: (a) bracing of the Main Arch and columns, (b) details of the columns bracing and (c) details of the main arch bracing; (d) inspection performed on foundations elements and (e) detail of project of the reinforced concrete roof slab built during the retrofitting measure [17].

performed in the 1970s, characterized essentially through bracing of the columns on the right and left naves (Fig. 4a and b) and main arch (Fig. 4c). Additionally, an inspection on the foundations elements was carried out (Fig. 4d) in order of to investigate the soil properties and its influence on damages progression. The experimental investigation concluded that the soil presented good characteristics without settlement risk. The retrofitting process included the arches and columns stabilization through the construction of a pre-stressed concrete slab, shown in Fig. 4e. After that, the relative displacements and column deformation were reduced, and the cracks emergence minimized, a fundamental measure for keeping the structural safety of the Church. However, new cracks have been observed in the arches and in the columns and the absence of periodic registers on relative displacements of the columns makes difficult to assess if the damages emergence are related with temperature effect or with structural problems.

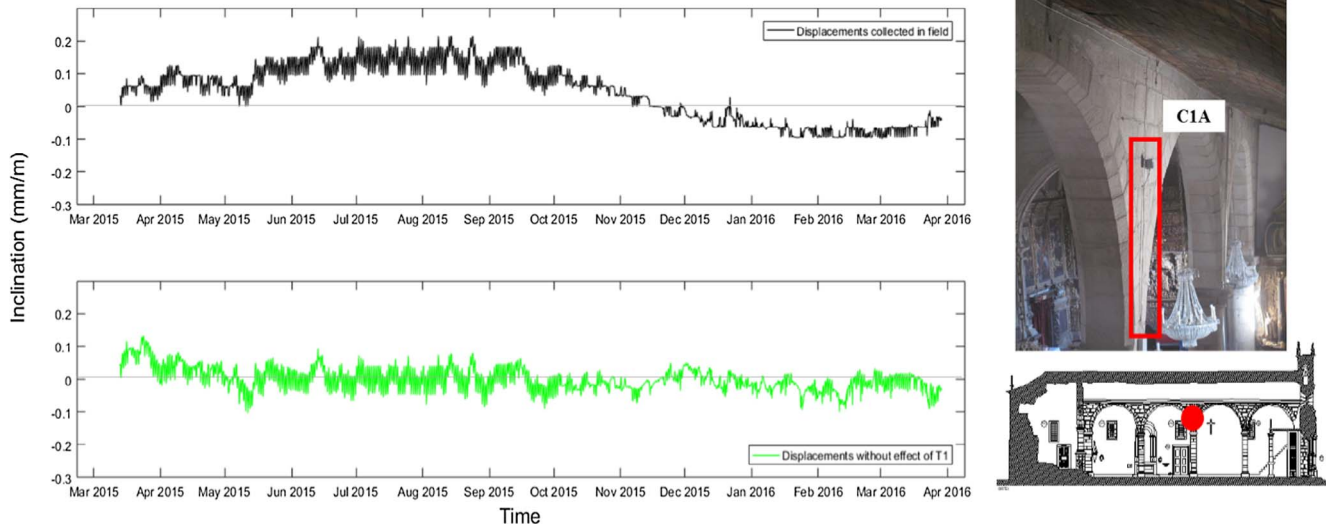
From the analyses of the inclination time evolution data, of the column 2, plotted in mm/m, it can be noticed that high temperatures are more influencing than low temperatures. In general, when the average temperature values are close to 38 °C, the inclination reach values around 0.320 mm/m. In contrast, during the winter, when the average temperature values are around 5 °C, the inclination measured values are close to 0.100 mm/m, in the opposite direction from the movement observed during the summer (see Fig. 11).

Removing the temperature effect from the inclination values recorded by sensor C1A, the curve can be fitted by a line (see Fig. 11). The inclination movements evolution over 1-year monitoring on the Column 2, without the temperature effect compensation shows maximum value of inclination of 0.320 mm/m (ranging from 0.320 mm/m to −0.200 mm/m), and with compensation a maximum value of 0.210 mm/m (in a range between 0.210 mm/m to −0.180 mm/m) was estimated. Therefore, a 34.4% difference was calculated between the maximum inclination values, estimated with and without compensating the thermal effects.

Essentially, the inclination movements collected over 1-year demonstrate that the increase of the temperature observed between March/2015 to the beginning of August/2015 are influent in the inclination value increase on column 2, to right lateral nave direction, while between August/2015 to beginning of March/2016, the inclination tends to go in the opposite way, namely to direction of the main nave. After the thermal effects removal, it was noticed that the inclination is not related with structural movements, only with annual thermal cycles.

Fig. 11. Time evolution of the inclination measured by sensor C1A on column 2 with and without the temperature effect.

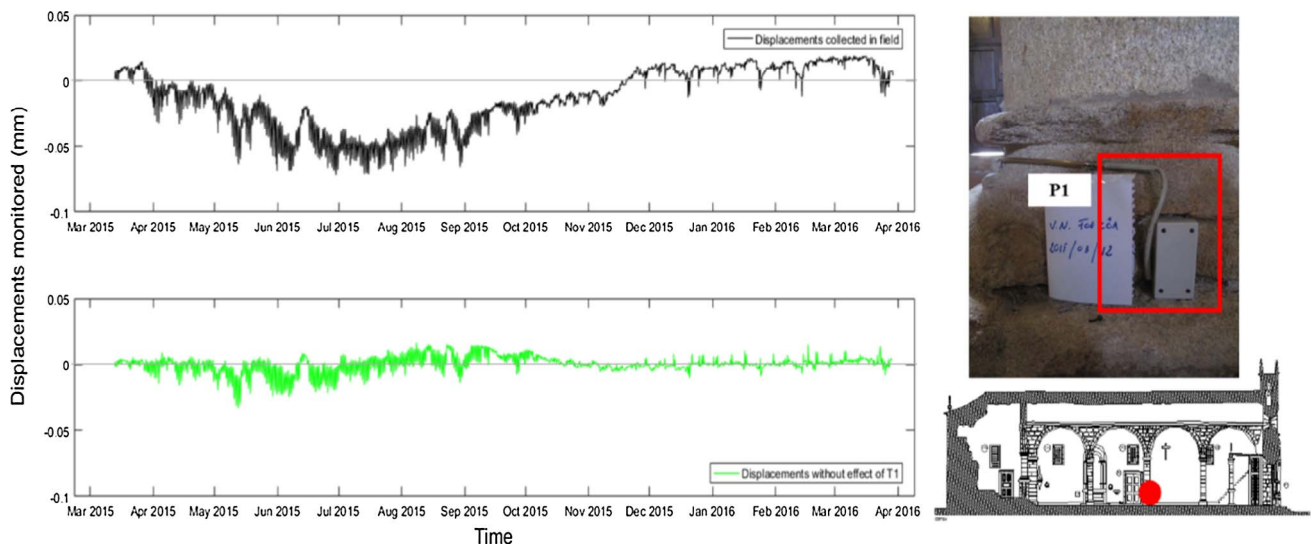
Concerning the displacements measured on the bottom of the column 2 by the potentiometer sensor P1, its time evolution is presented in Fig. 12. To identify the thermal effects on the relative displacement collected, a correlation between the displacements and the temperature evolution (t_1) was done and Eq. (2) was obtained, where $D_{P1}(t_1)$ is the relative displacements in function of the temperature T1C, in mm, and t_1 represents the temperature value, in °C. The respective correlation coefficient (R^2) is shown in Table 1.

Through the time evolution analysis, while the temperature stimulus induces a displacement, acquired by sensor P1, varying from −0.078 mm to 0.020 mm, the displacement behavior without the thermal effects vary from −0.040 mm to 0.020 mm, evidencing the temperature influence at the base of the column to the up direction, in this case, assigned as the negative values. Essentially, these relative displacements, related with the temperature increases, can be due to the inclination movements, collected by C1A, as well. In fact, the temperature increases can induce the base of the column 2 to move, aggravating the emergence of tension on it.

Especially during the summer period, the relative displacements recorded through P1 achieved higher values. This way, the temperatures and the relative displacements recorded in July and August of 2015 are presented in Fig. 13, allowing to observe the day-by-day thermic cycles, and its correspondent effects on the relative displacements evolution. After removing the temperature effect, the relative displacements tend to stabilize around zero, supporting our finding of absence representative structural movements.

Fig. 12. Time evolution of the displacements measured by sensor P1 on the bottom of the column 2 with and without the temperature effect of t_1 .

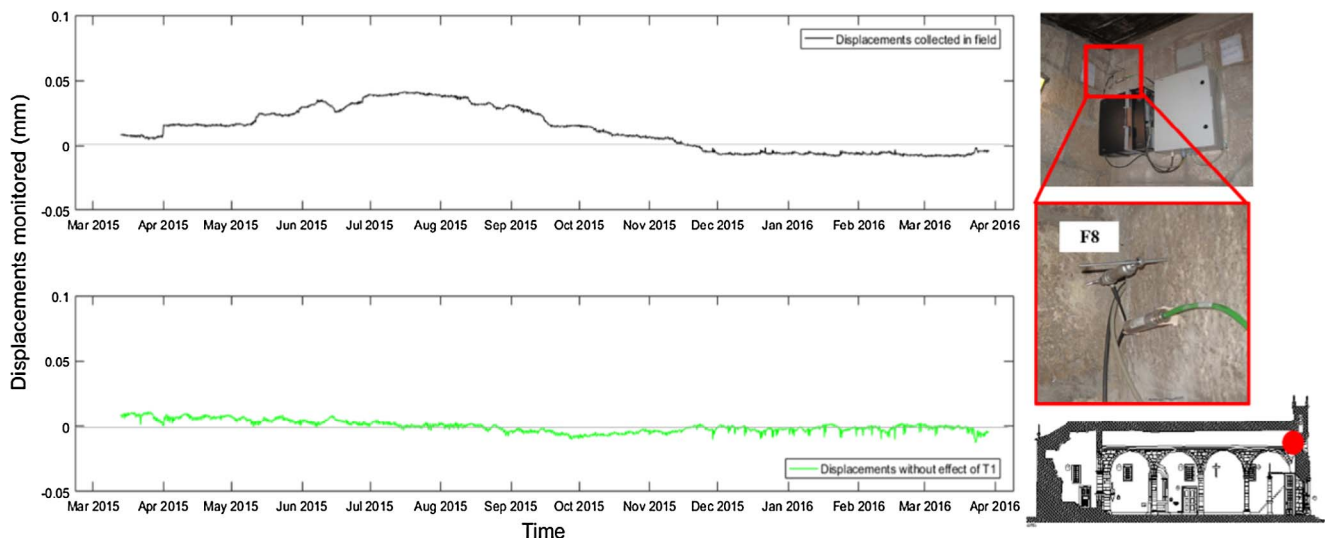
The displacements data, collected by sensor F8, with and without the effect of the temperature t_1 is shown in Fig. 14. The correlation function between relative displacements and the temperature values

Based on the evolution of the measured linear displacements at the sensor F8 location, after the removal of the thermal effect (t_1), the amplitude of the relative displacement along the longitudinal direction decreased. In July 22, 2015, for instance, the displacement curve with the temperature effect presented a maximum of 0.05 mm, while after the removal of the internal temperature effect (t_1), the maximum displacement found was 0.02 mm, in other words, the internal temperature effect virtually increased the displacement up to 250%.

Fig. 14. Time evolution of the displacements measured by sensor F8 on the top of the internal side of the main façade with effect of the temperature and without temperature effect of t_1 .

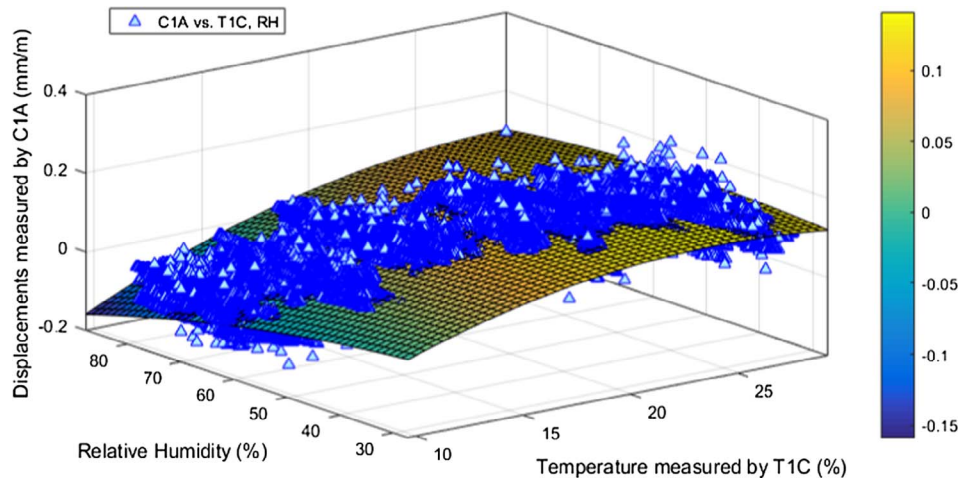
The correlation between the temperature (collected through sensor T1C) and the relative humidity values and the inclination measured at C1A sensor location, is shown in Fig. 15, with an estimated correlation coefficient, R^2 , of 0.86.

humidity (around 80%) and temperature increase (around 10 °C) can aggravate an inclination movement of the column 2 of roughly 0.150 mm, in the main nave direction of the Church. Otherwise, a low relative humidity (between 50% and 60%, for instance) can constrain the column 2 inclination for the same level of temperature variation. The inclination movement in the opposite situation, namely in the direction of the right lateral nave, occur when the values of temperature are near or higher than 20 °C for all levels of relative humidity.

Fig. 15. Influence of the combined effect of the internal temperature and relative humidity on the inclination movements, measured through sensor C1A at column 2.

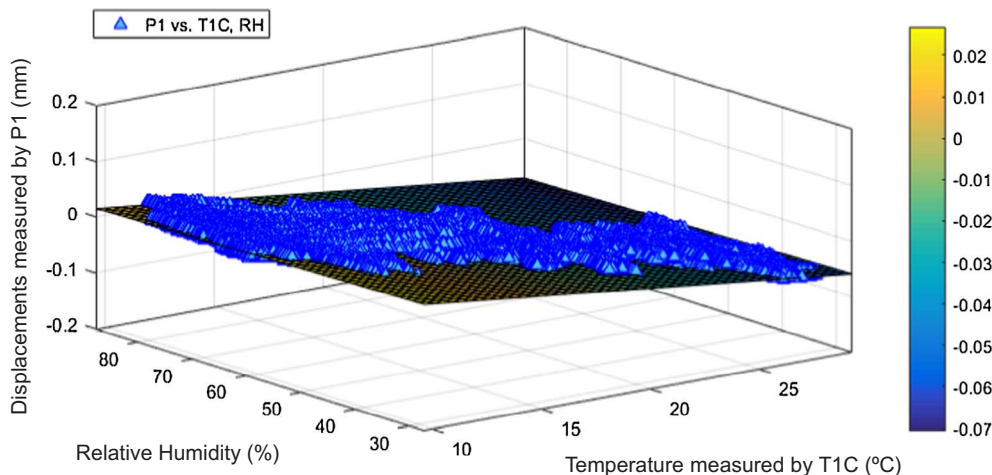
Concerning the combined effect of the temperature and relative humidity on the relative displacement observed at the column 2 base, the results are presented in Fig. 16, with an estimated correlation coefficient, R^2 , of 0.92.

relative displacement at the basis of the column 2 are mostly influenced by temperature rather than relative humidity changes. Additionally, inclination along the column 2 also has an impact on the relative displacement observed at the basis, contributing for overlapping the relative humidity effect on the structural movement at the basis of the column 2.

Fig. 16. Influence of the combined effect of the internal temperature and relative humidity on the displacement measured at the bottom of column 2, by sensor P1.

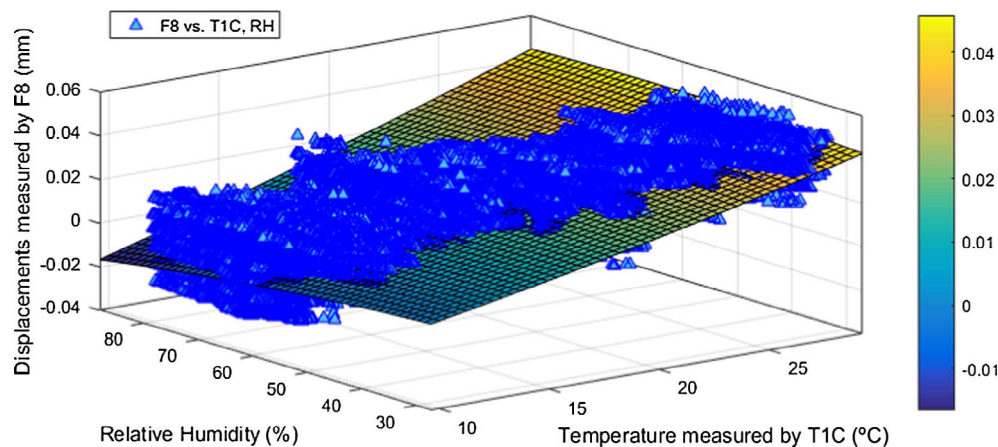
Regarding the relative displacement measured on the stone wall, the combination between the temperature (t_i) and the relative humidity effects, in the longitudinal direction, is shown in Fig. 17. The correlation coefficient R^2 was identified as 0.84.

The surface represented in Fig. 17 data present a smooth curvature with higher slope and parallel to the temperature axis. Only in the 60% to 80% RH range, combined with temperature values over 20 °C, incites the wall movement (on the monitored point) to the interior direction of the main nave, otherwise the temperature increase induces a movement in the opposite direction. It was estimated that an 80% RH combined with a temperature value of 10 °C produce an average displacement of 0.02 mm to the interior direction of the main nave.

Fig. 17. Influence of the combined effect of the internal temperature and relative humidity on the movements at internal side of the main façade collected by sensor F8.
