Multiple TOCTOU conditions in SMIFlash SW SMI handlers

BIOS Image: G513QR.330 (2022/10/28) - Latest available as on Feb 2023

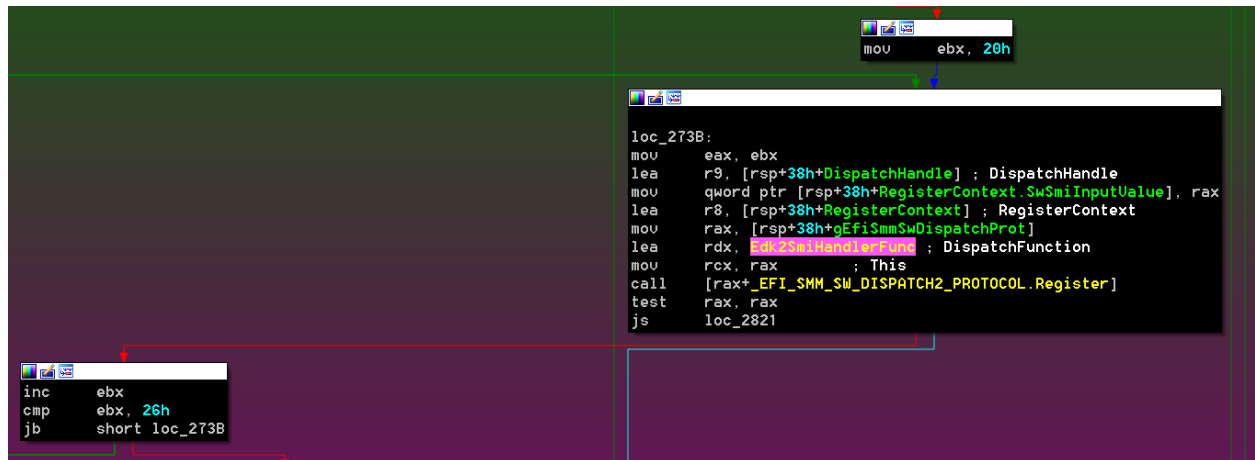
The SMIFlash module (GUID BC327DBD-B982-4F55-9F79-056AD7E987C5) is one of the SMM Modules that are included in the BIOS Image G513QR.330 for the ASUS Rog Strix G513QR. This module registers a single SW SMI handler for six different `SwSmiInputs` (0x20, 0x21, 0x22, 0x23, 0x24, 0x25) via the `EFI_SMM_SW_DISPATCH2_PROTOCOL` protocol:

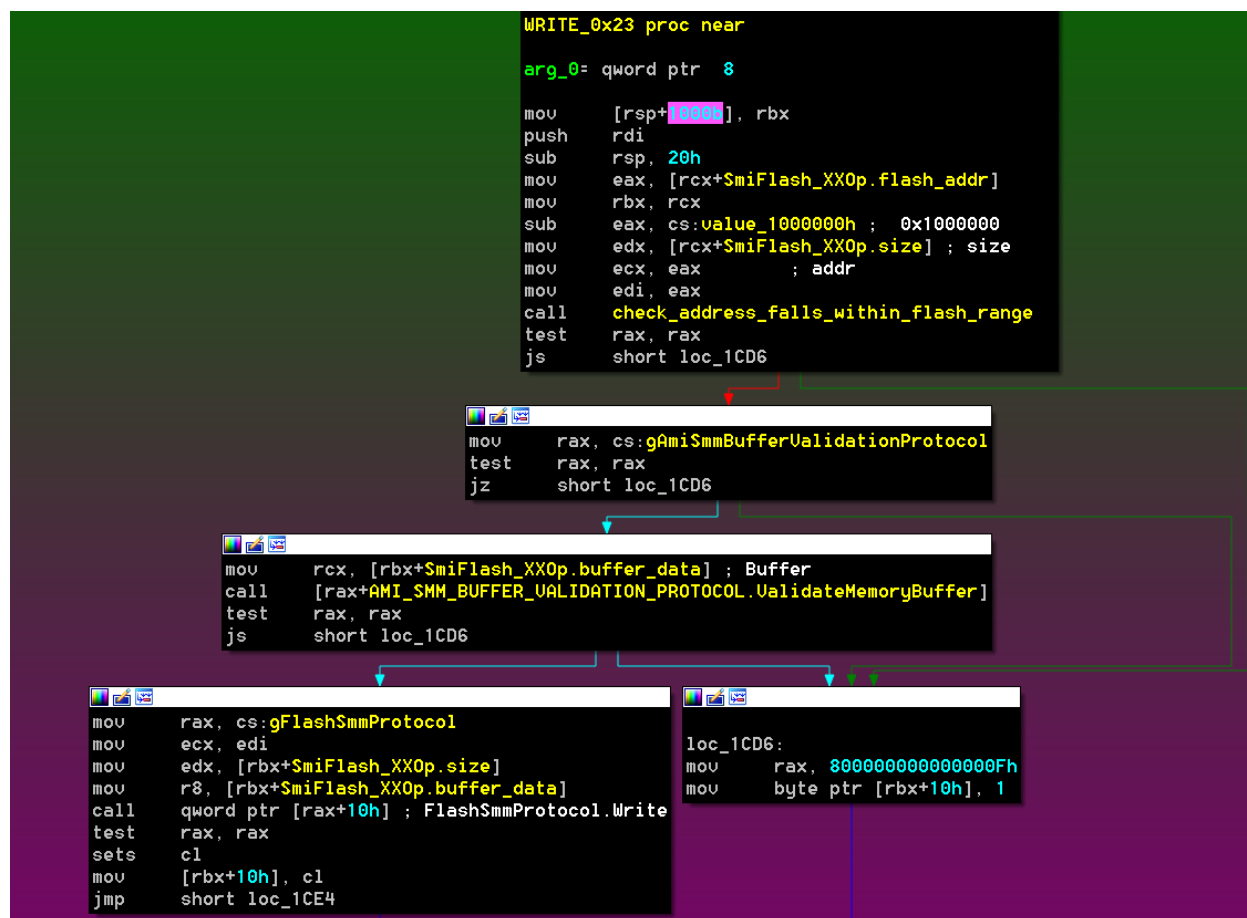
The Write operation has the exact same condition, although in this case, winning the race means leaking content from SMRAM into the Flash:

As a summary, in both cases, the block of code performing the checks did not make local copies of the values into SMRAM. The values are being retrieved again from user controlled memory when they are about to be used, which means they could have changed.

- Copy the provided arguments into SMRAM and then perform the corresponding validation in order to avoid double-fetch issues.
- Call `AMI_SMM_BUFFER_VALIDATION_PROTOCOL.ValidateMemoryBuffer` on provided buffers before reading or writing to them.

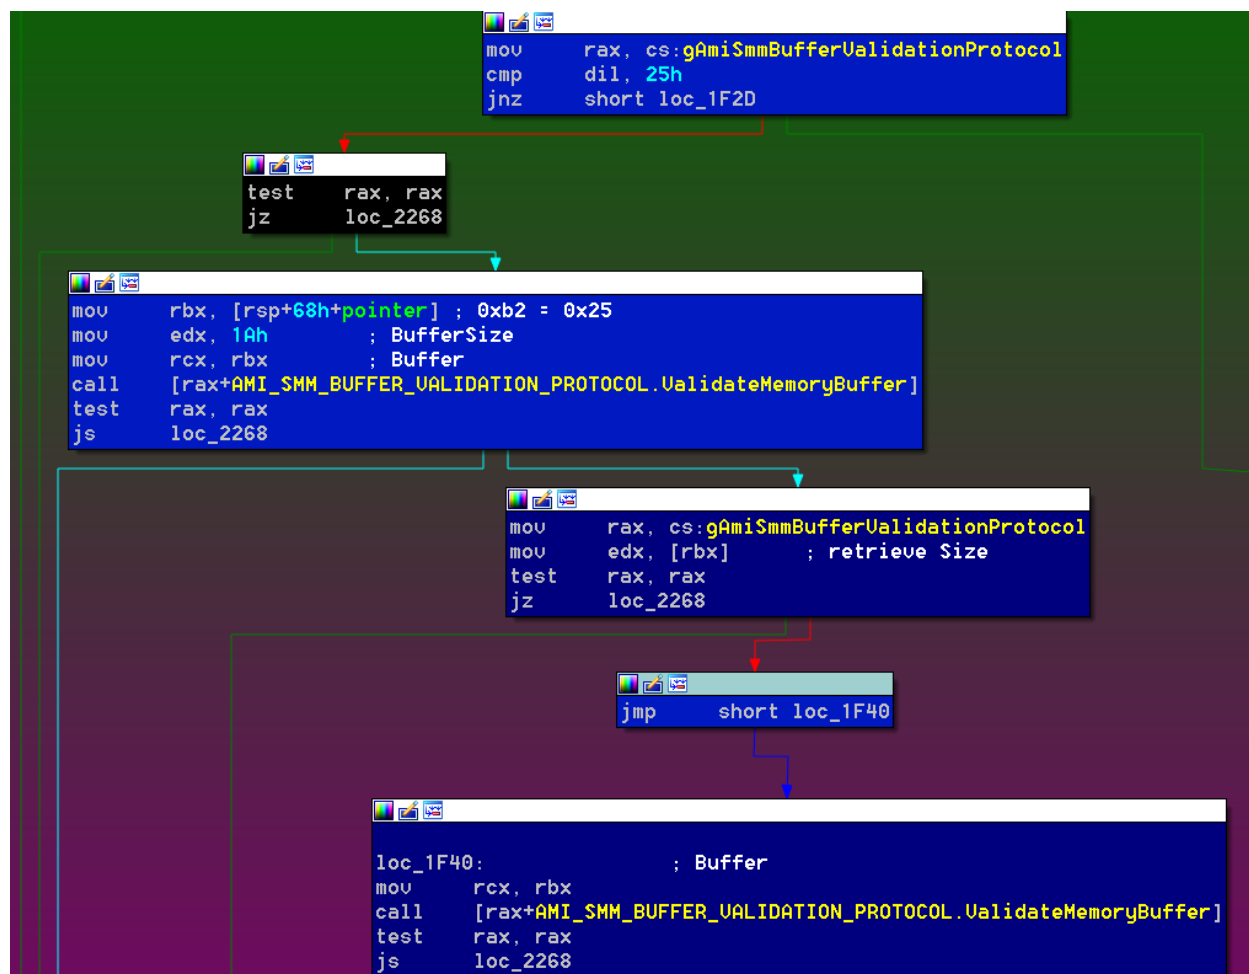
The operation GET_INFO (0x25) is affected by the same condition, although in a different way. In this case, as soon as the user pointer is constructed, the code verifies it to be outside of SMRAM for at least 1Ah bytes. Then, it retrieves the value of the first dword and uses it to further check the length of the provided region:

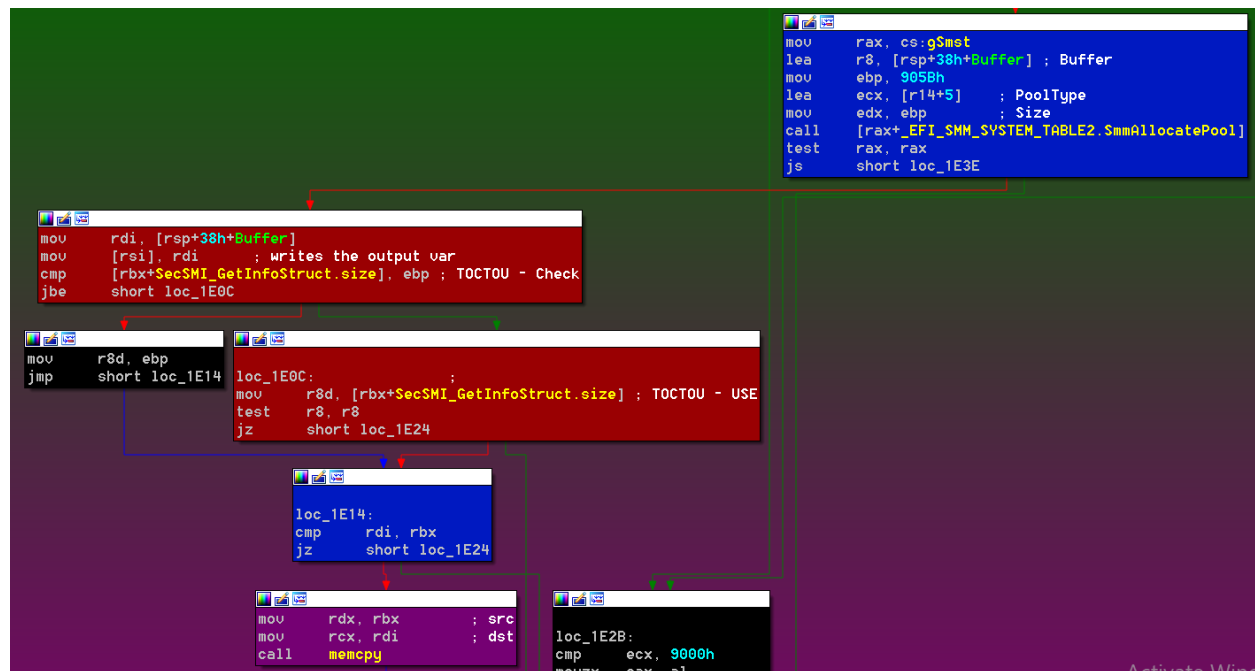
The code continues by calling into a function that allocates 905Bh bytes of SMRAM memory and attempts to copy the data into it. RBX is the pointer to the record, and the double-fetch is clear:

The code is trying to enforce 905Bh bytes as an upper limit for the copy but because the memory is fetched twice, the value could have changed after the check passed. As a result, SMRAM memory will be corrupted.
