Health and Safety near miss

Croydon & Lewisham Street Lighting

Incident notification

Date and time of incident:	23/07/22 10.56	Injury severity:	n/a
Alert Author:	Lisa O'Connor	Potential severity:	Major
HS&W Lead:	Leon Reilly	Investigation Completed:	Full
Trade/company involved:	Milestone Street Lighting	Operational disturbance:	Fall from permanent structure

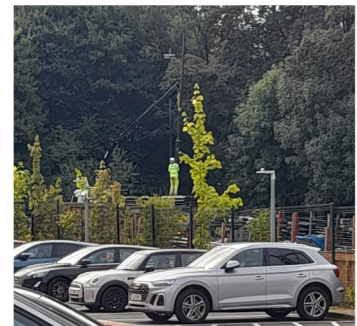
A Milestone Street lighting operative was seen working unsafely in their Leatherhead depot. The Operative climbed onto the bed of the vehicle and then stood on the columns to attach a chain, without any fall arrest. The activity was seen and stopped by the client, Connect Plus Services, and a discussion was held with the operatives. Connect Plus Services submitted a near miss through their own system and raised the issue with the contract lead. A full investigation was carried out.

- Operative was stood on a pack of columns on the bed of a Hiab Lorry without fall arrest whilst guiding a column into place.
- Fall from Height was not managed with the lack of fall arrest equipment.

- The sequence of loading the columns was not considered so that the columns could fit correctly in the lorry bed preventing the operative to climb up without any fall arrest.
- The team was not briefed on the Work at Height Procedure or the Lift Plan.

Familiarise yourself with the current Lift Plan & Work at Height Procedure on MIMs.
Ensure all procedures are briefed and a signed copy logged for future reference.
Have you developed and briefed a Loading & Unloading SSoW.
Ensure your team complete a LOWRA at the start of each task.
