Lessons Learned

High Pressure Gas Main – High Potential Event

Date of incident	05/05/2022	Incident type	High Potential (HiPo)
Incident ref number	INC12388	Contractor	BBV
Sublot	SL7.1	Location	Curdworth Cutting
Keyword search	High Pressure Gas Main	Reported by	David Hayward

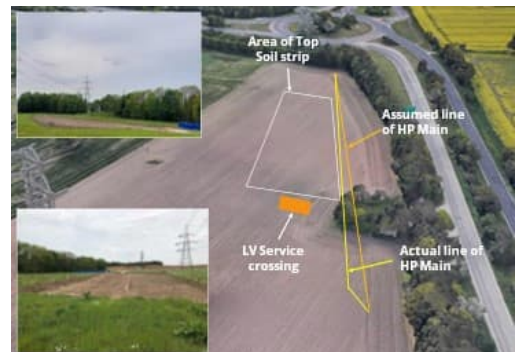
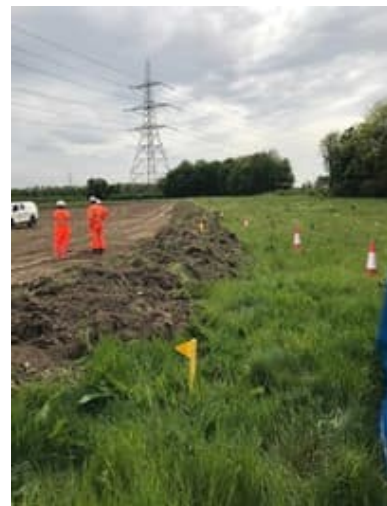
Photographs

A Cadent gas surveyor observed BBV using plant in the vicinity of their High Pressure (HP) Gas Main and requested work to cease. A Cadent Surveyor later visited site to mark out the asset and it was confirmed that the works were taking place within the gas main's exclusion zone, with a bund, formed by the topsoil/vegetation removal, positioned above the main.

- No easement fencing was in place for the HP Gas Main.
- The route of the HP Main was clearly shown on iSpatial/drawings.
- No confirmation of the actual HP Main route was undertaken by BBV, either during planning phase or during the works.
- BBV did not follow Cadents' 'Pink Slip' Site Visit Request Process.
- No Permit to break ground was requested / issued.
- Daily Coordination Meetings were not attended by all Teams, including the Earthworks and Permit Teams.
- There was a lack of understanding of the Setting People to Work procedure and Service Avoidance requirements.
- Risk Assessment, Method Statement (RAMS) covering the activity were insufficient and not reviewed following a change to the design of the pond being constructed.

- Onboarding process needs improving to ensure key procedural requirements are communicated and understood, particularly to Supervisors.
- Project wide approach to 'Asset Protection Teams' needs to be confirmed and reflected in the Underground/Overhead (UG/OH) Services Procedure.
- An accurate register of ALL known assets in each Sub Lot, plus details of easement fencing/protection measures is required.
- A series of roadshow presentations is to be undertaken in all Sub Lots, supported by Cadent. These will remind people of the risks of UG/OH services, share findings/lessons learned from BBV incidents and provide guidance on Asset Owner requirements.
