Safety Briefing

Contractor Safety Assurance Team

April 7th 2022

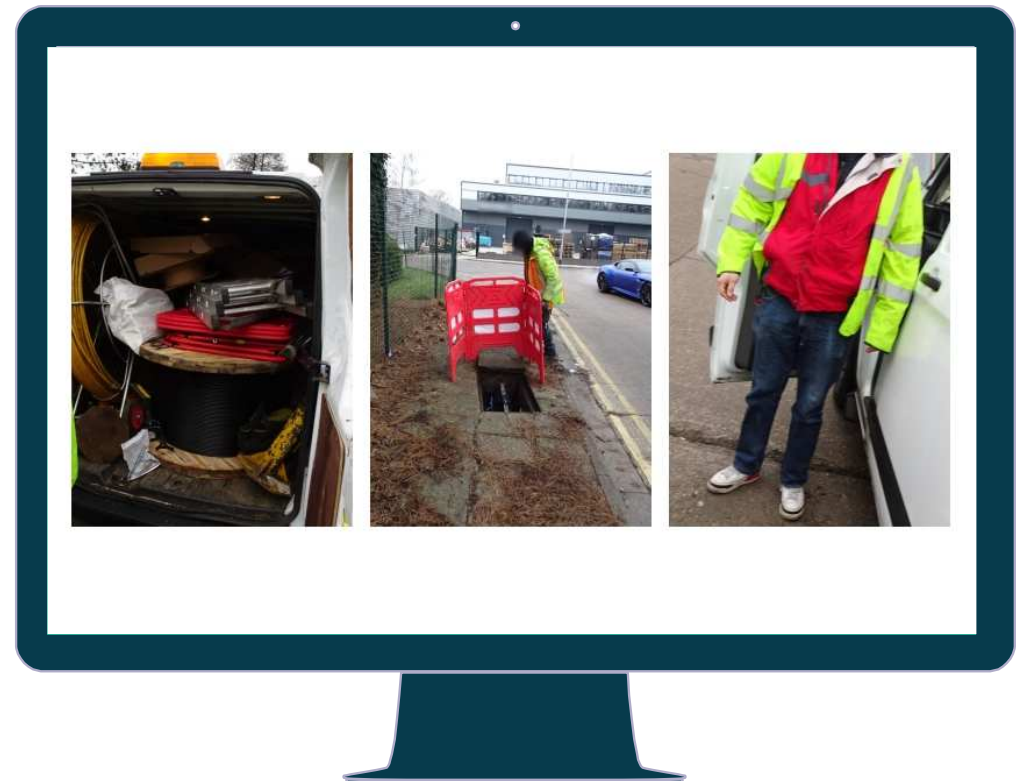
Incident 1

Unsafe Site Set Up and Poor Vehicle Storage

An operative was witnessed working in a joint box without appropriate signing, lighting and guarding (SLG), no Gas Detection Unit (GDU), unsuitable Personal Protective Equipment (PPE) and without the appropriate lifting key or rolling bar. The van internal storage was unsafe.

- The GDU should also be used when first opening a joint box and should be in use and as close as possible to the open joint box.
- All PPE including boots should be worn.
- Enough SLG to cover the whole working area should be in place.
- Missing SLG, PPE or GDU should be reported to the line manager immediately.
- The rear space of commercial vehicles should never be overloaded and tools and items should be stored correctly. If the vehicle is missing appropriate racking, the operative should inform their line manager.

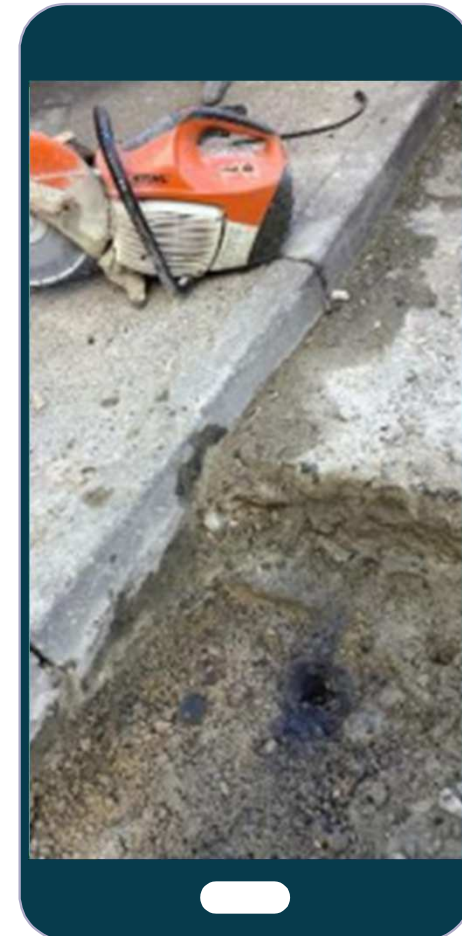
Incident 2

Electric Cable Strike

Whilst excavating in the public highway, an operative damaged an electric cable, causing burns to the skin.

Cable detection devices were not utilised and after conducting a visual survey of the site, it was assumed that all electrical cables in the area were housed in a nearby box and not in the working area.

- When any undertaking excavation work, no matter how small or shallow, cable detection equipment should be used to confirm whether underground utilities are present.
- Always follow safe excavating practices.
- Always ensure that Linesearch has been undertaken and that utility drawings are present.
- Assumptions should never be made regarding the location of underground utilities.

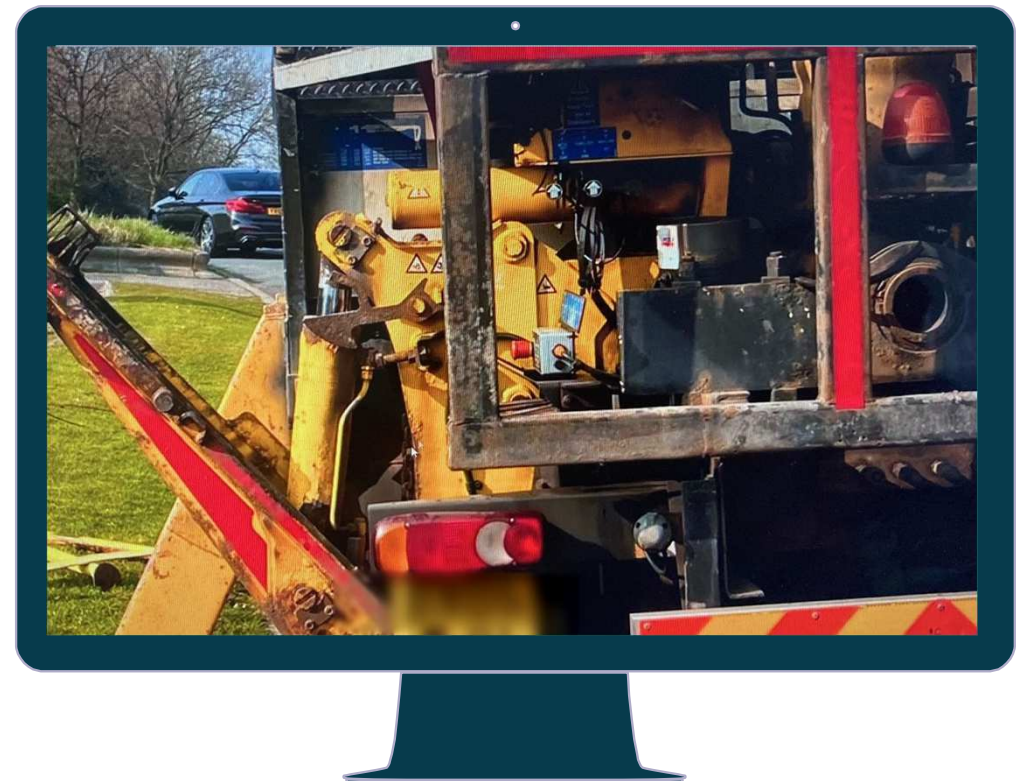
Incident 3

Event: Arm Trapped in PEU Leg Mechanism

An operative was working at the back of a PEU vehicle, when his arm became trapped between the vehicle and the stabilising leg, causing the arm to break.

- Only trained individuals should operate the machinery on any PEU or MEWP vehicles.
- Operatives should stand clear and only use the buttons as they are intended.
- Vehicle safety inspections should be carried out as per manufacturers' recommendations.
- Daily inspections should also be carried out by the operators.

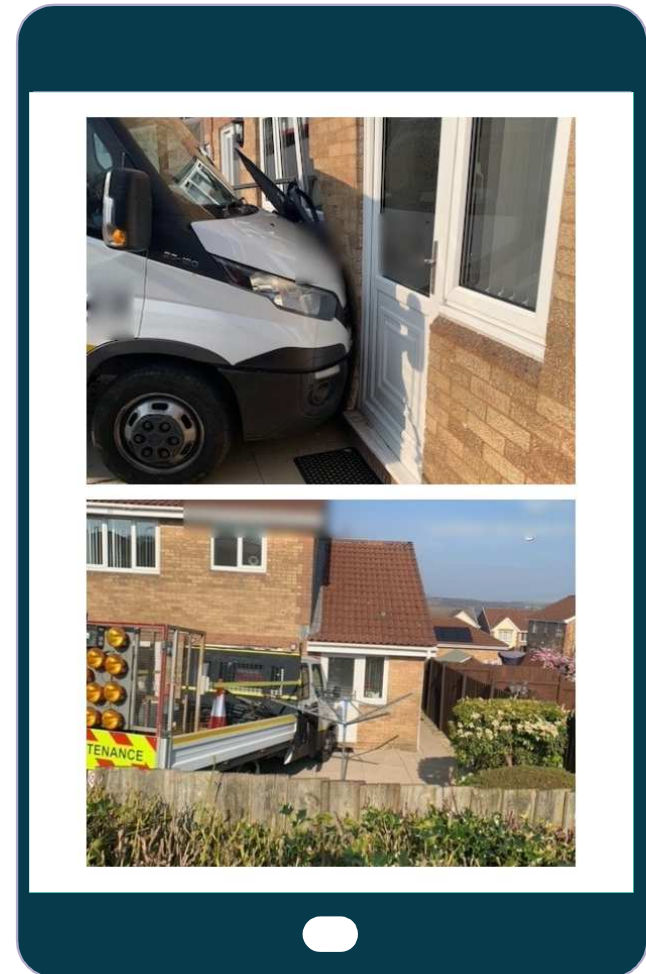
Incident 4

Vehicle Rolled Uncontrolled into a Private Residential Premises

A traffic management vehicle rolled uncontrolled into a nearby residence. No one was hurt but the potential was there.

- Daily vehicle checks are mandatory including checks of the vehicle's brakes and handbrake.
- If parking on a hill, the vehicle must be left in gear. If facing uphill leave in a forward gear, if facing downhill, leave in reverse.
- Before leaving a vehicle, always double check to make sure the handbrake is applied.
- If parking on a hill, turn your wheels into the curb to minimise the risk of rolling into traffic.

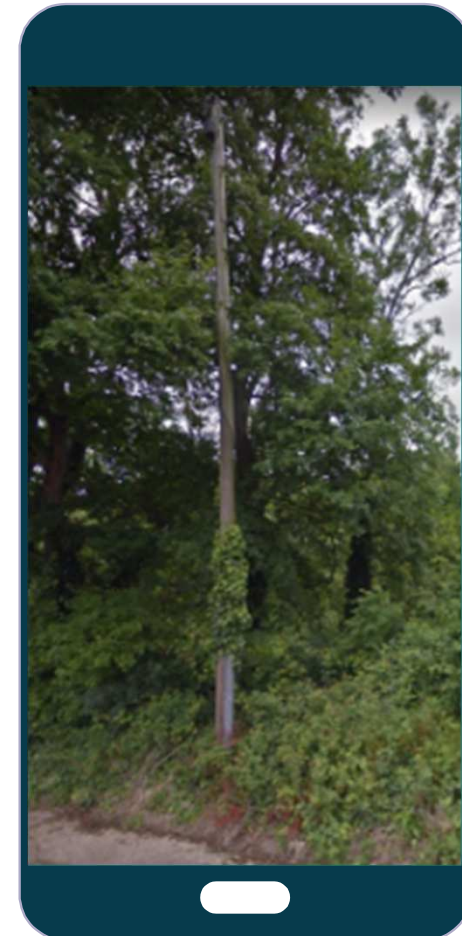
Incident 5

Fall From Height

When working from a pole, an operative attempted to climb a ladder without the use of a fall arrest system. He fell 2-3 metres and lost consciousness, before taken by ambulance to hospital.

- Use of a fall arrest system - TETRA or equivalent is mandatory where ladders are used.
- If the ground is uneven, bottom end stability devices or packing blocks are to be used.

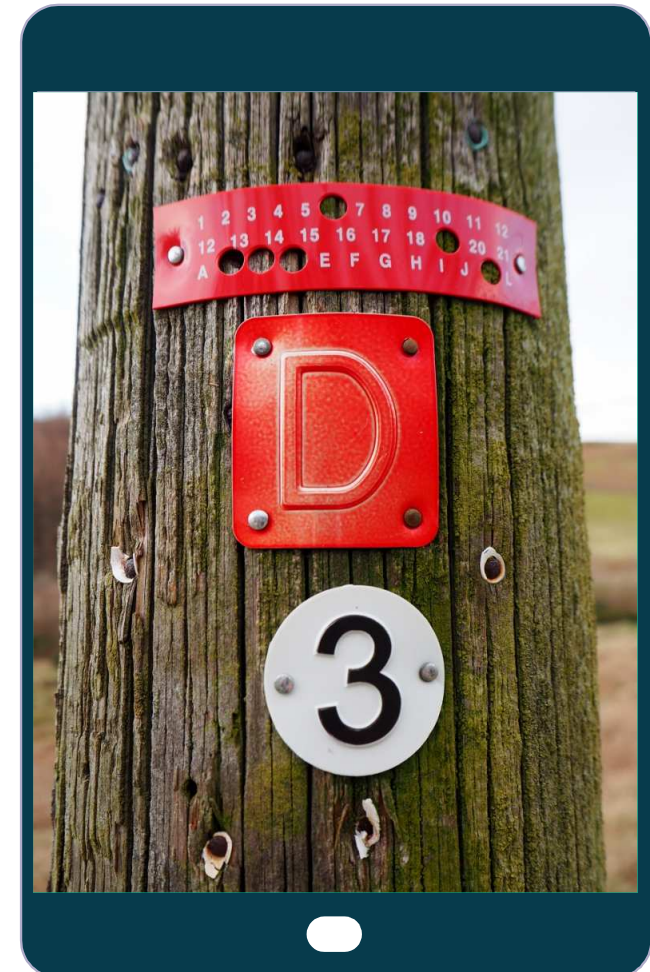
Incident 6

Operative Climbed 'D' Pole

An operative was witnessed climbing a 'D' pole.

- Under no circumstances should a 'D' pole be climbed
- A MEWP should have been used in this situation.
- Pole checks must be undertaken.
- All pole climbing must be with a fall arrest system in place – TETRA or equivalent.
- If in doubt of any pole markings, operatives should notify their line manager in the first instance.

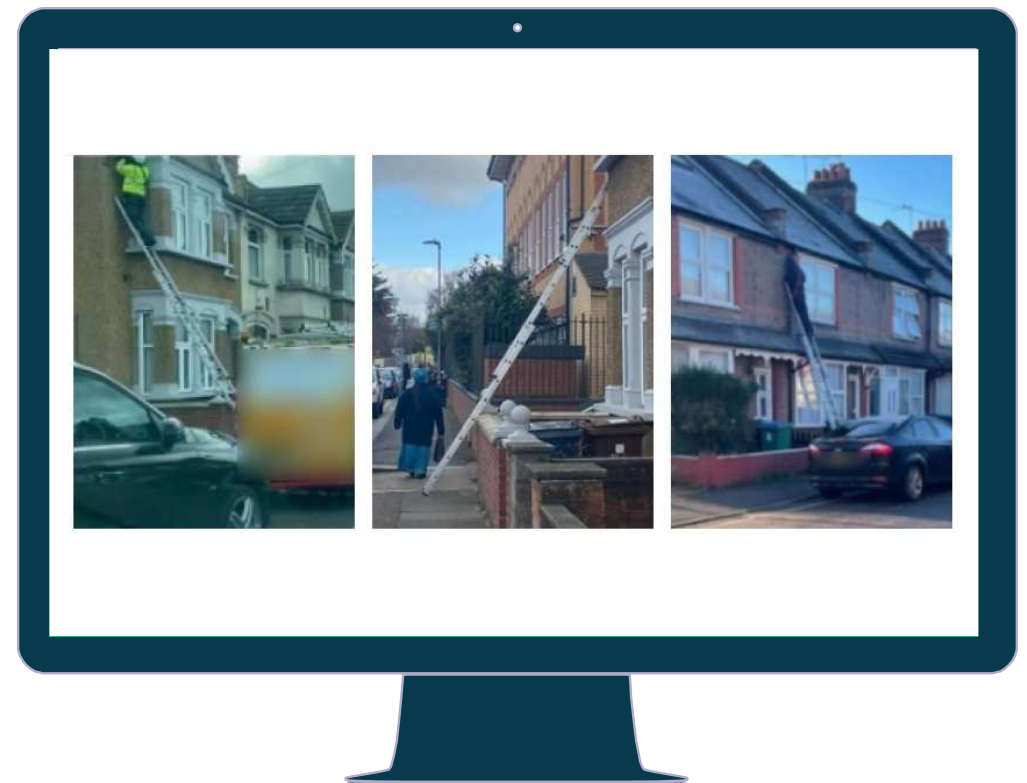
Incident 7

Working at Height Without Fall Arrest System and Appropriate PPE and Guarding

An operative had set their ladders up in the footpath without any guarding. A second operative on a different job did not wear a high viz or helmet whilst completing the works. On both occasions, TETRA or equivalent fall arrest system was not used.

- Use of a fall arrest system, TETRA or equivalent is mandatory where ladders are used.
- Gate guards should be used when ladders are in the public footway to protect the public and the user.
- All PPE must be used when working at height including boots, high viz and a hard hat.
- If an operative is missing any tools or PPE required for working at height, they must contact their line manager immediately.

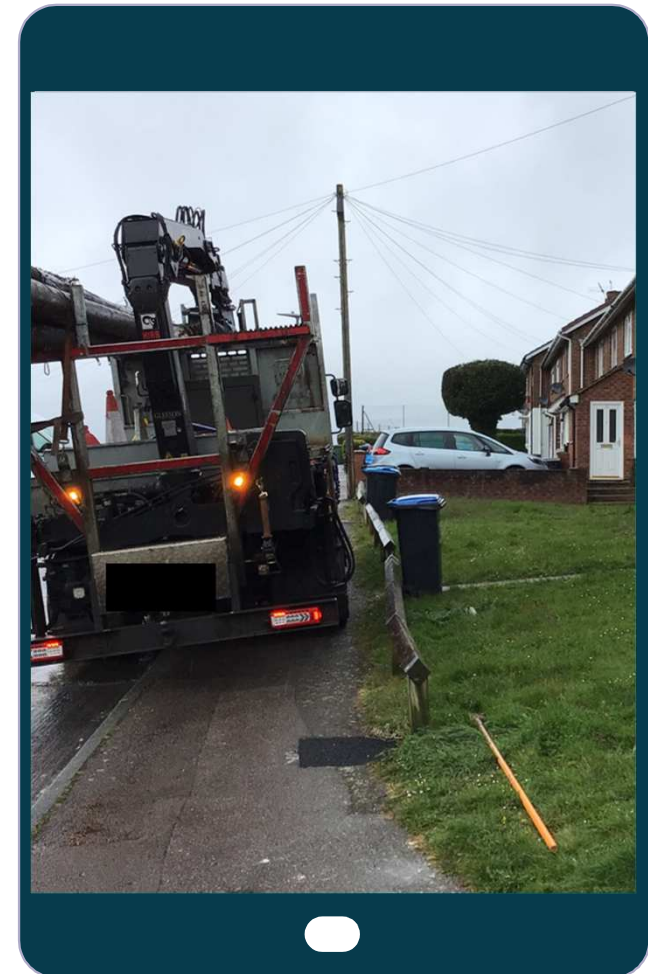
Incident 8

Broken Leg When Descending PEU

An operative accessed the rear of a PEU after lowering the HIAB arm to the flat bed to unclip the spoil sheet. He lost his footing on spoil that had spilled onto the flatbed resulting in him jumping or falling from the rear side of the vehicle. This resulted in a broken right tibia.

- Working on the flatbed of a PEU is working at height and the means to prevent falls should be in place.
- Access routes on flatbed vehicles must be kept clear.
- Ensure the work area is as clean as possible and free from obstructions.
