Planning Policy Briefing

openreach

A CBT must only be served from one SASA/Splitter

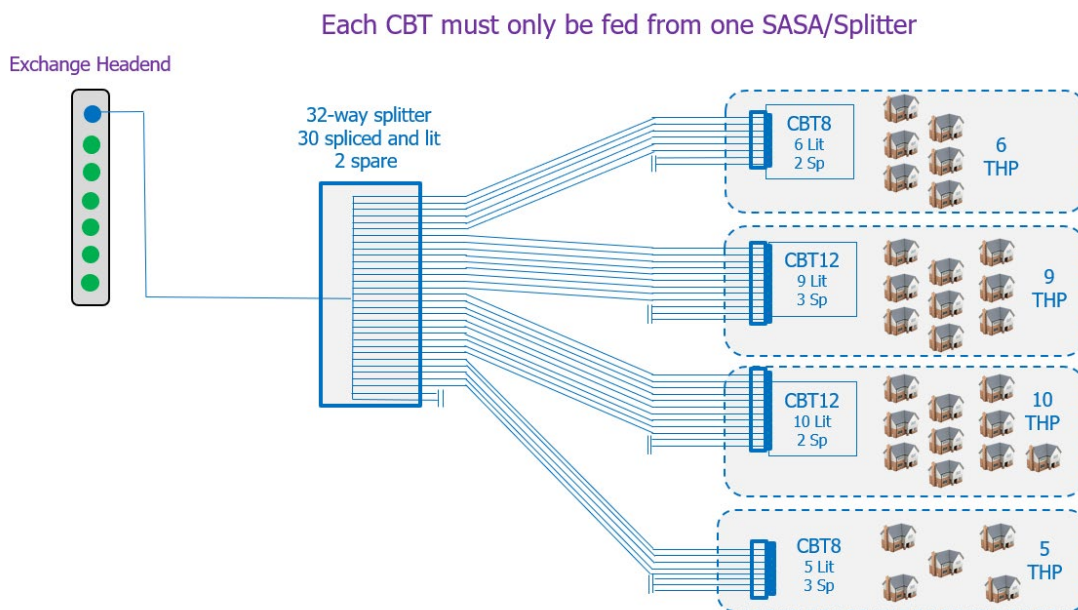
Diagram1 – Example of a correctly built SASA/Splitter to CBT network (above)

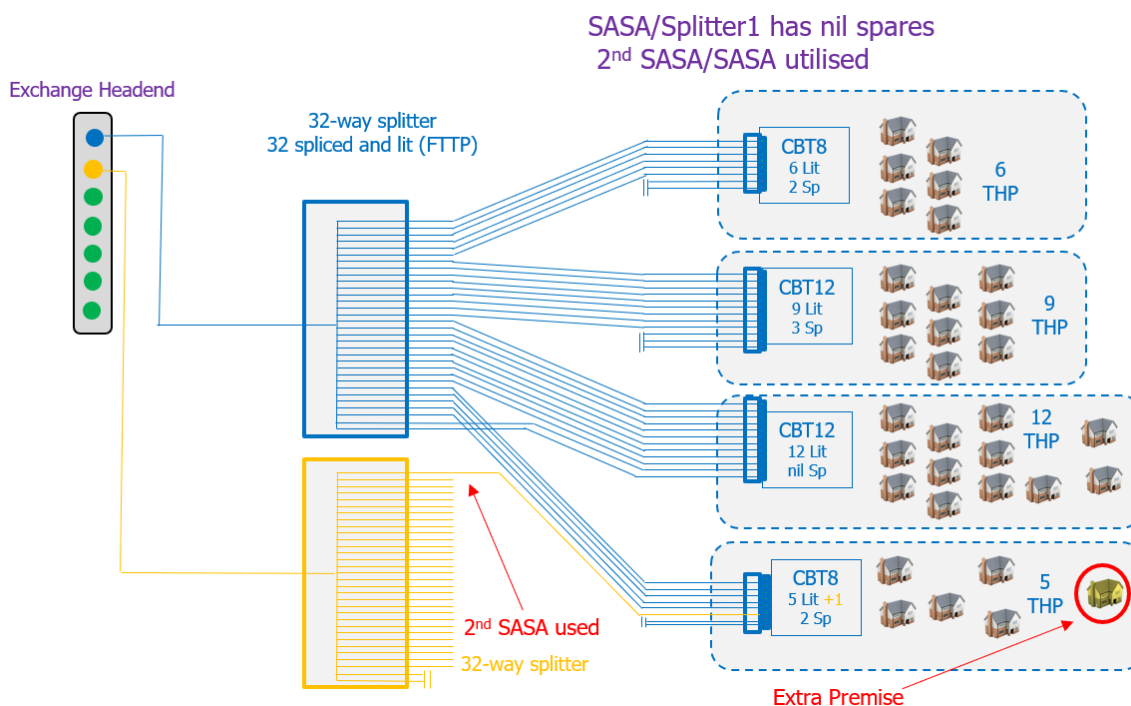
Additional premises have been added to CBT's and this has resulted in all outputs from the SASA/splitter being utilised.

Another new premise now requires service (shown below) and a non-compliant solution has utilised a spare output from the 2nd SASA/Splitter and provided connectivity to the existing spare port on the CBT.

Diagram 2 (Above) – Example of a **non-compliant** solution (above)

During L2C easy fix, do not rearrange a fibre from one SASA to another SASA to provide service and sync the ONT light

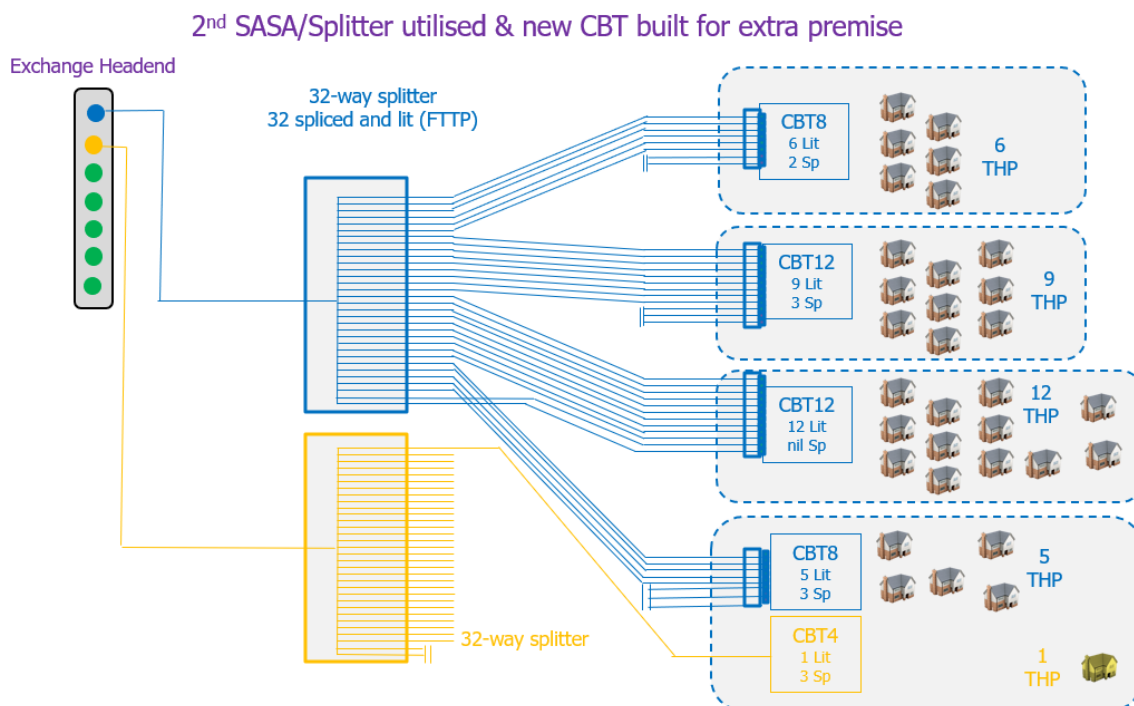
Diagram 3 – This shows a policy compliant solution. Please note that the new CBT can be located in a new position to help an easier L2C journey provision.

Where a new premise requires service and nil spares exist at the SASA/Splitter. The correct solution is shown below in diagram 3. A new CBT should be provided to allow connectivity to the customer from the next available SASA/Splitter outputs.
