Work related injury

Cambridgeshire Highways

Incident notification

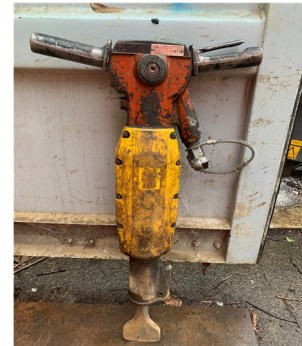
[Pneumatic hand breaker]

On Friday the 25th February 2022 a subcontractor operative was operating a pneumatic breaker to break up some concrete. The concrete was extremely hard and as the concrete broke away the operative lost his balance and fell causing him to trap his fingers between the pneumatic breaker handle and the side wall of the drainage trench which he was working in at the time.

- Incorrect selection of breaker attachment (Bolster Chisel)
- IP returned to banksman duties

- Consideration of plant, equipment and associated attachments are suitable and appropriate for the task
- Review and up-date of RAMS if the work or site conditions change
- Ensure all equipment is used appropriately in accordance with safe system of work

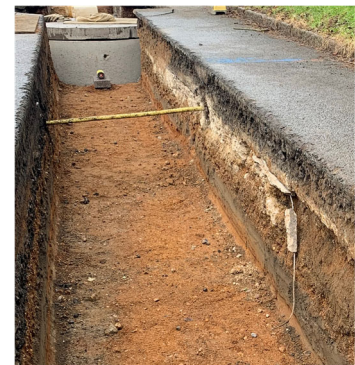
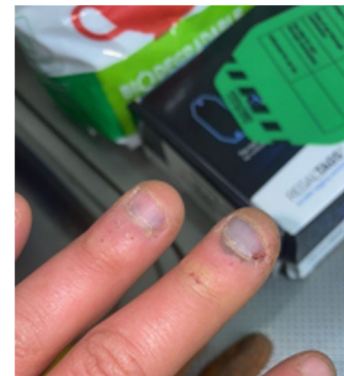
[Post incident location]

- Change in ground conditions (old kerb line). Contractor made Milestone aware and had been breaking out concrete with no issues prior to accident
- Equipment being used slightly above IP's feet. Potential manual handling issue Musculoskeletal injury. Control of breaker slightly compromised as using above feet and therefore unable to fully control breaker with upper body strength

- Thought process was to not use excavator mounted pecker due to proximity of gas service, decision was made to use hand breaker
- IP held onto breaker as he lost control and trapped fingers between handle of breaker and trench wall

- Where appropriate ensure all ground conditions surveys are carried out prior to start of work
- Consideration of plant, equipment and associated attachments are suitable and appropriate for the task
- Review and up-date of RAMS if the work or site conditions change
