High Potential Near Miss Incident – Excavation Safety

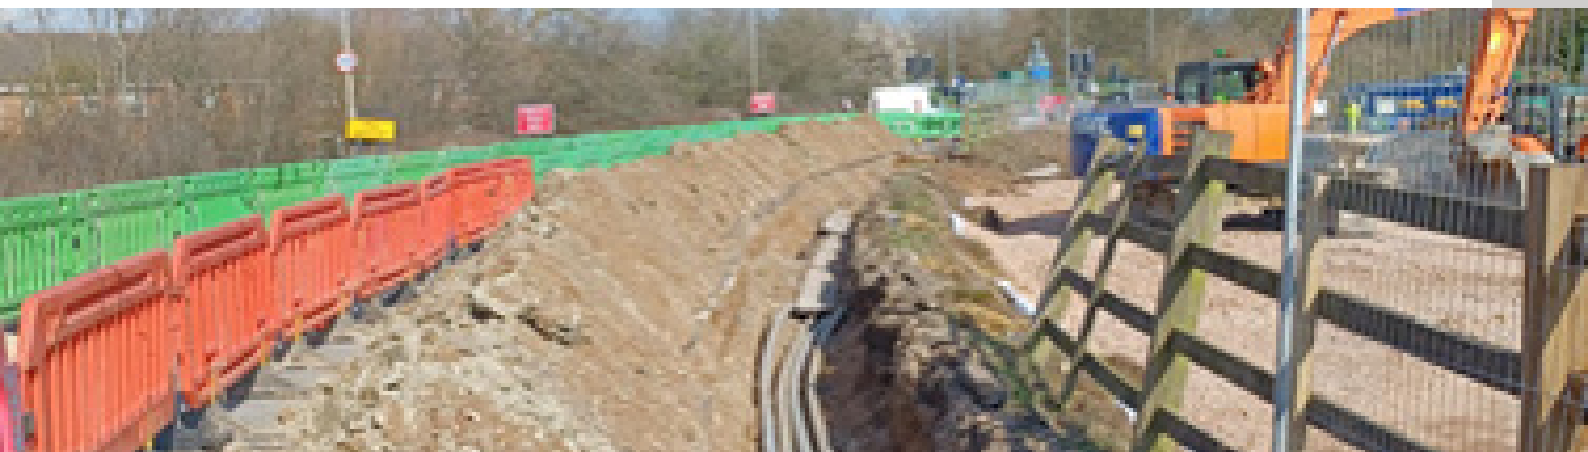
Once completed the team commenced repositioning the four-way ducts, when a piece of tarmac fell away from the side of the excavation (between the two working areas) making contact with the right calf of the IP coming to rest against the exposed four-way ducts.

The tarmac between the two work areas was undermined and with the significant loading of excavated material created an unsafe working condition for the working party.

The construction site operating heavy plant to grade and compact the adjacent roadway causing a vibration factor to already unstable ground.

- Always assess your working area, identify all associated hazards, and implement appropriate control measures and record via the on-site/ point of work risk assessment app
- All excavated material shall be suitably positioned to prevent increased side loading and materials falling into the excavation
- Implement and install protective systems (Benching, Sloping, Shoring, Shielding) where required to prevent trench collapse
- Always consider how other people's work activities impact and increase the risk to your working environment
- **If unsure, Stop Work and Ask!**
