Paul Vahle GmbH & Co. KG

Burger

## Current status of the system in Burger

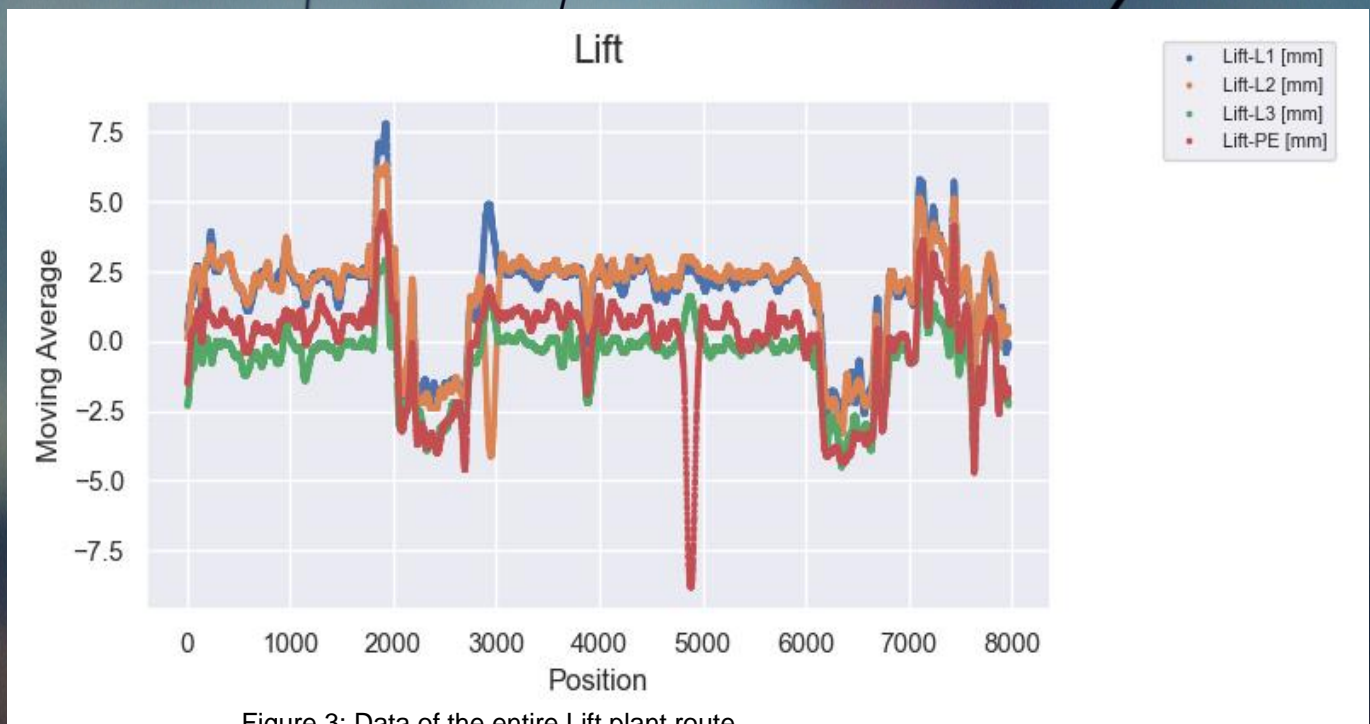
Figure 3: Data of the entire Lift plant route

As can be seen in the above illustration, the Lift path and the Deflection path of the entire plant section of 7967 cm Length determined.

The Current Collector moves in the range of 7.8 mm to -8.8 mm in Lift and in range of 4.0 mm to -14.9 mm in Deflection and thus in its permissible range overall. The visible gaps in the display are due to the fact that the Current Collector did not travel through all the routes/areas of the system during the recording time.

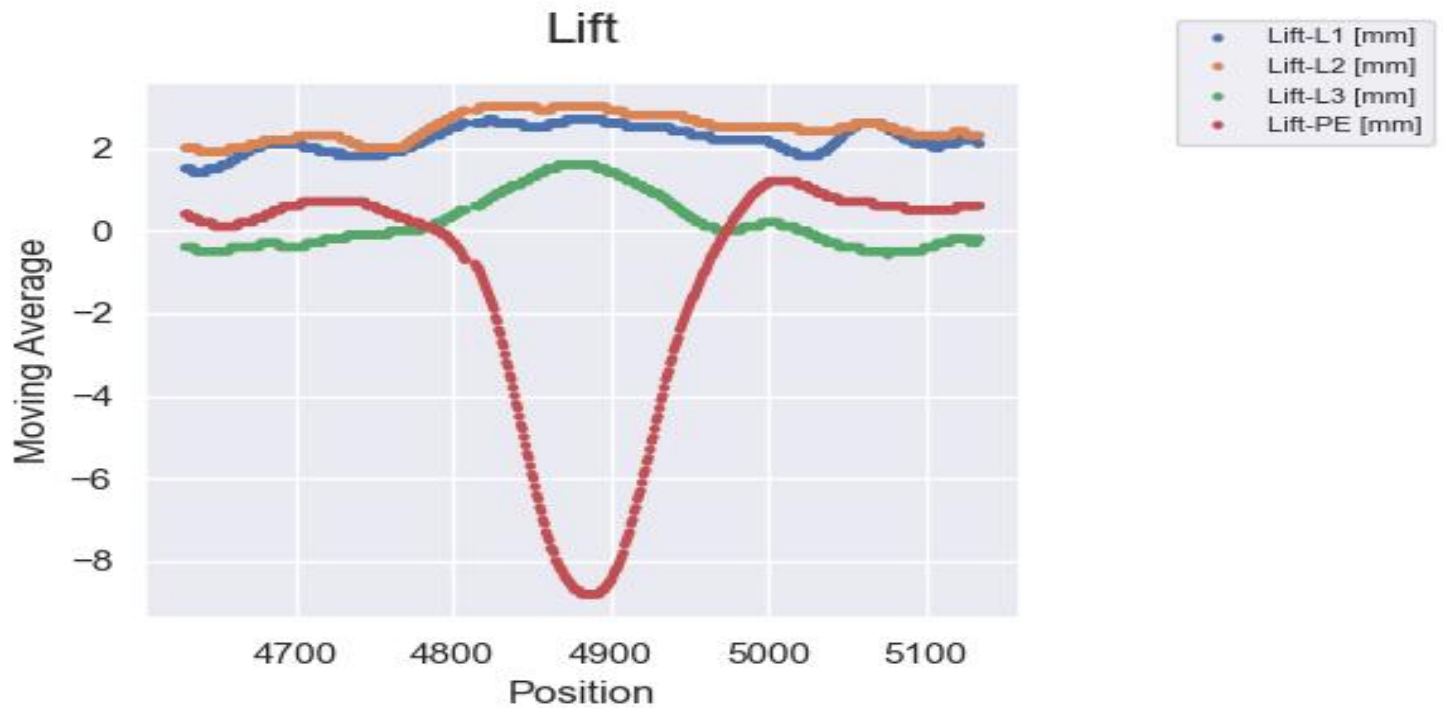
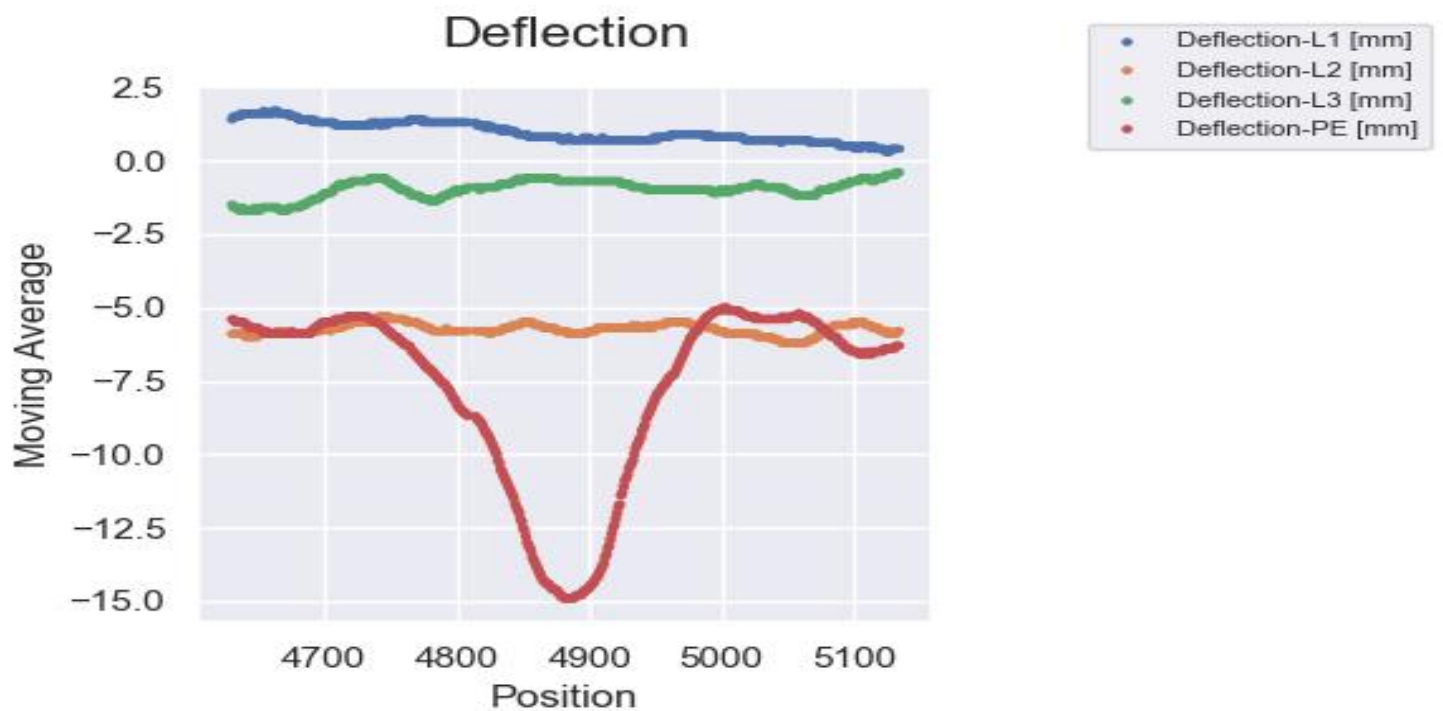
The warning values exceeded ( $\pm 10$  mm) 1 in the Deflection field between positions: 4830 and 4934/n

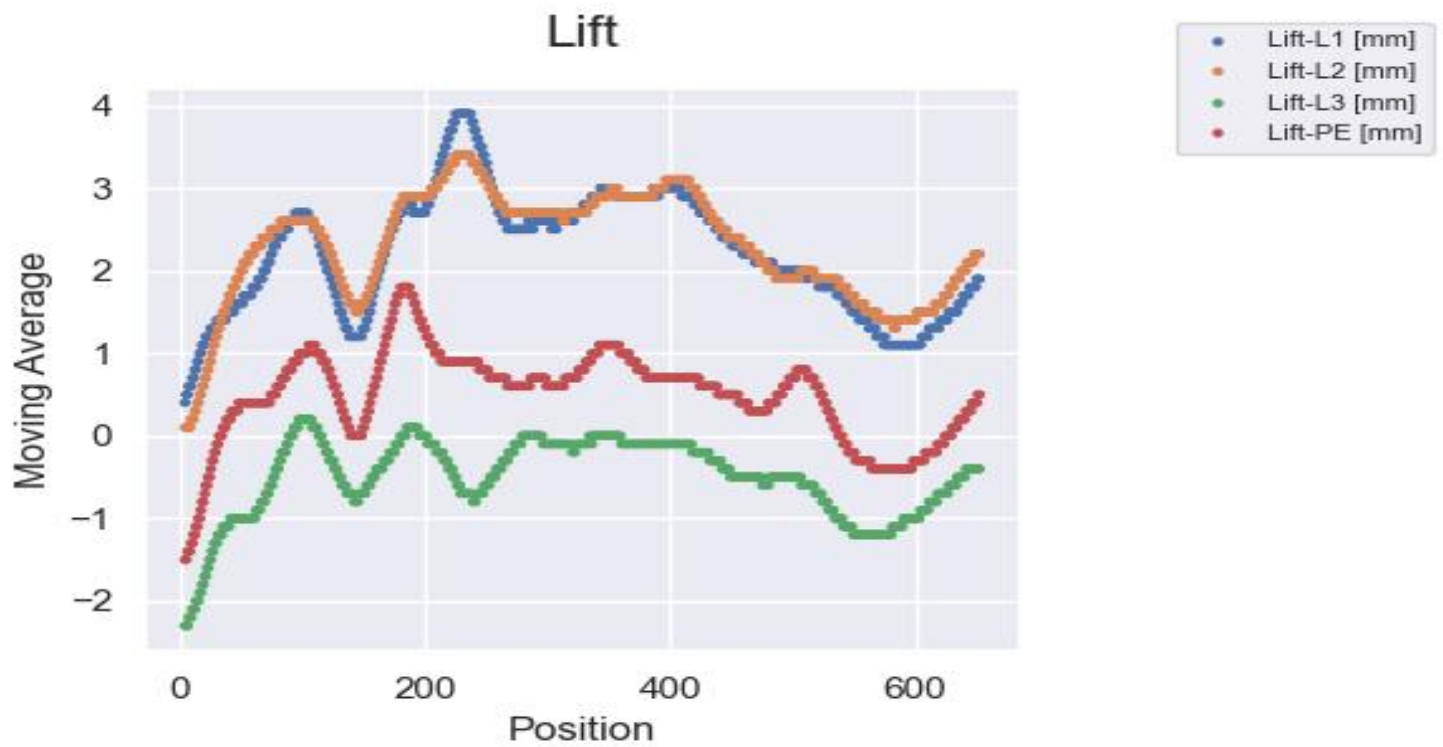
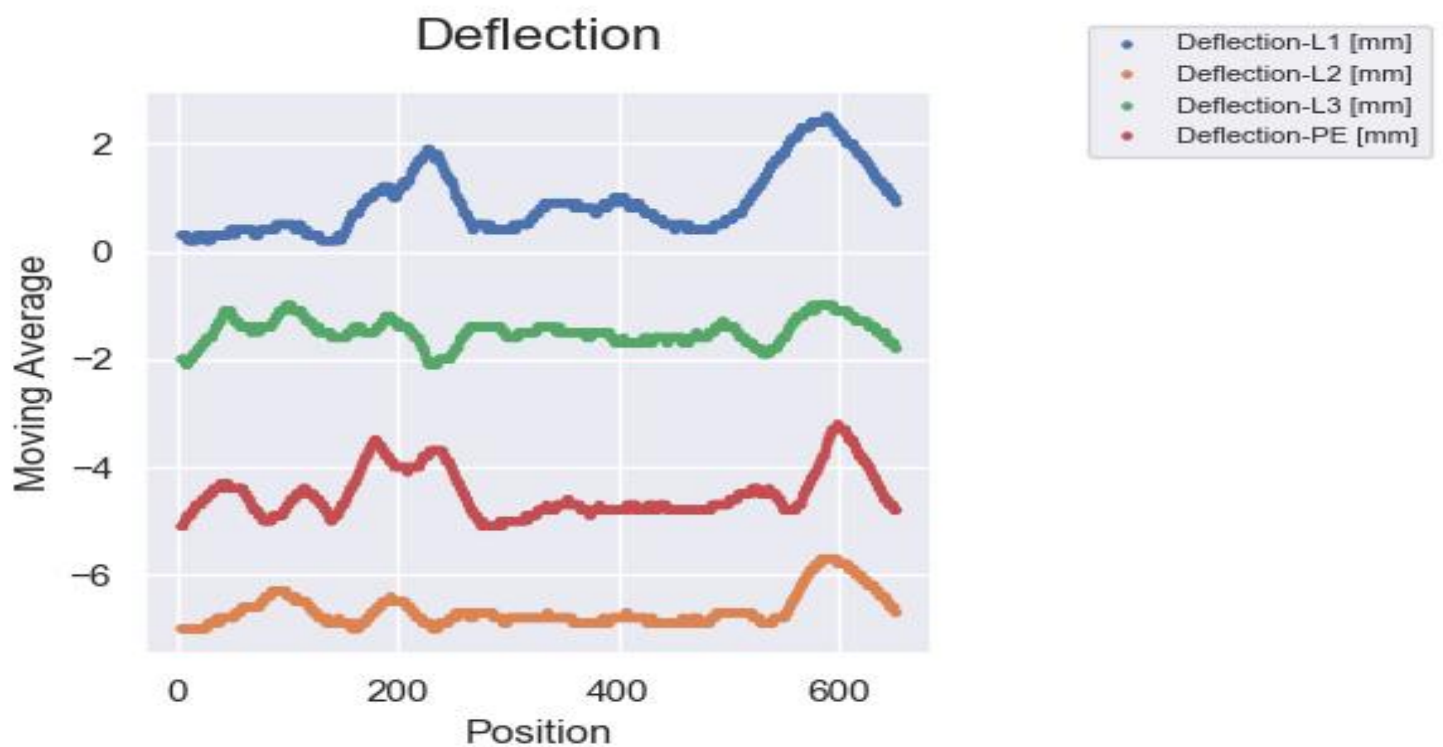
possible anomalies between positions: 4 and 452

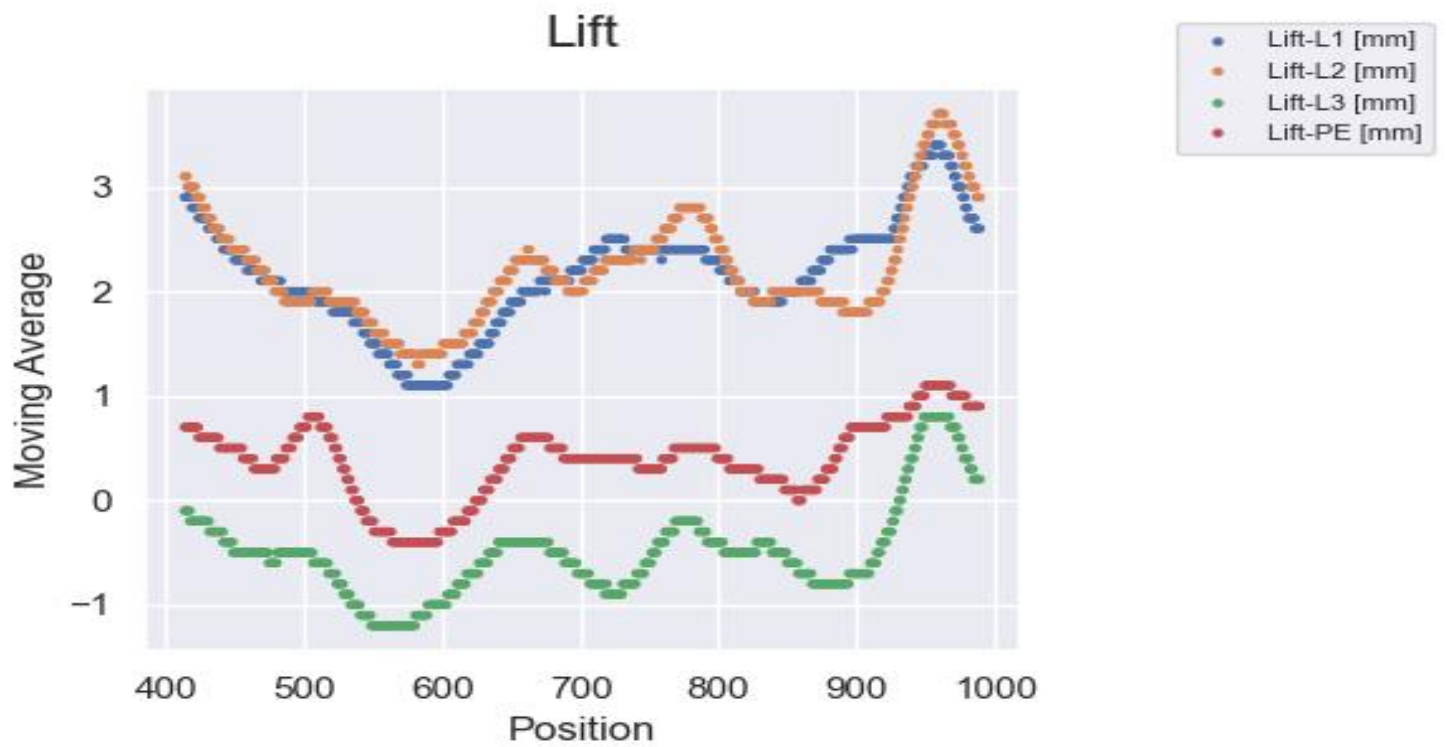
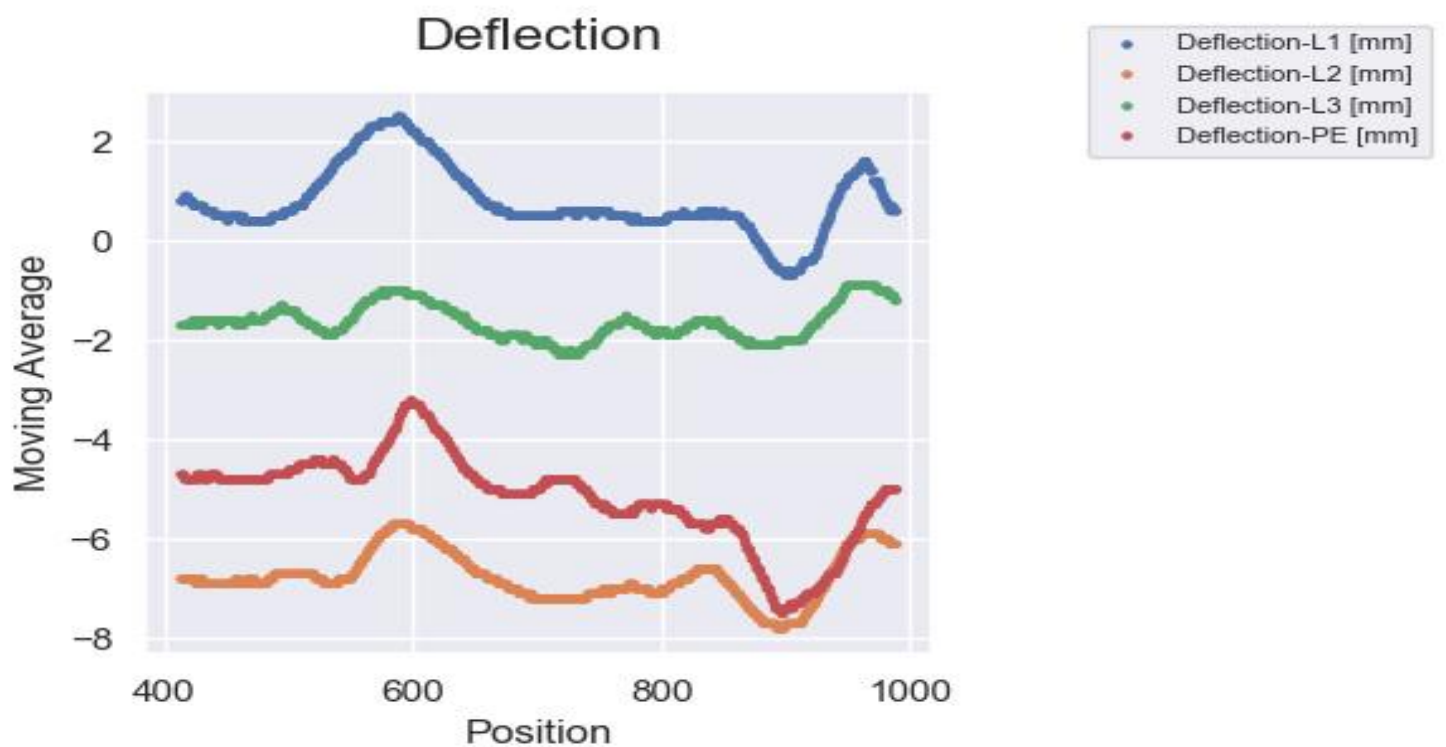
possible anomalies between positions: 614 and 789

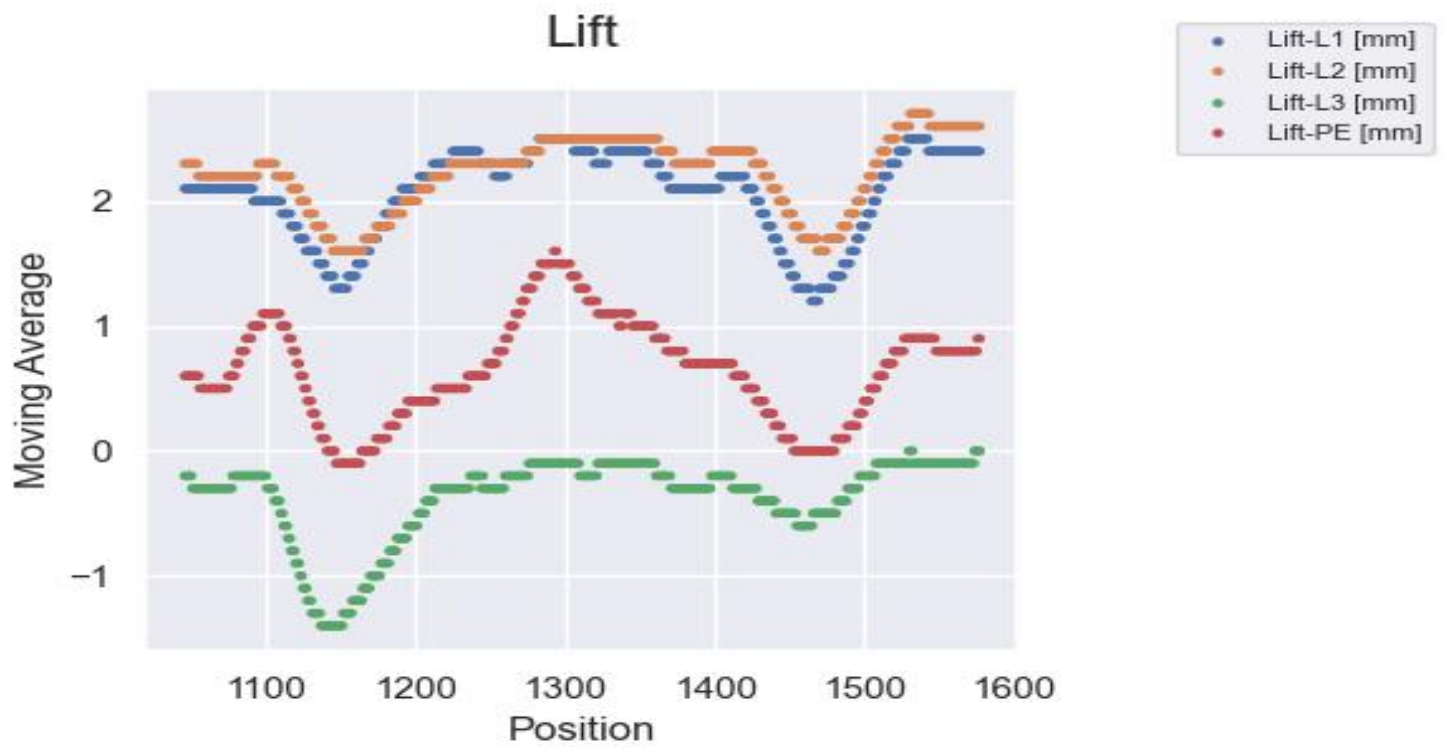
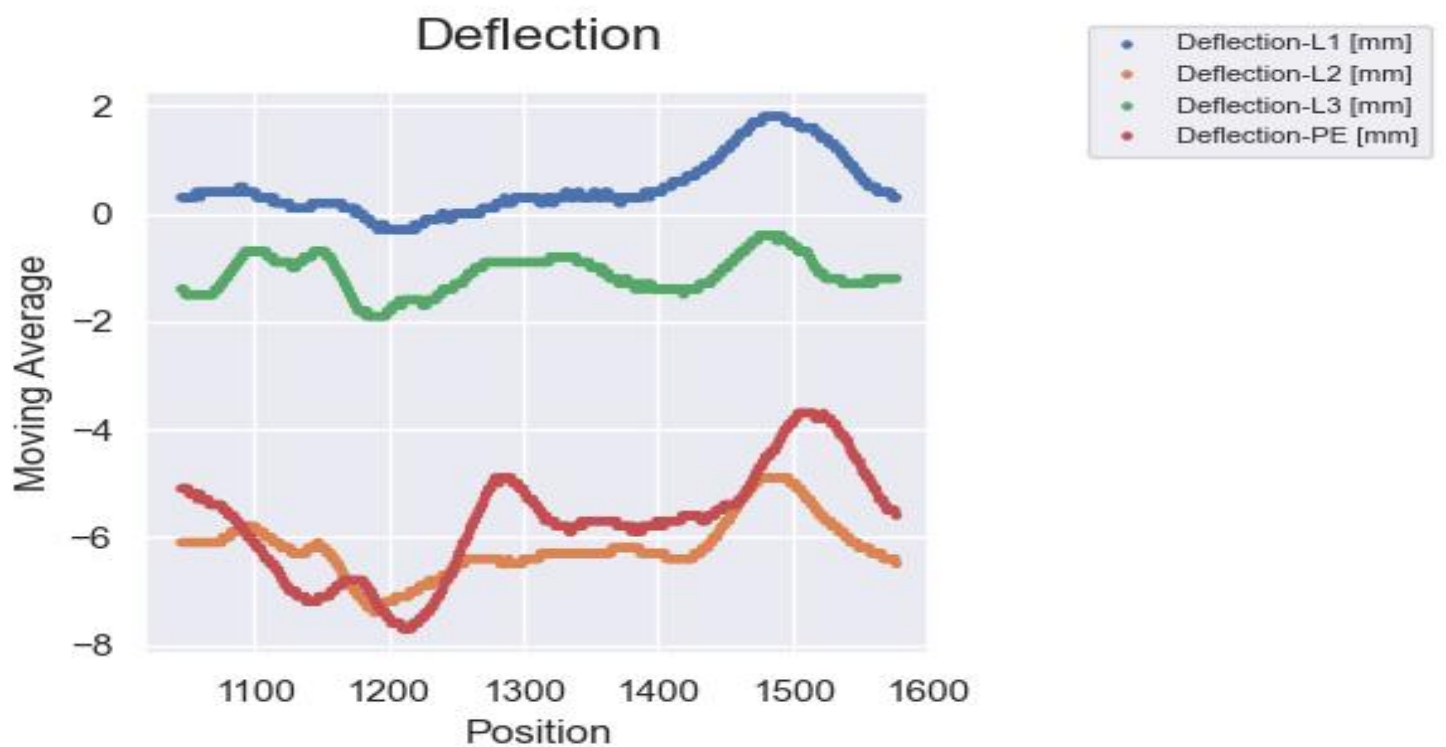
possible anomalies between positions: 1246 and 1377

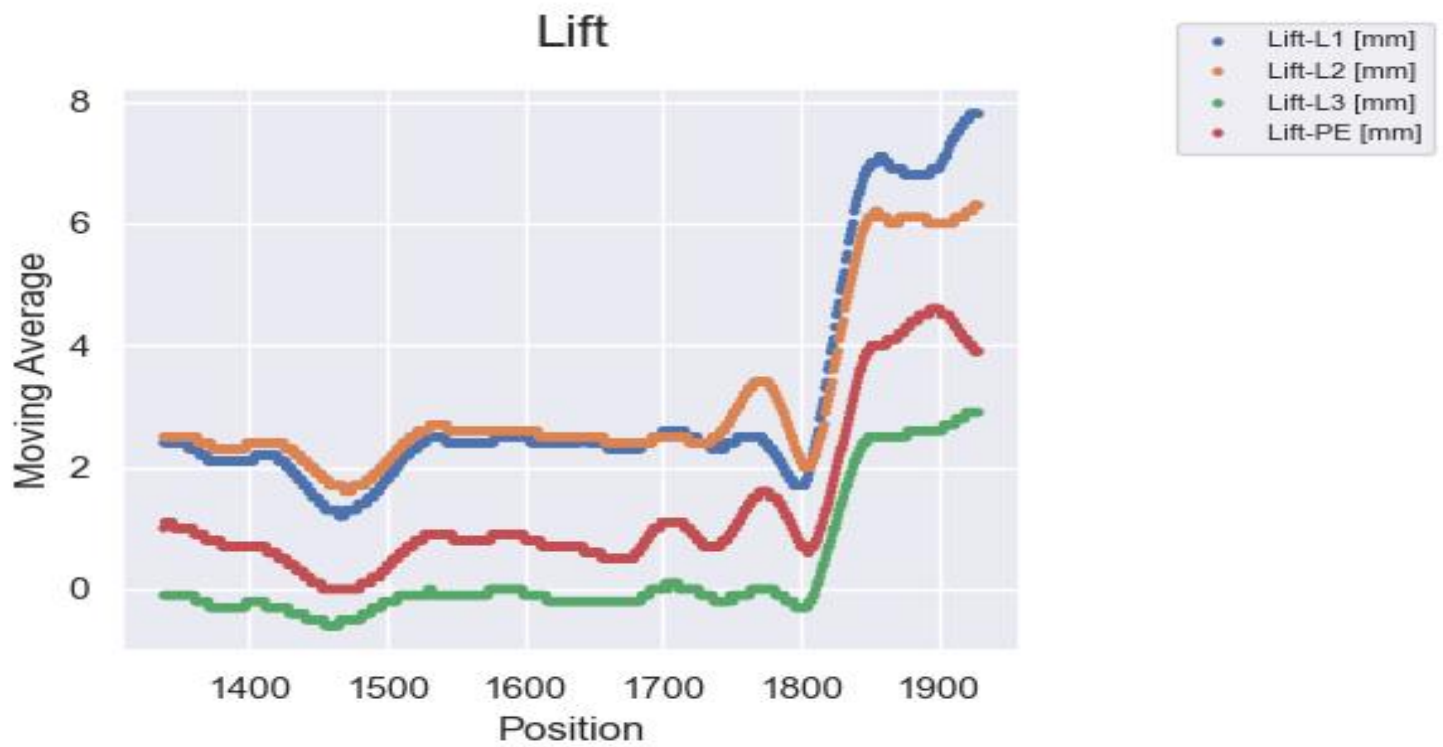
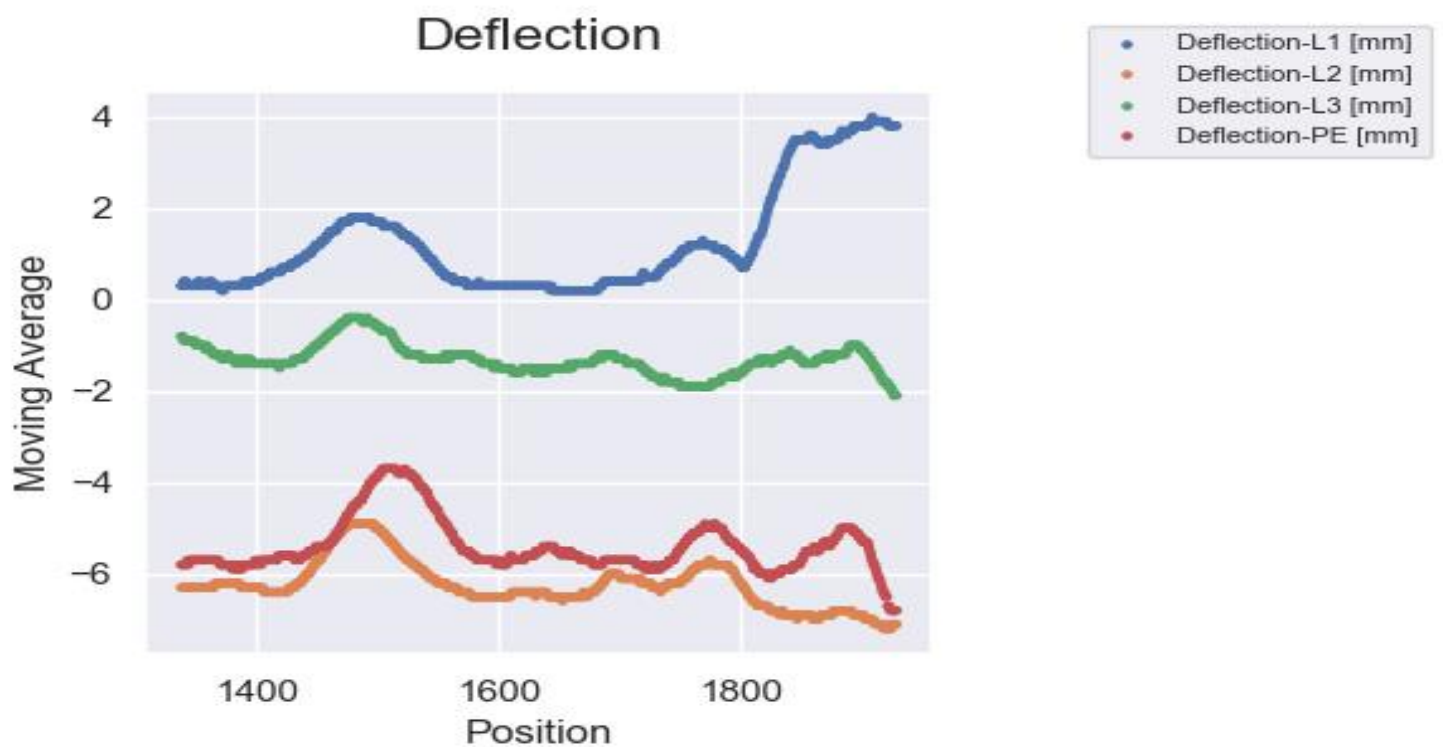
possible anomalies between positions: 1538 and 1729

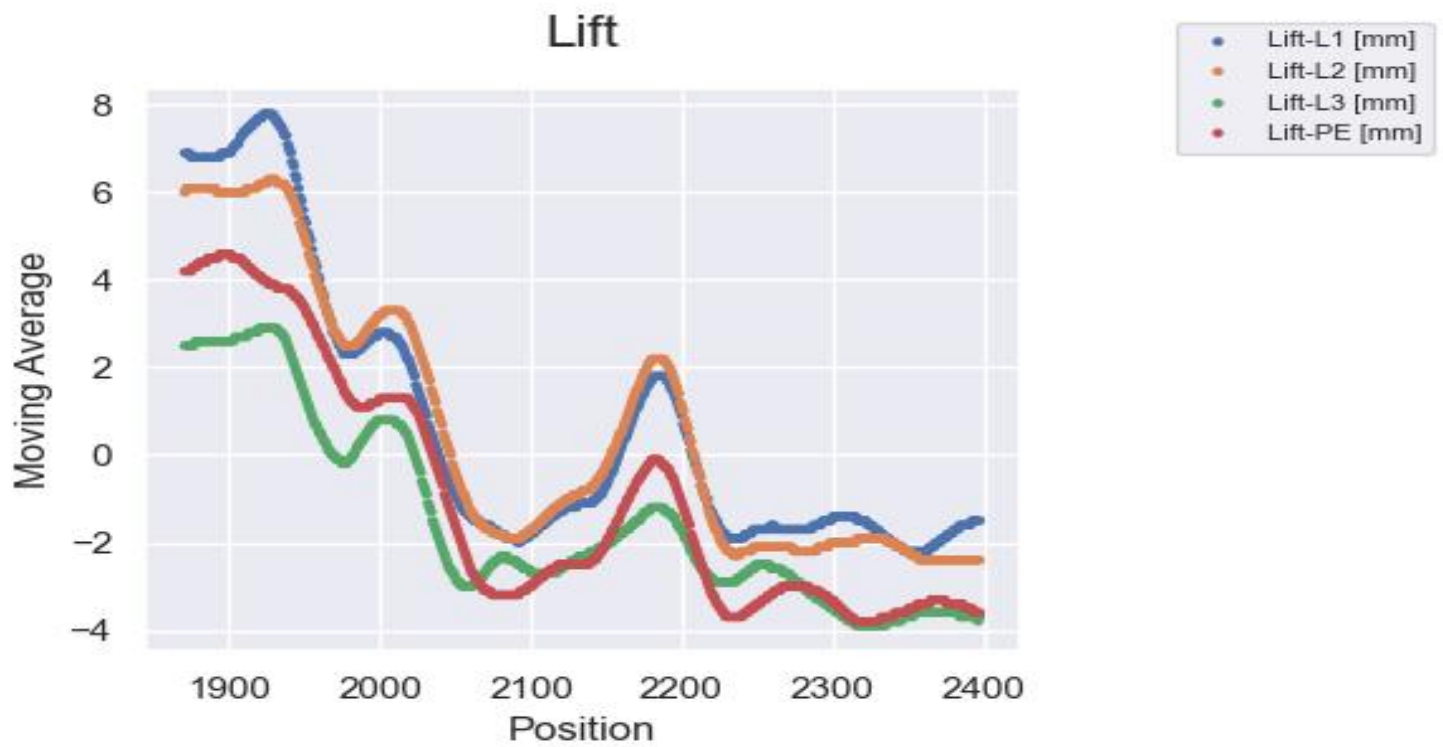
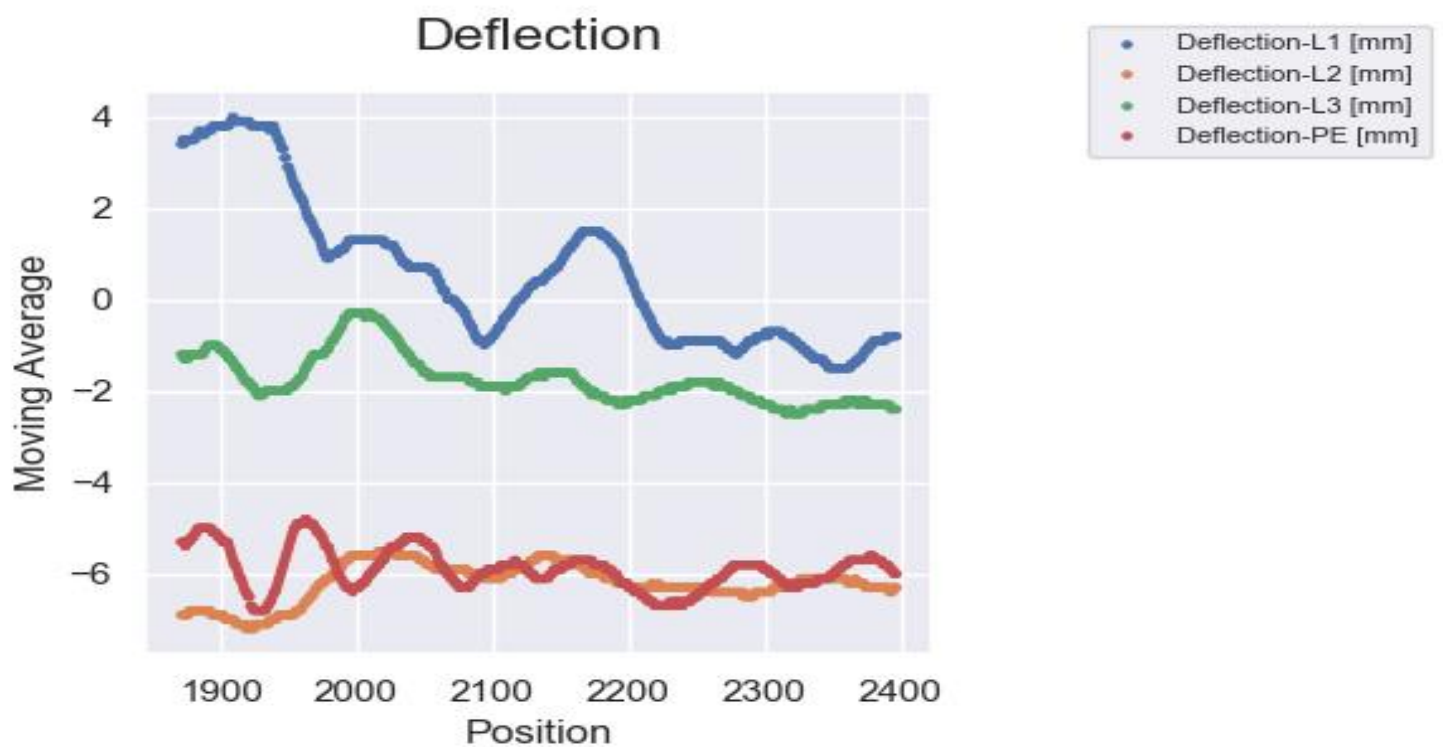
possible anomalies between positions: 2071 and 2197

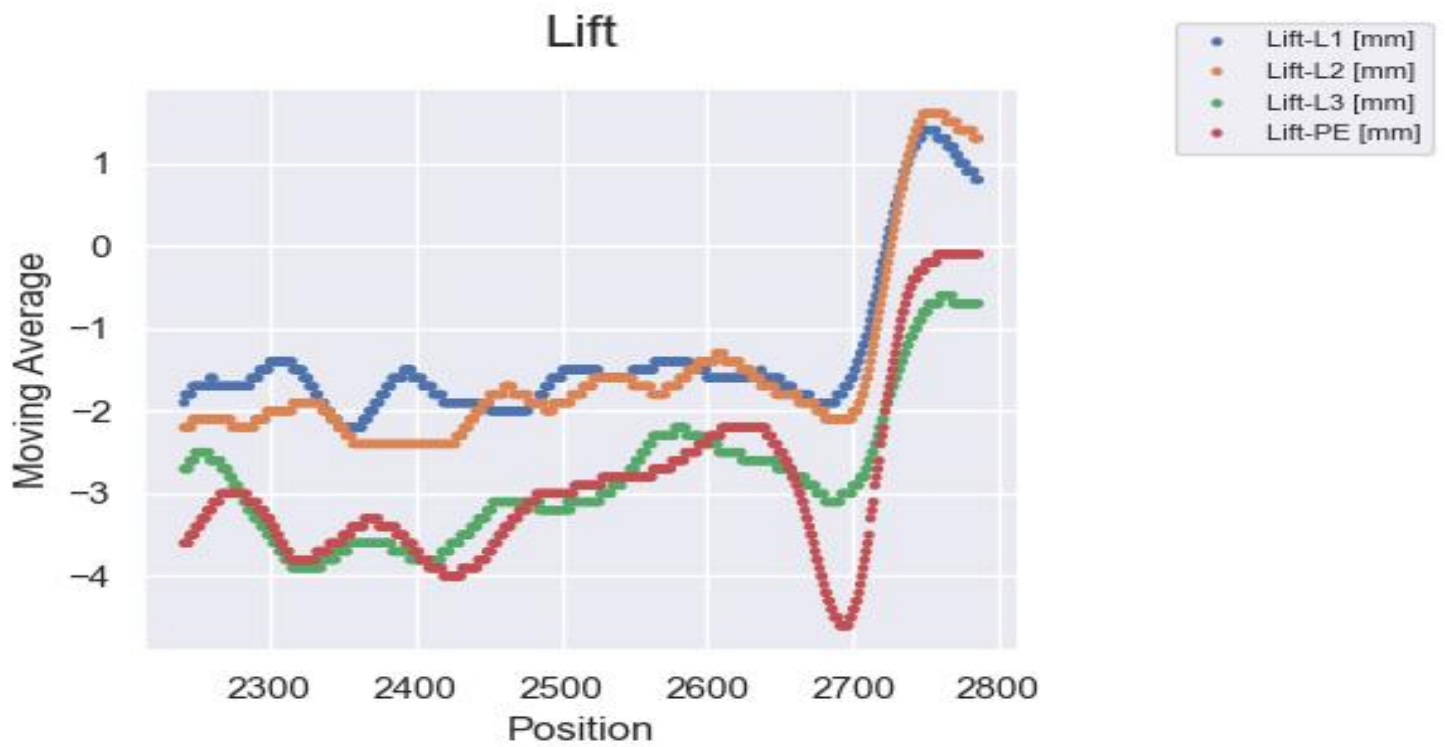
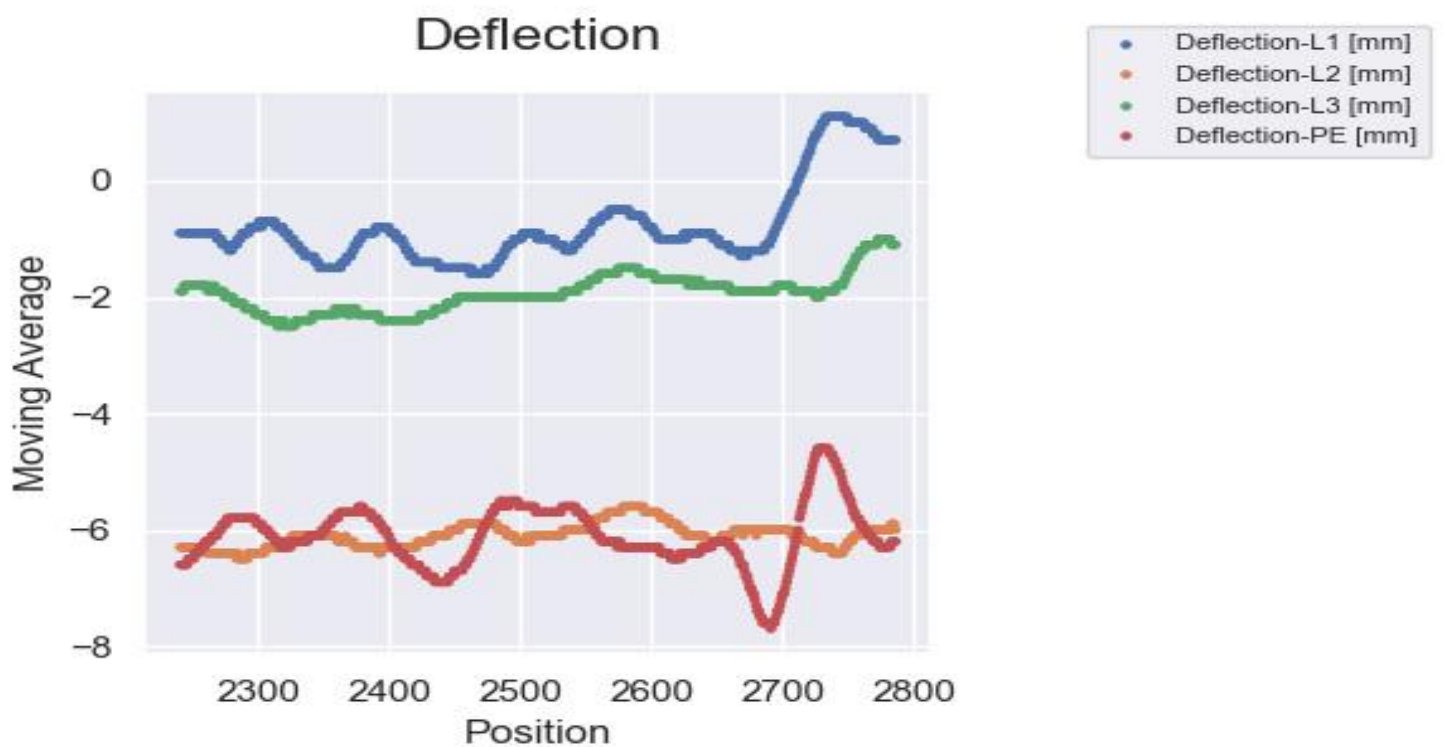
possible anomalies between positions: 2441 and 2586

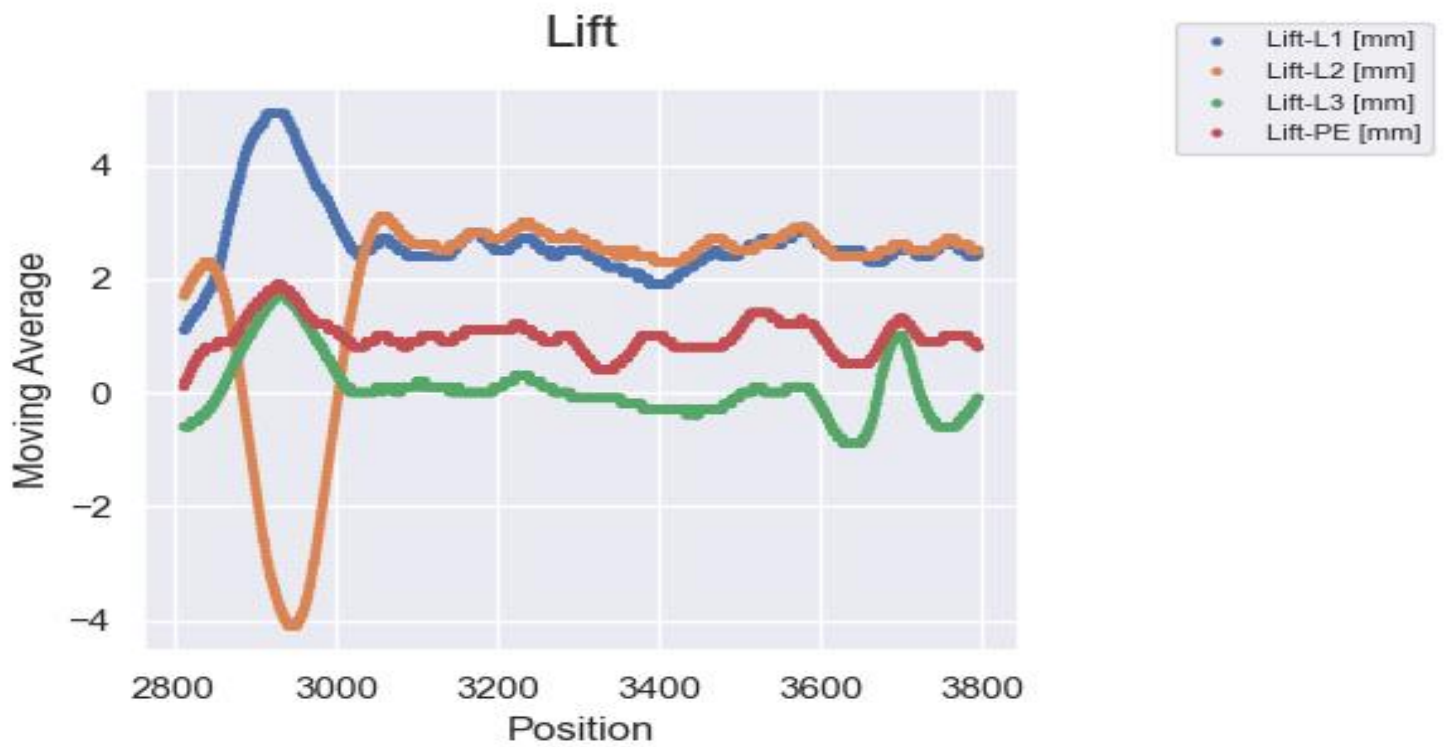
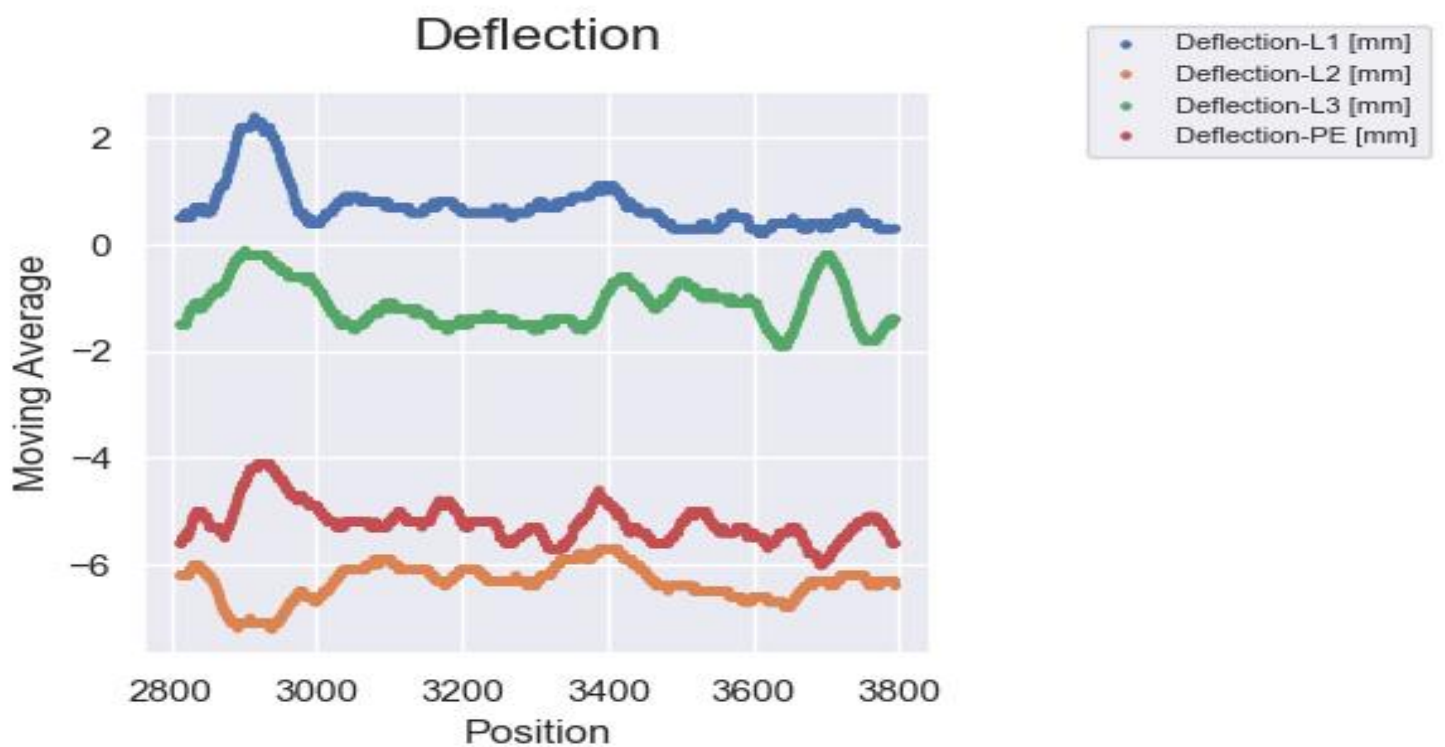
possible anomalies between positions: 3013 and 3595

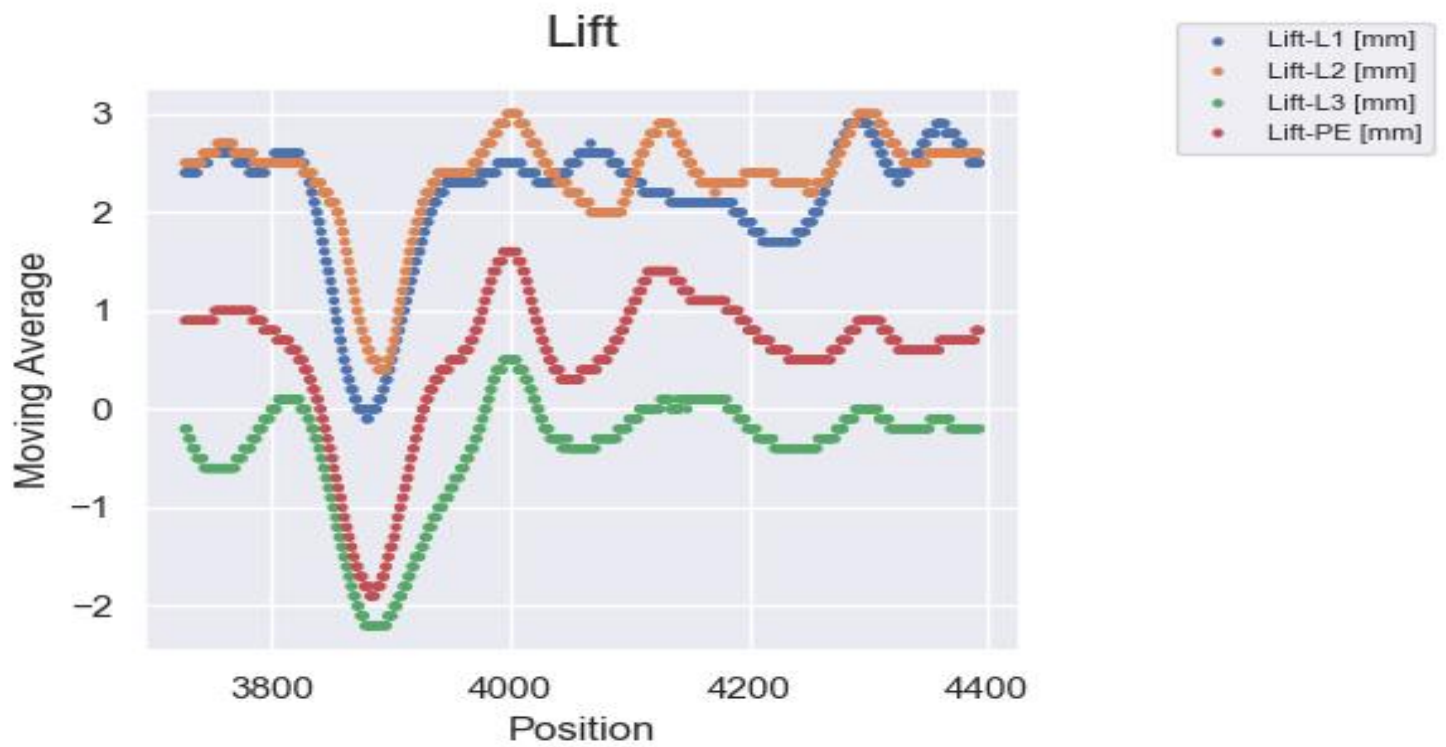
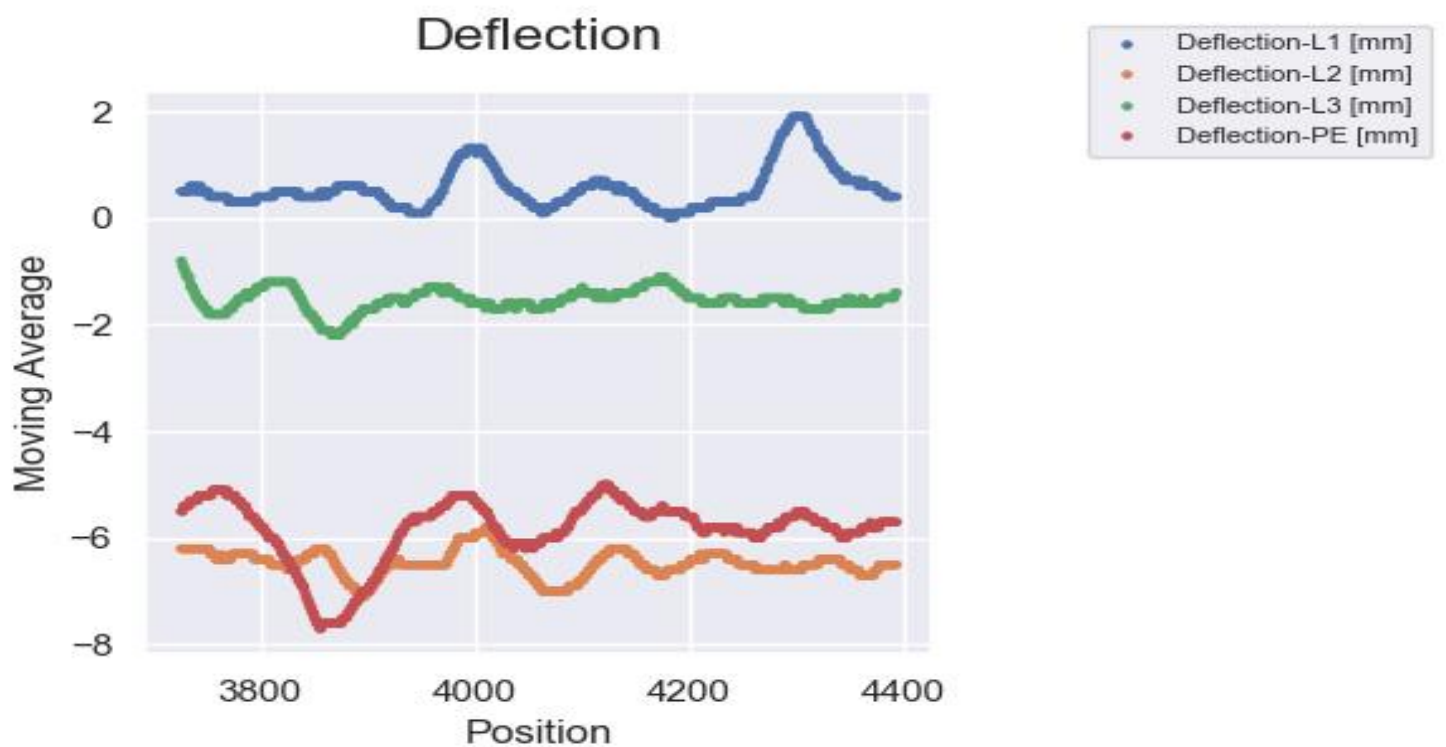
possible anomalies between positions: 3927 and 4193

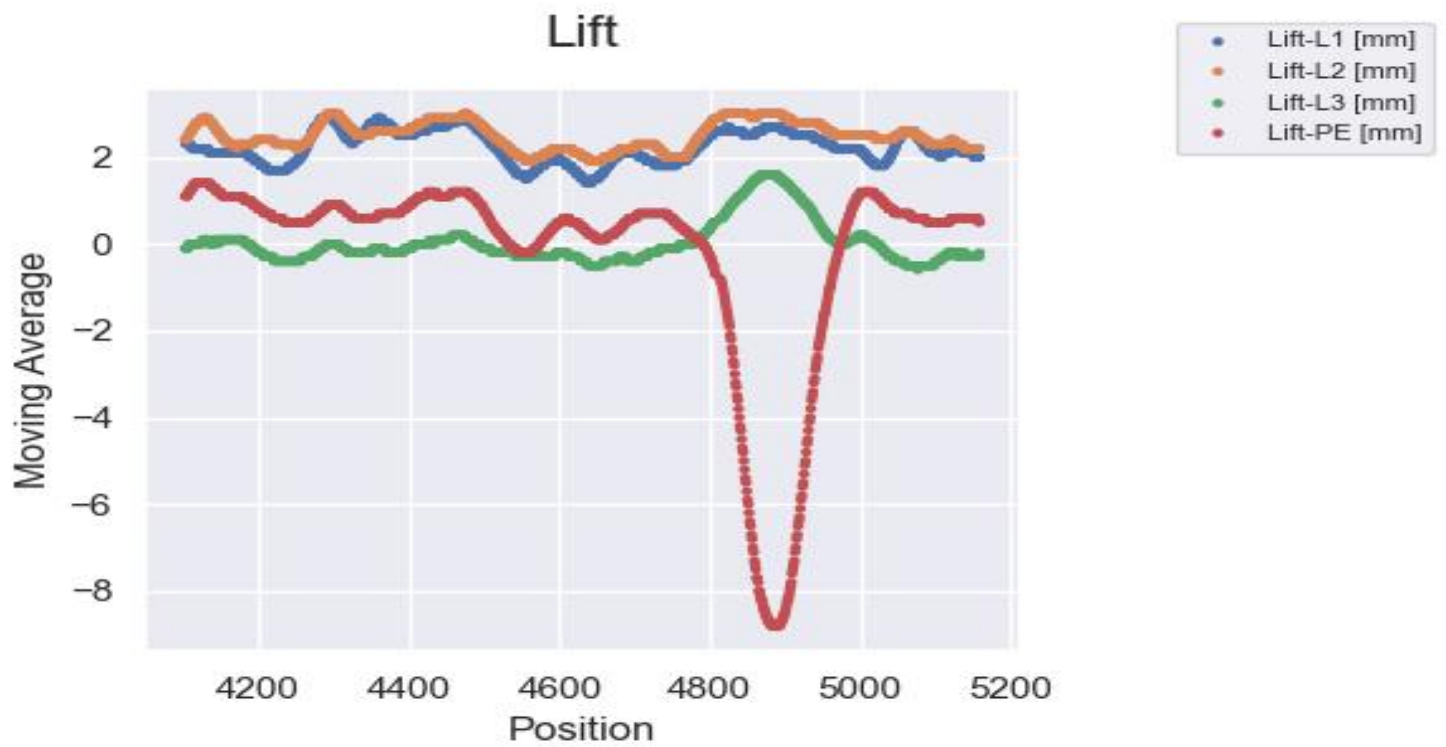
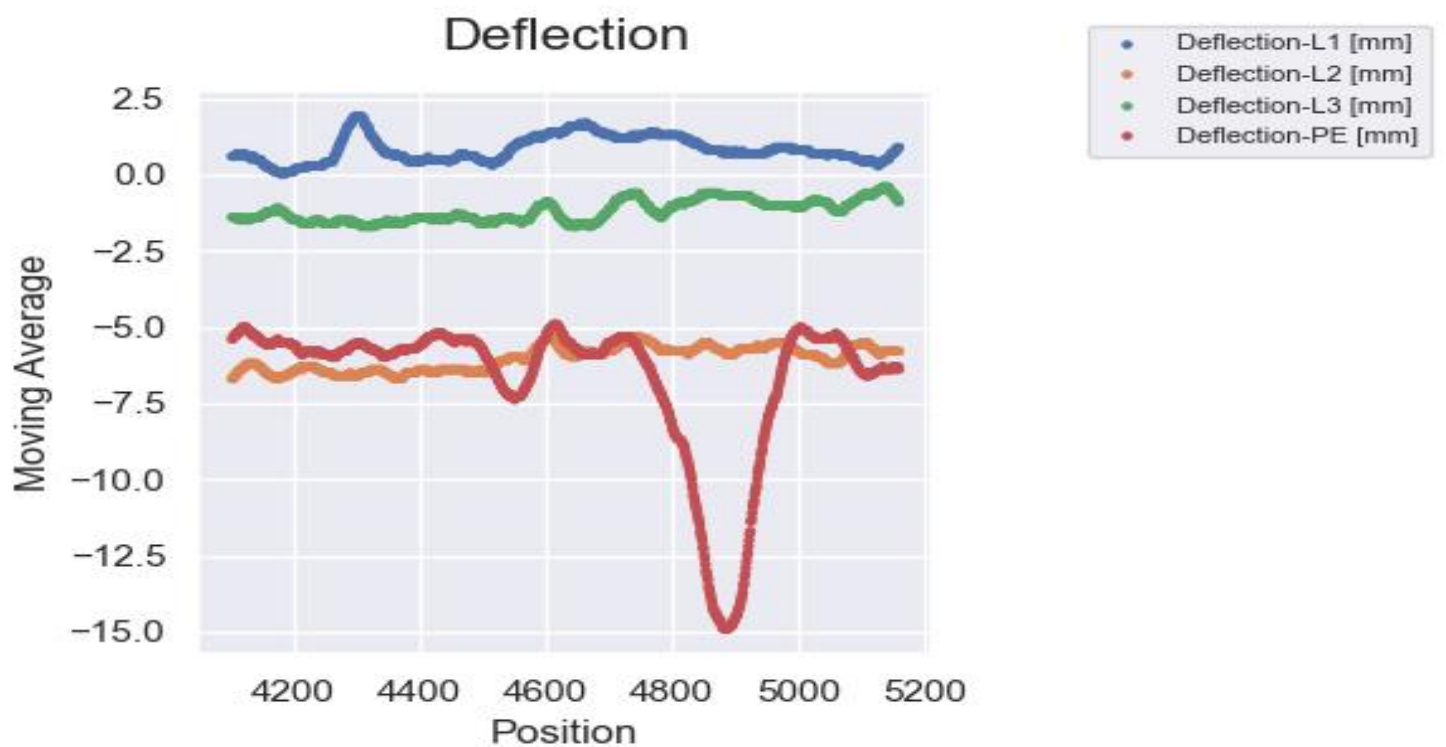
possible anomalies between positions: 4303 and 4958
