Paul Vahle GmbH & Co. KG

Burger

## Current status of the system in Burger

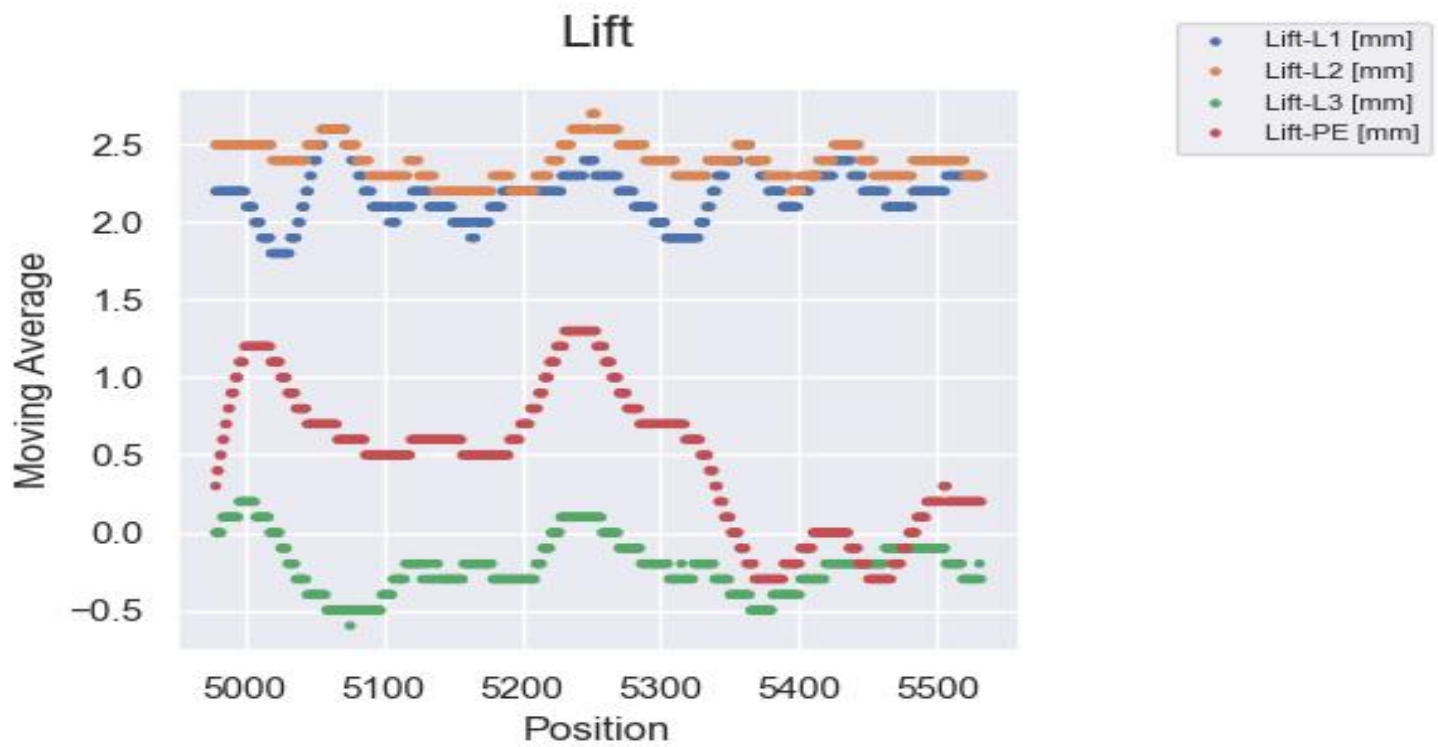
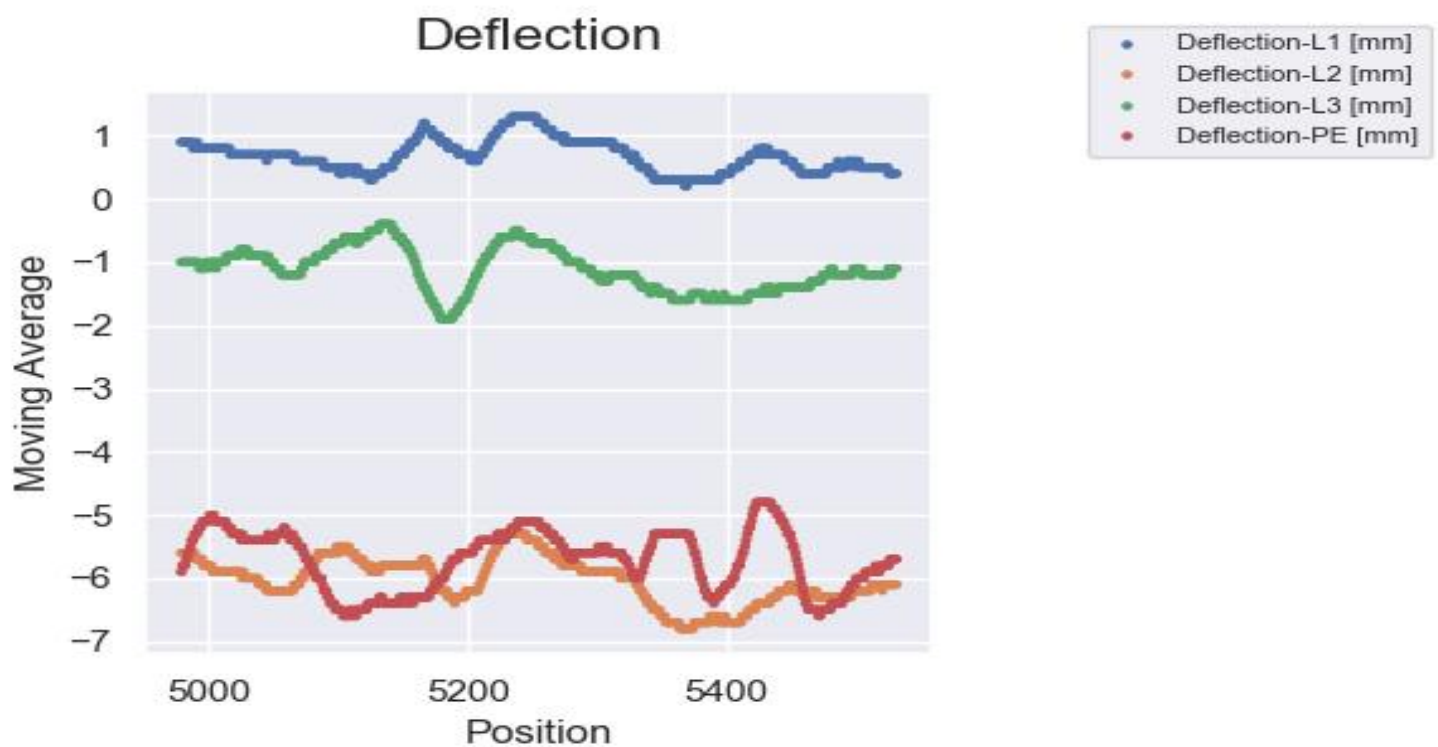
possible anomalies between positions: 5179 and 5331

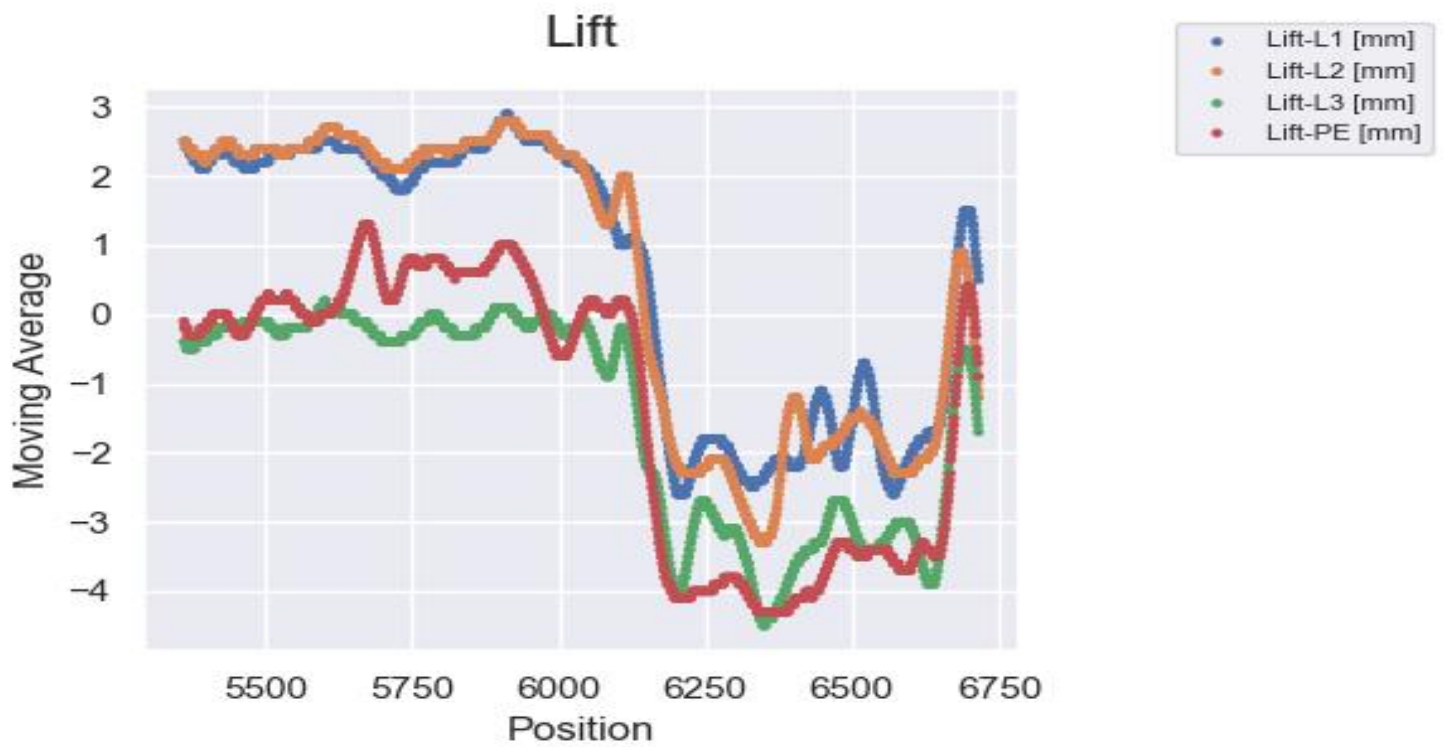
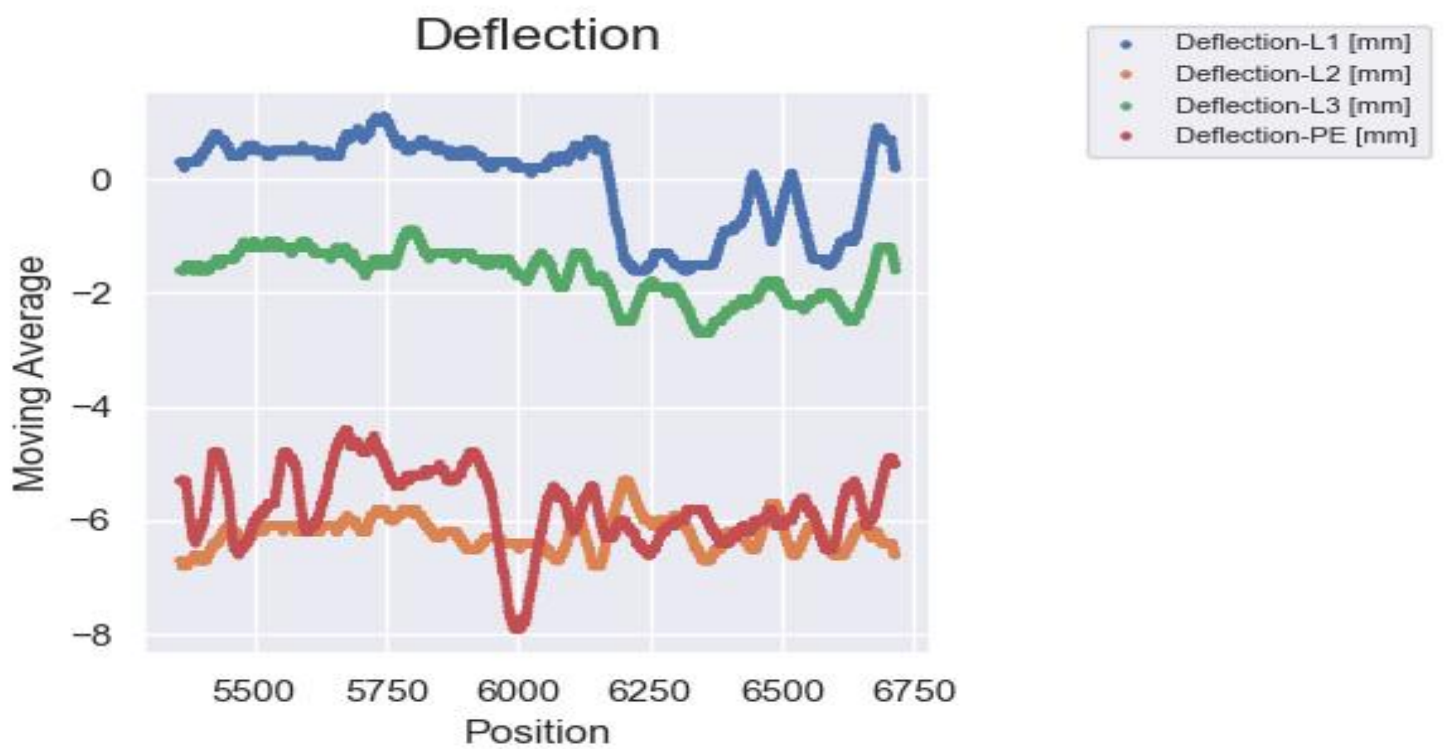
possible anomalies between positions: 5561 and 6515

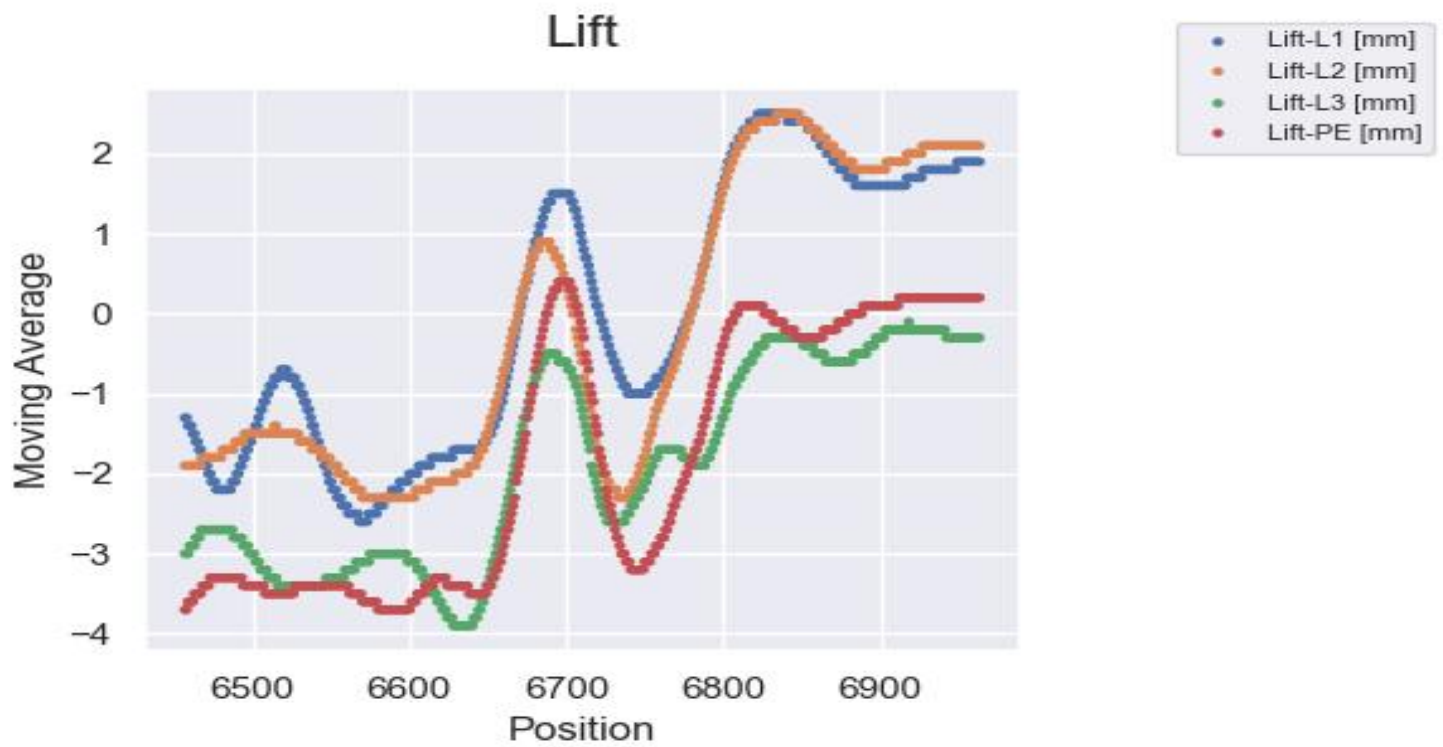
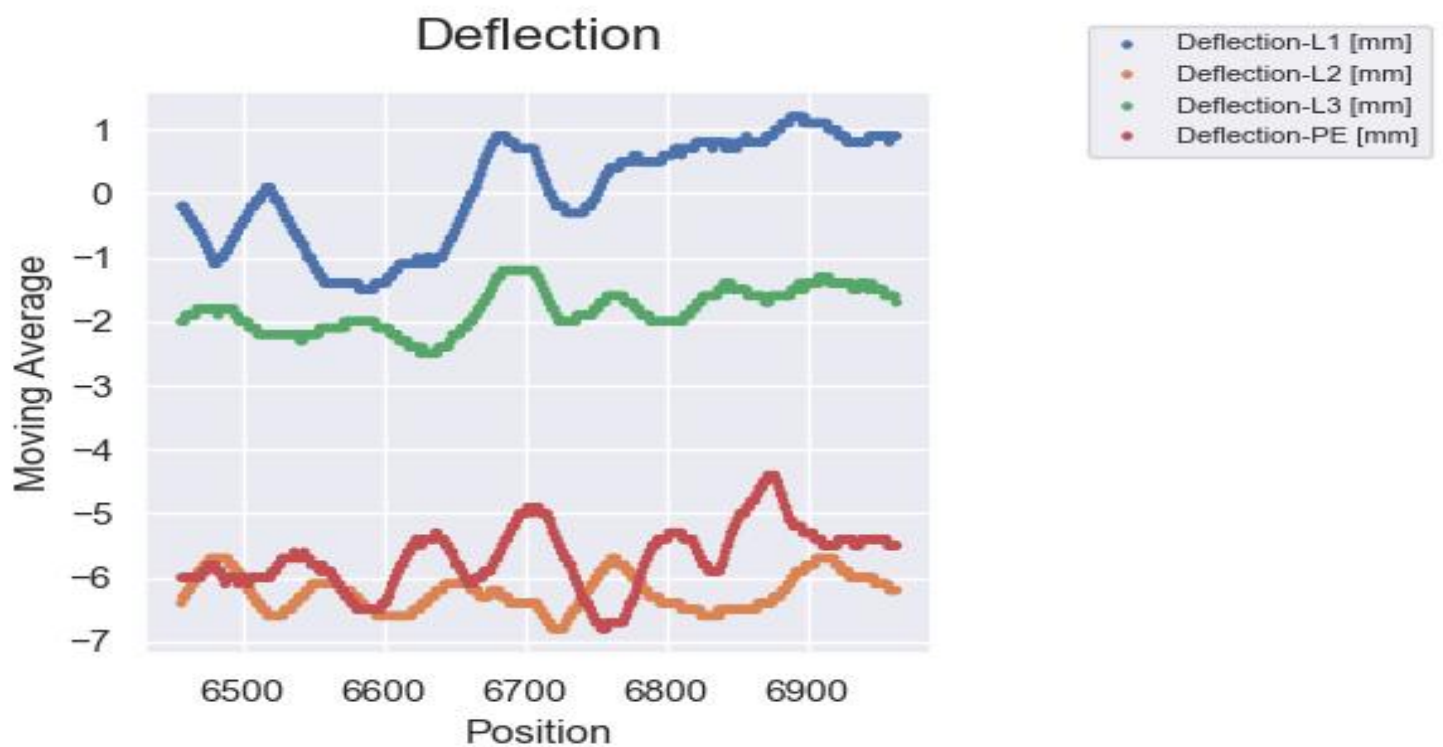
possible anomalies between positions: 6657 and 6763

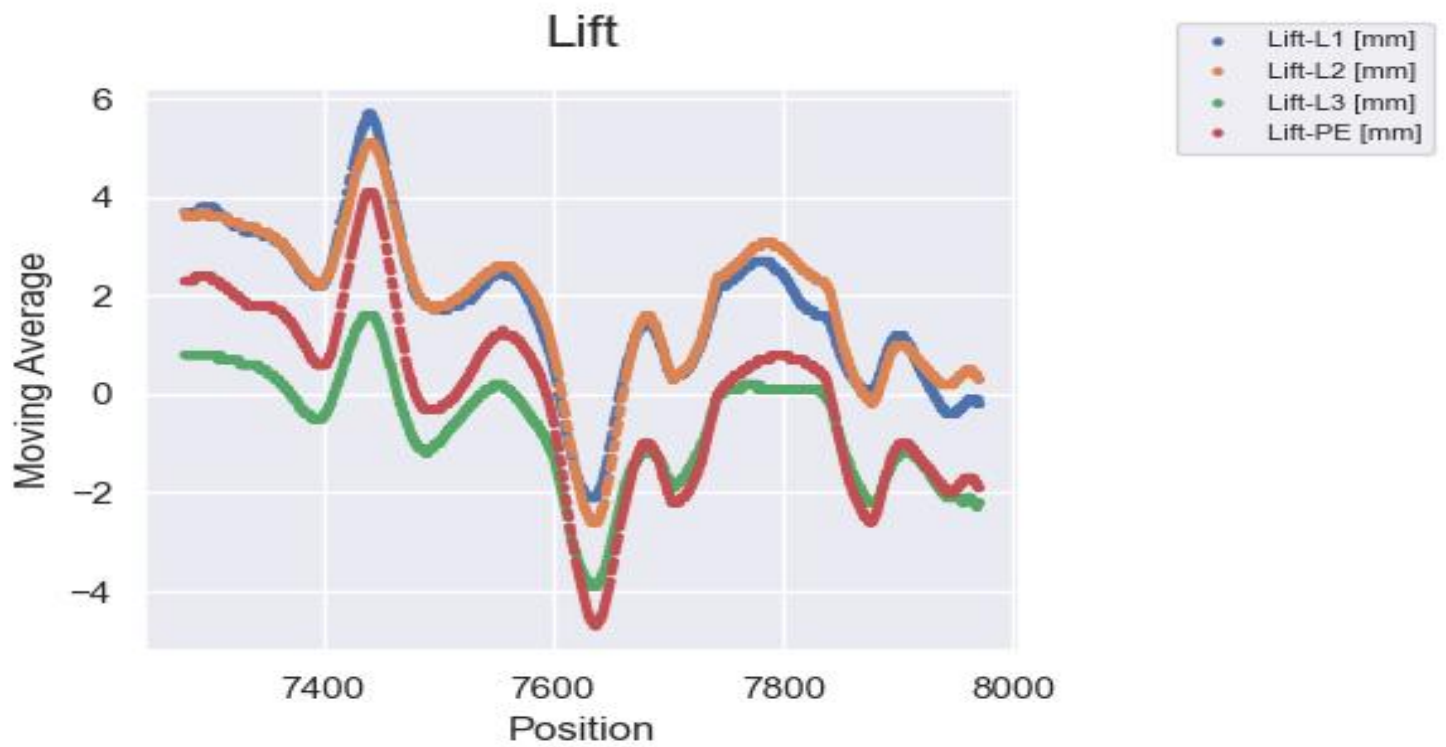
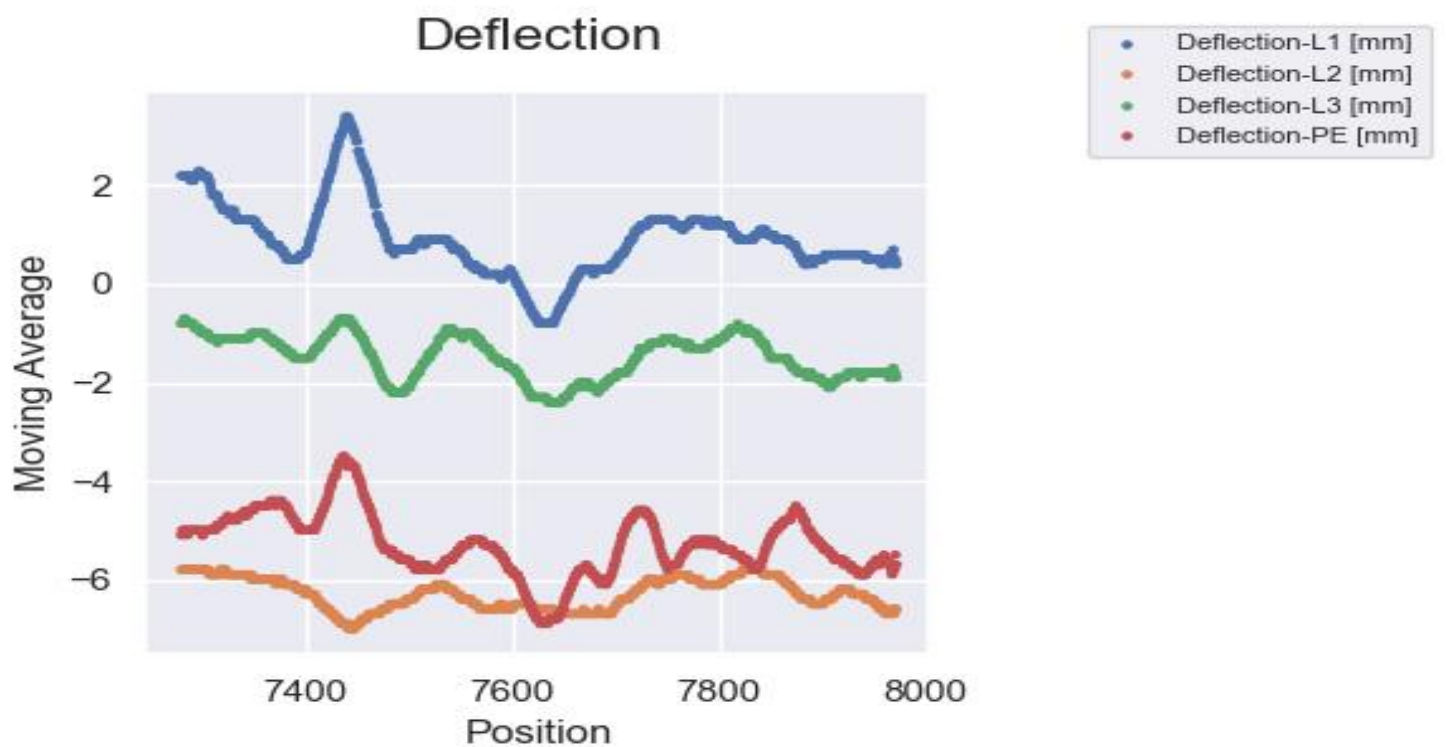
possible anomalies between positions: 7480 and 7841
