Burger Group
04/23/2024, 02:34:40

Current status of the system in Burger Group

Results of the inspection trip Burger Group

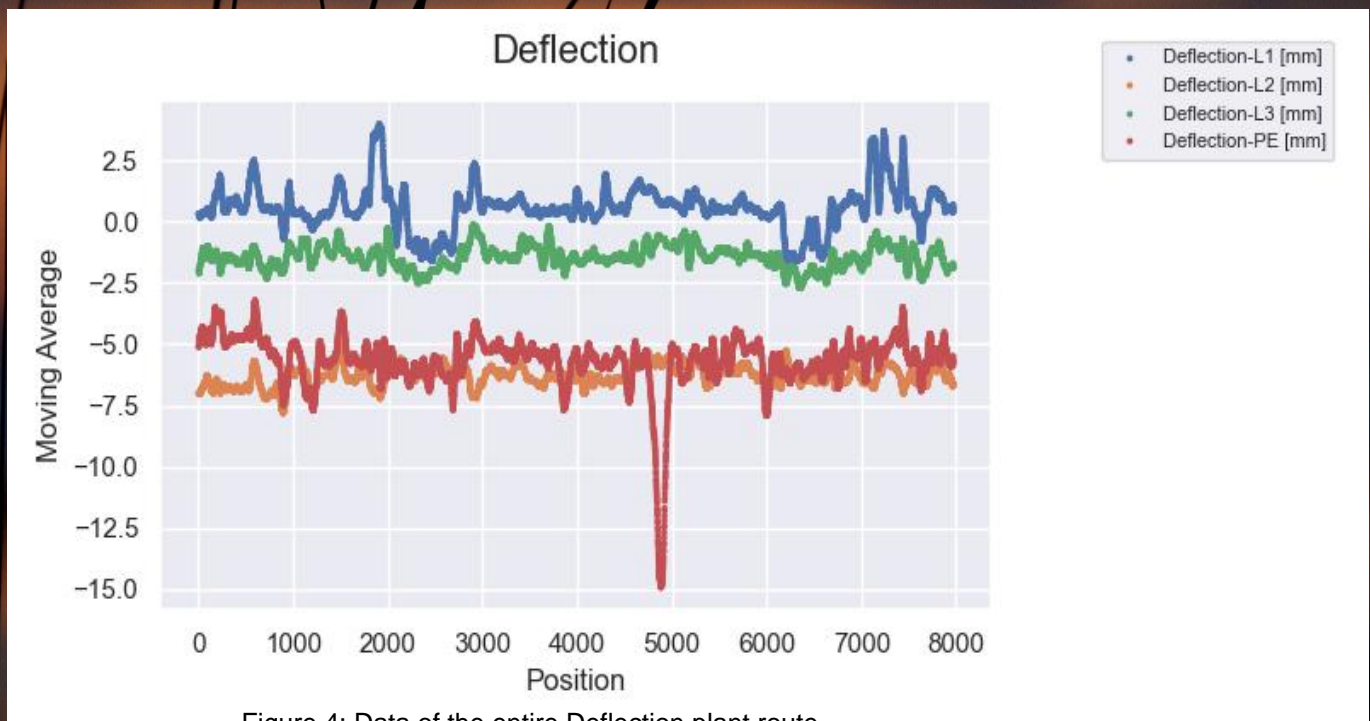
As can be seen in the above illustration, the Lift path and the Deflection path of the entire plant section of 7967 cm Length determined.

The Current Collector moves in the range of 7.8 mm to -8.8 mm in Lift and in range of 4.0 mm to -14.9 mm in Deflection and thus in its permissible range overall. The visible gaps in the display are due to the fact that the Current Collector did not travel through all the routes/areas of the system during the recording time.
