Safety Risks to Emergency Responders from Lithium-Ion Battery Fires in Electric Vehicles

Safety Report

NTSB/SR-20/01
PB2020-101011

**National
Transportation
Safety Board**

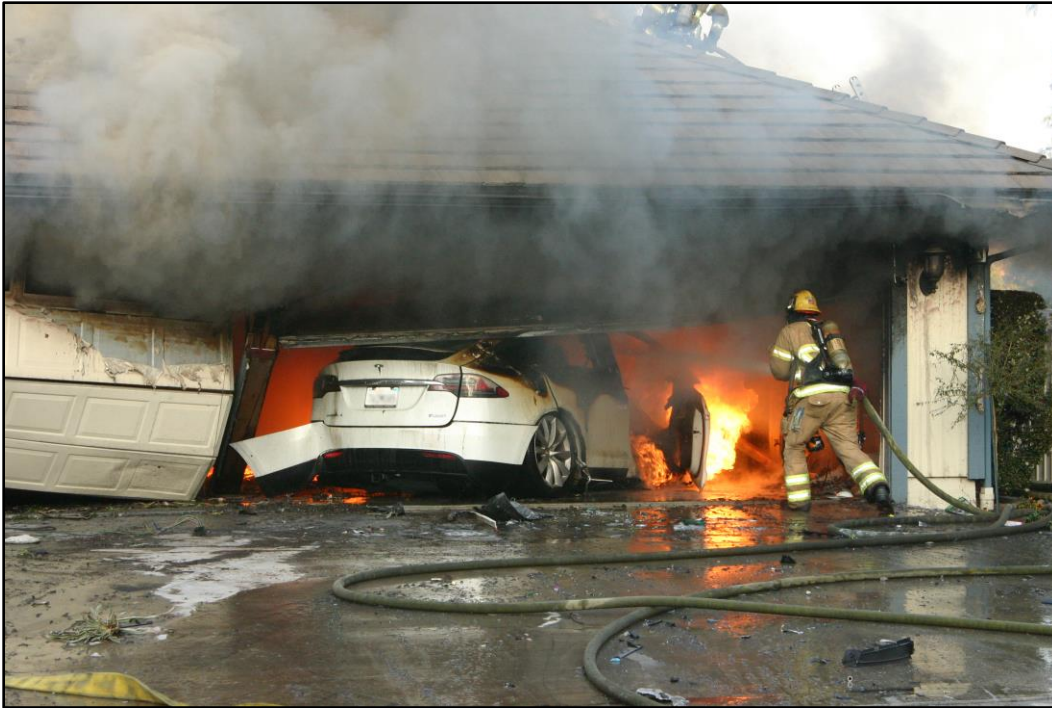
Figure 2. Postcrash view of garage showing firefighter directing water onto burning SUV and smoke coming from garage roof. (Source: Orange County Sheriff's Department)

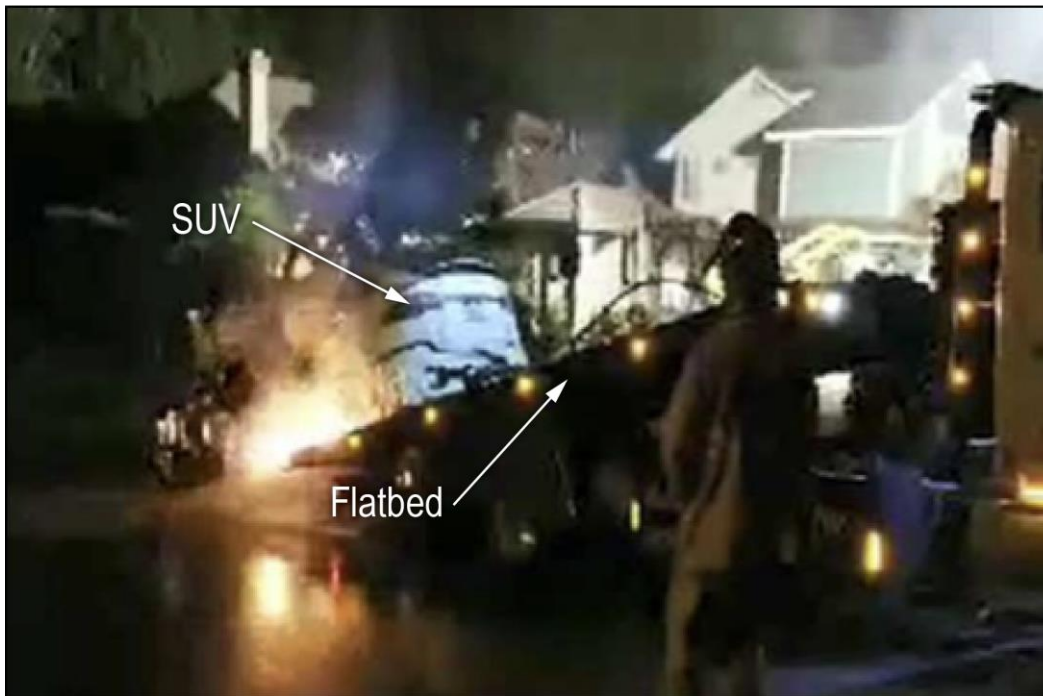
Figure 3. Still image from video taken by sheriff's department officer showing SUV reloaded on flatbed of tow truck. (Source: Orange County Sheriff's Department)

The battery reignited for a few seconds while the SUV was being unloaded at the tow yard. Although the vehicle emitted smoke, it did not catch fire, and the tow driver did not call for an emergency response.³⁴ The SUV was positioned at the tow yard as far from other vehicles or buildings as possible—about 40 feet from other vehicles on two sides, about 20 feet from other vehicles on the third side, and about 10 feet from a concrete wall on the fourth side. According to the towing log, the job was completed at 1:15 a.m.

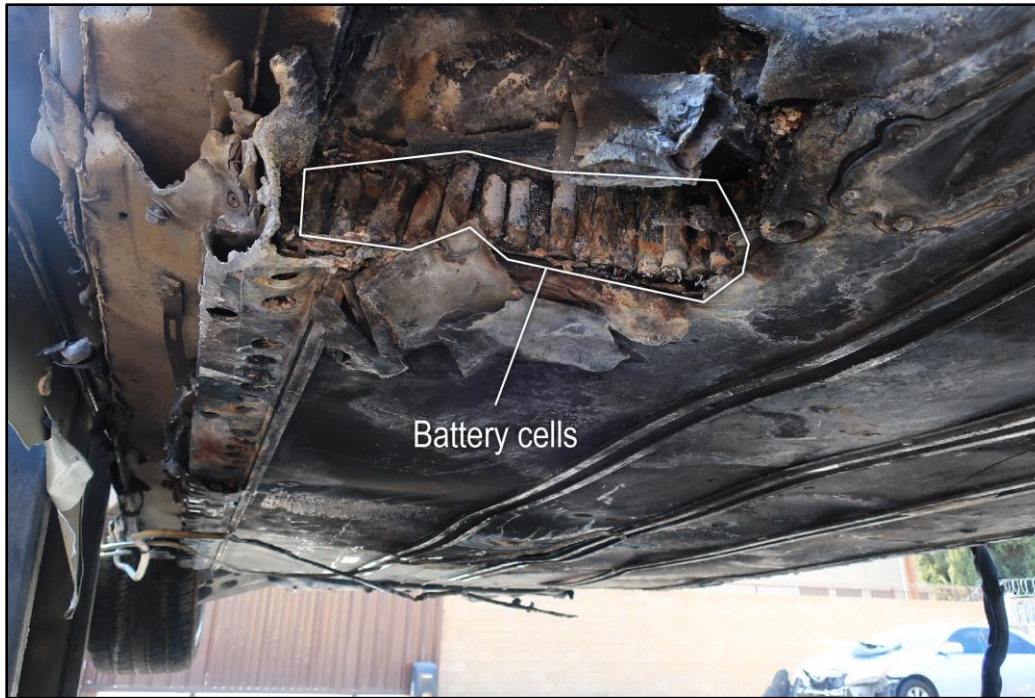
On September 6–7, 2017, NTSB investigators examined the SUV and the battery at the tow yard. They also visited the crash site. The SUV had extensive fire and impact damage. The high-voltage cut loop had been in the area of severe fire and impact damage to the interior, making it impossible to determine whether firefighters had been able to access and cut it. When the vehicle was raised so the underside could be viewed, investigators found that the right front corner of the battery case had ruptured, revealing individual battery cells, as shown in figure 4.

Figure 4. View from below and toward rear of SUV's underside showing ruptured right front corner of battery case and highlighting individual battery cells uncovered by rupture. Right rear wheel is visible in background.

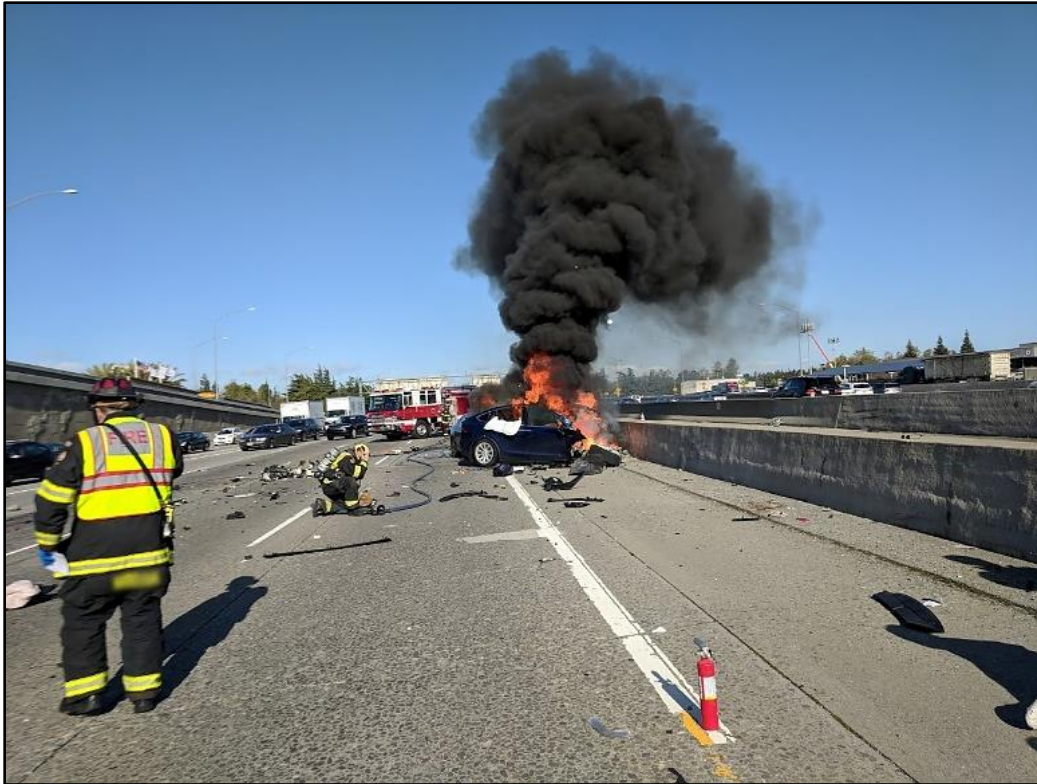
Figure 6. Burning SUV on northbound US-101 postcrash. (Source: witness S. Engleman)

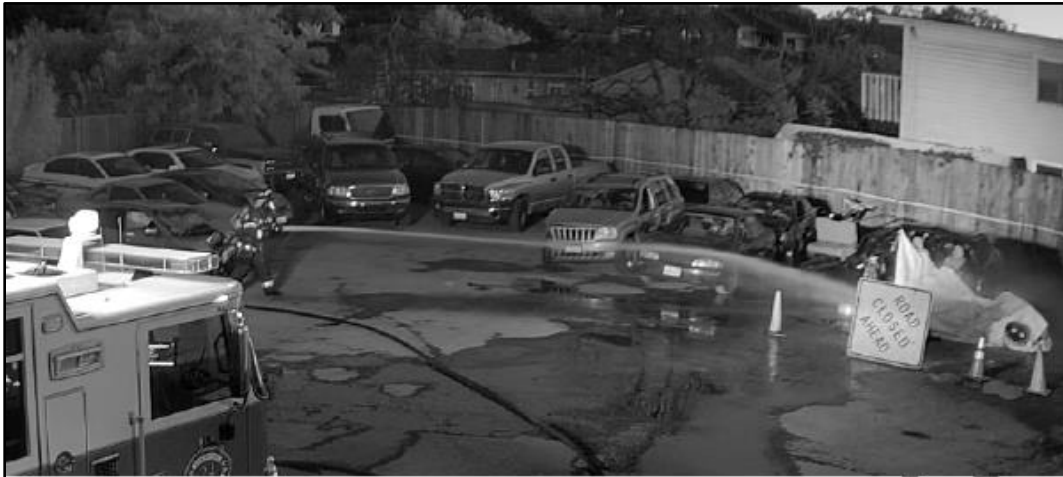
According to the San Mateo Fire Department's dispatch log, firefighters arrived at 7:09 p.m. and reported flames 8 to 12 inches high coming from the right front side of the SUV. Firefighters suppressed the fire using water and foam. A security camera recorded a firefighter applying water and foam onto the SUV, which was still partly covered by the tarp and a road sign that had been used to anchor the tarp (figure 7).

Figure 7. Image from security video at impound yard showing firefighter pouring water onto SUV at right, partly covered by tarp and road sign; fire engine is visible on left. (Source: Atlas Towing)

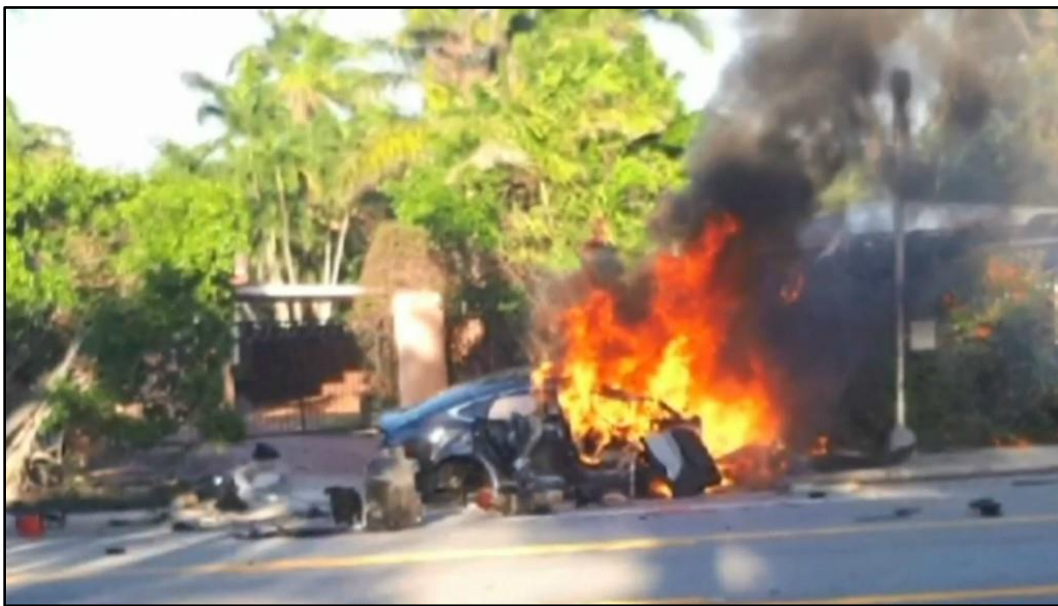
Figure 9. Car burning next to residential driveway postcrash. (Source: CBS4 Miami)

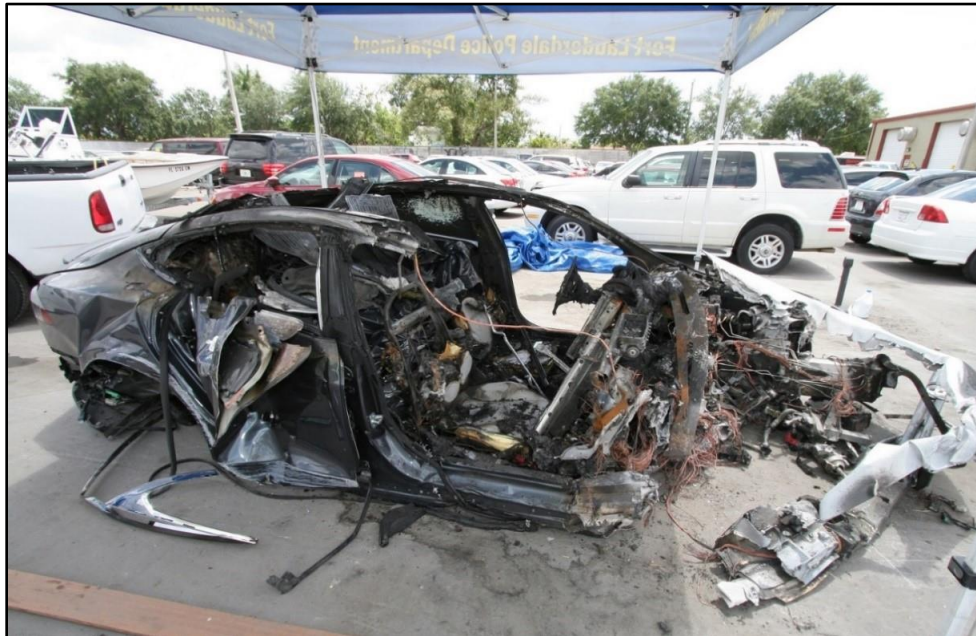
On June 7, 2018, the NTSB met at the tow yard with representatives of the Fort Lauderdale Police Department and Florida Highway Patrol to inspect the vehicle (figure 10) and the debris piles. The items wrapped in the tarp were removed and placed near the vehicle. Individual loose battery cells were found in the tarp, as well as the right front tire and small debris. Large items, including the left front door, front electric motor, right front wheel assembly, and damaged battery modules that had separated from the vehicle (determined to be modules 15 and 16), were found on top of the battery case in the second debris pile (figure 11).

Figure 10. Car parked at tow yard showing severe crash and fire damage.

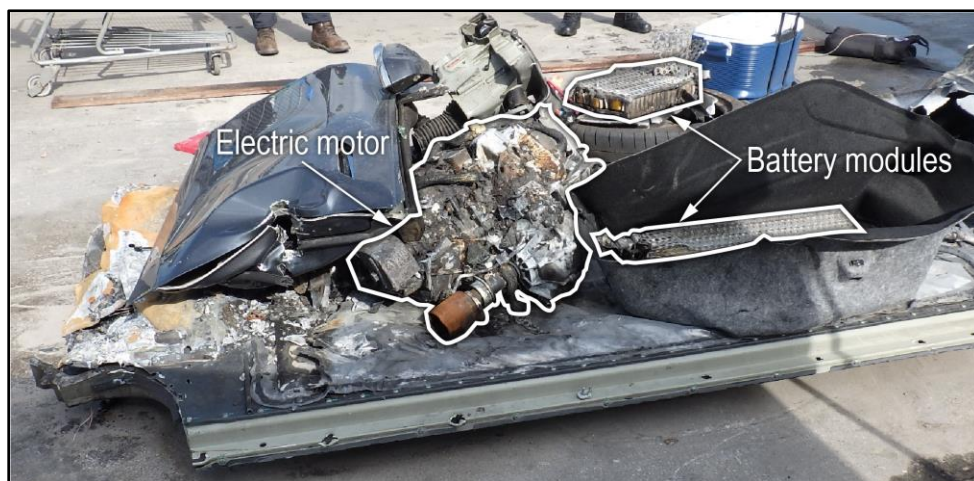
Figure 11. Debris pile on pallet with remains of electric motor and battery modules highlighted.

The high-voltage cut loop was found attached to the front electric motor and had not been cut. Firefighters told investigators that the cut loop was inaccessible during the fire response. Review of the cut loop, emergency response guidance, and exemplar vehicles revealed a minor inconsistency in the cut loop instructions, such that in some vehicles, the cut loop label might be obscured from view under a trim panel. This vehicle model, manufactured after June 2013, also had a cut loop at the left rear door frame, in case the front cut loop was not accessible. Reaching the rear cut loop required penetrating the door frame with a circular saw at a depth indicated by a label at the location of the cut loop. The label was found to have been attached incorrectly to the vehicle's right rear door, where no cut loop was installed. Firefighters had not attempted to use the rear cut loop.

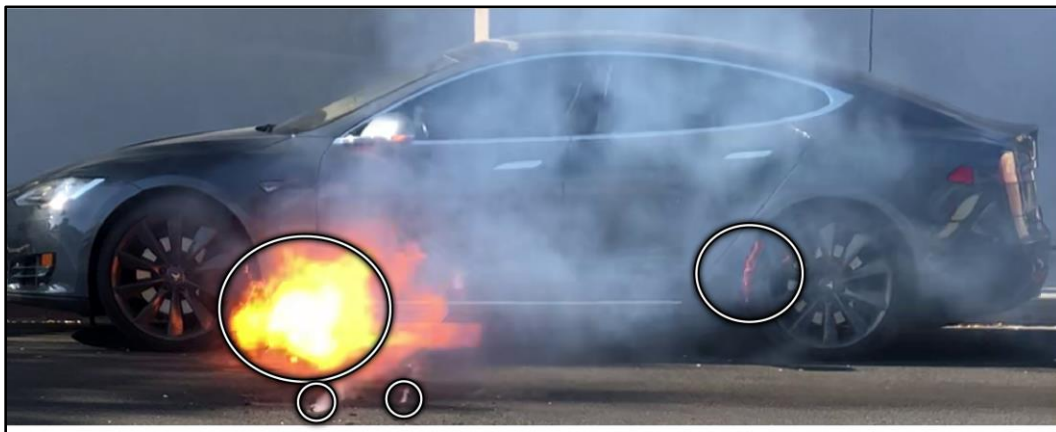
Two people captured videos of the event—a bystander and the driver. Video taken by the bystander captured the left side of the car. Figure 13 is a still image taken from the bystander's video showing fires behind the left front wheel and in the left rear wheel well (large circles), as well as pieces of material ejected from the vehicle (small circles). The image was taken 26 seconds from the start of the bystander's recording and occurred within 2 minutes of the start of the incident.

Figure 13. Image from bystander's video with fire visible behind left front wheel and in left rear wheel well. (Source: Los Angeles County Sheriff's Department)

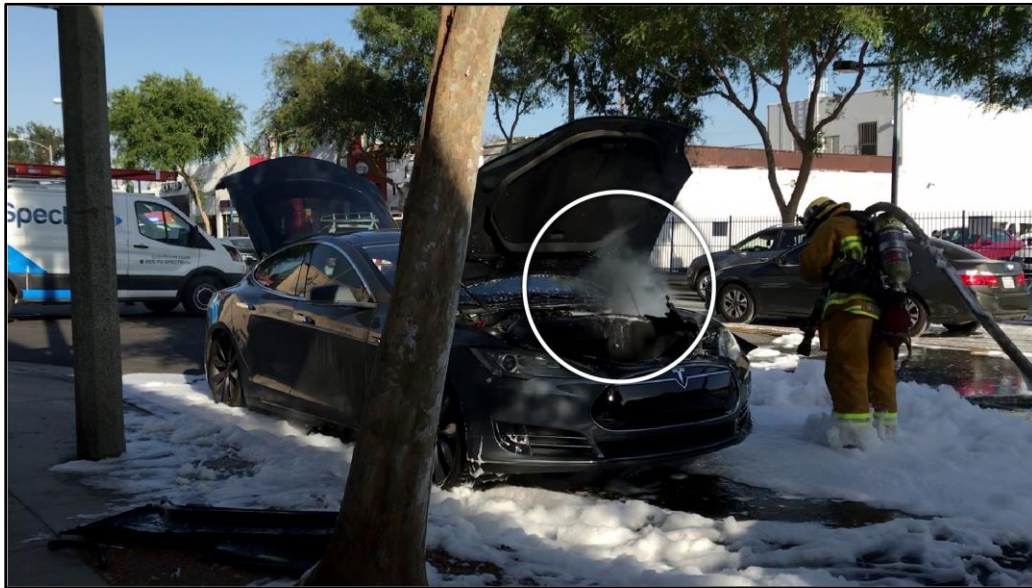
Figure 14. Image from driver's video showing car after flames were extinguished but with smoke still rising (circled). (Source: car's driver)

The fire captain told NTSB investigators in a postincident interview that the flames were extinguished quickly, but that smoke continued to come from the vehicle. He was surprised that the vehicle continued to emit smoke and said that firefighters applied water for longer (about 30 minutes) than he would have expected for such an event. He estimated that firefighters used 300 gallons of water and foam and said that they did not connect to a hydrant.

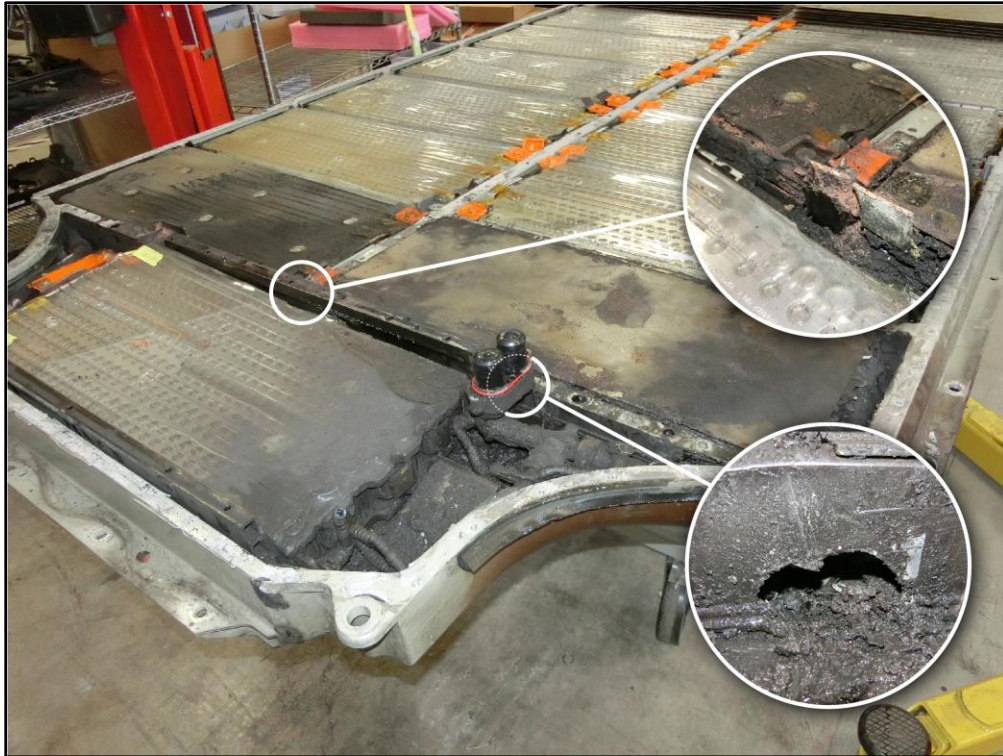
NTSB investigators attended a second inspection in Sunnyvale to view the damage to the vehicle, the battery, and the battery case and to observe the effects of thermal runaway. The vehicle inspection was followed by a teardown of the battery pack. The battery case exhibited holes at the left and mid-front that appeared to be caused by venting gas. Figure 15 shows the whole pack, with damaged areas circled and insets highlighting details of the damage. The damage created paths for vented gas and flames to reach both the left- and right-side overpressure vents of the battery pack. The damaged areas were photographed after debris and parts of the battery pack were removed.

Figure 15. Battery pack with top cover removed to show location of holes in battery case and insets showing closeups of damaged areas.

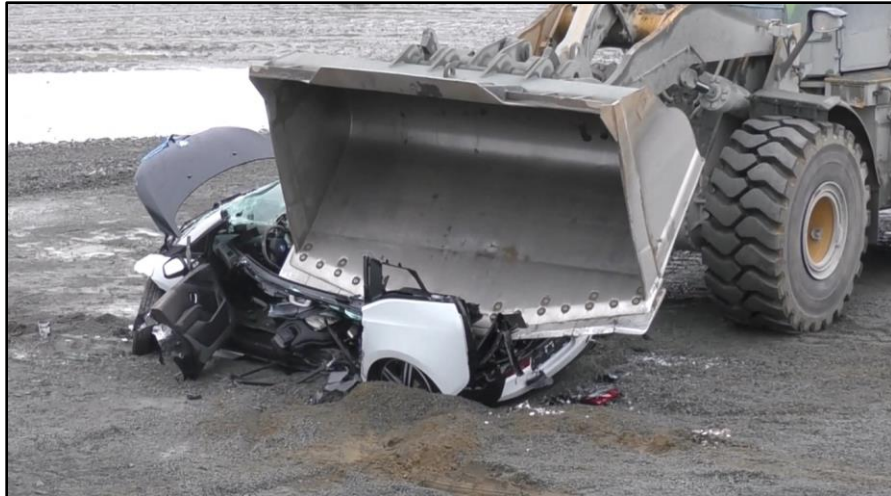
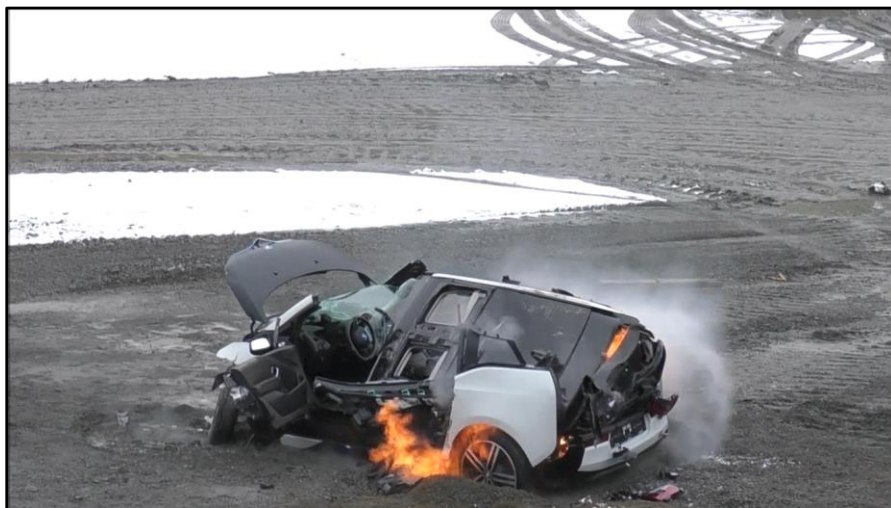
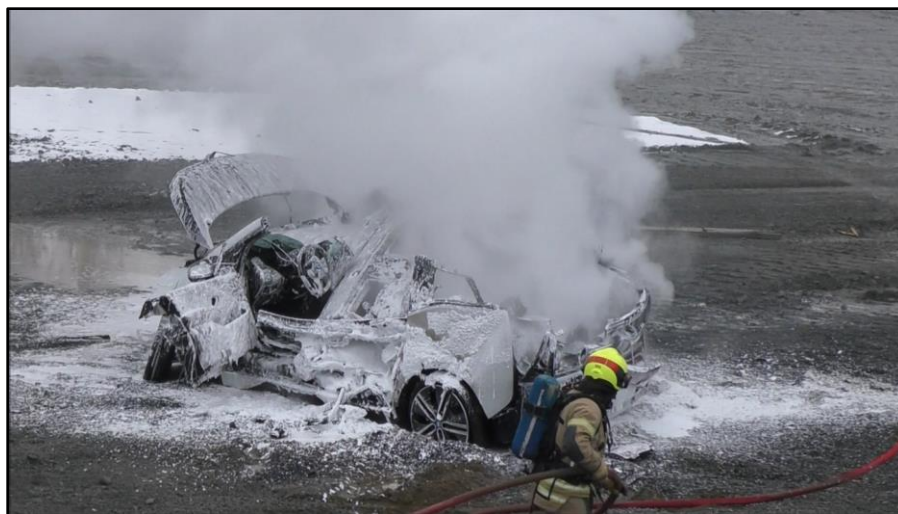
Figure 16. Series of images showing (a) attempt to trigger short circuit by crushing car with bulldozer; (b) flames erupting 8 minutes after piercing car with metal rod; (c) flames no longer visible, but battery continuing in thermal runaway; and (d) fire burning itself out, with arrow pointing to metal rod. (Source: NFRD video)

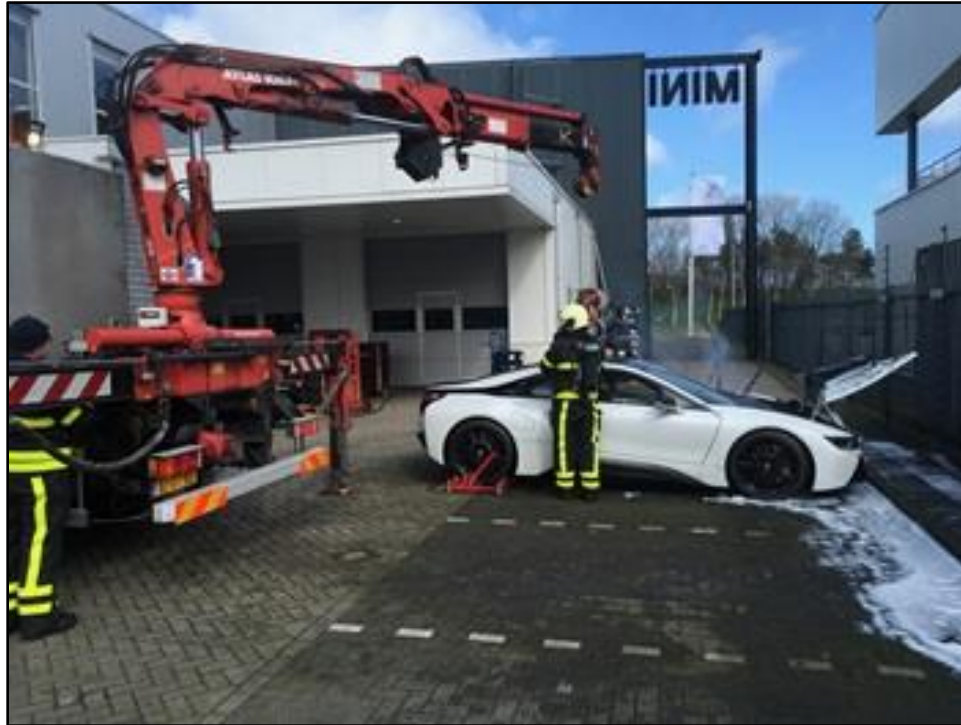
On March 25, 2019, in Tilburg, the Netherlands, firefighters dropped a BMW model i8 coupe into a water bath after the car began smoking while on display at a dealership (see figures 17 and 18).⁶⁴ The car was kept in the water for 24 hours. As the Central and West Brabant Fire Brigade explained in a message on its Facebook page, “Extinguishing an electric car requires a lot of water for a longer period of time, partly because the battery packs are difficult to reach and the fire flares up again cell after cell.”⁶⁵

Figure 17. BMW after firefighters attempted to extinguish fire, with crane positioned above and faint plume of smoke visible above car's windshield. (Source: Central and West Brabant Fire Brigade)

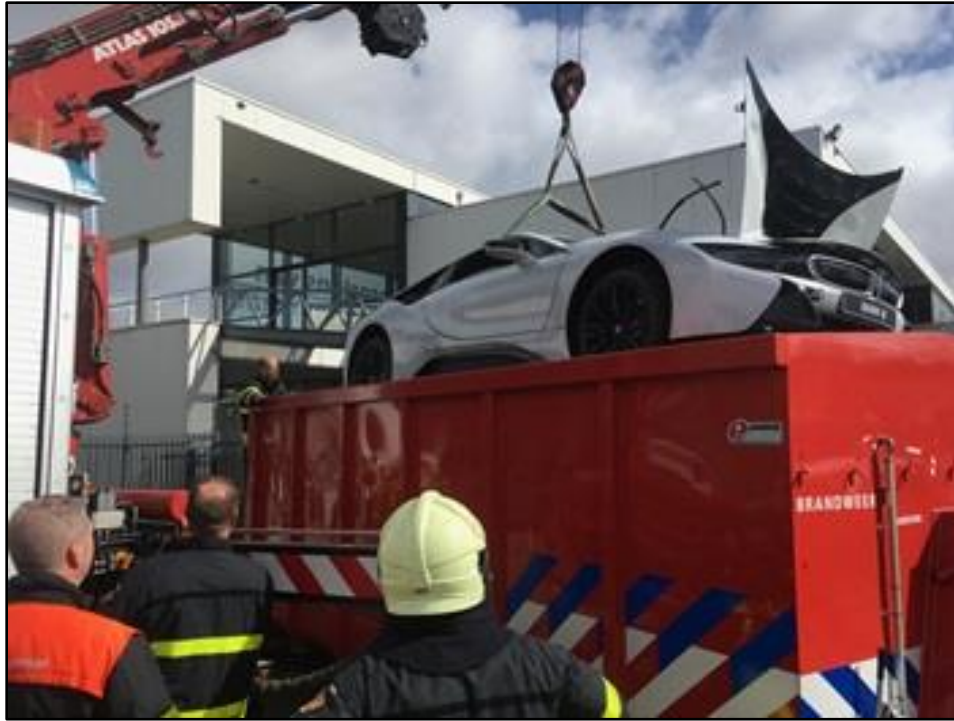
Figure 18. BMW being loaded into tank filled with water. (Source: Central and West Brabant Fire Brigade)
