PCAL assembly – Module-I

Box assembly

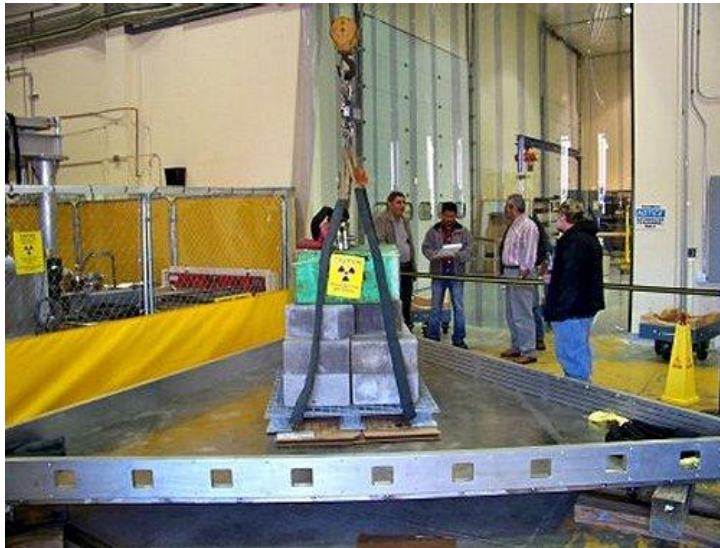
Three sidewalls and retaining assembly for the first module were received in February and the machined pieces were within design tolerances except for the position of the window screw holes used to attach the sidewalls to the window frame, they were out of alignment with the threaded holes in the sidewalls by a few millimeters. Survey showed

that the incorrect holes corresponded to the window's frame.

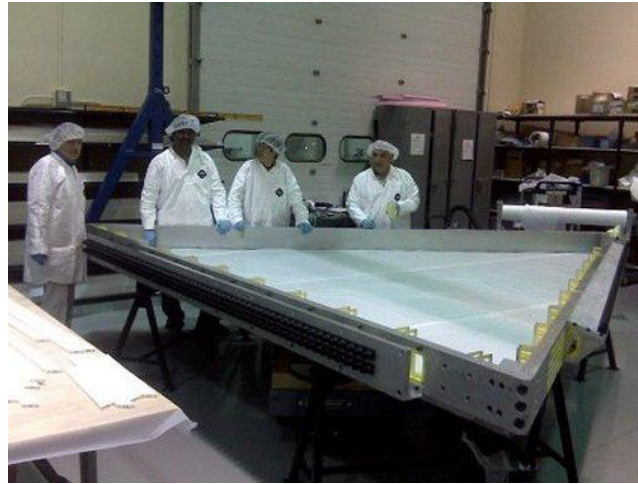
- It took a few hours to accommodate the 84 scintillator strips of the first U-layer. Overall looked good, but the springs for about 20 scintillator bars in the middle were too tight. It was decided to “shave” 1 mm off of the retainer on the readout end of the retaining bar.

- May 4, the first retainer for the U-layer bars was replaced after the removal of 1mm. It was decided that instead of one long aluminum retainer strip, to make machining easier it was decided for the remaining bars to cut them into 4 pieces of equal thickness as specified but with a width 1mm smaller than the original retainer. In order to make sure that 4-piece retainer will not move or “fall apart”, they were spot glued to the window with two-component epoxy (DP-120). Most of springs were installed to see how they fit with the new retainer (they were removed for fiber installation afterwards).

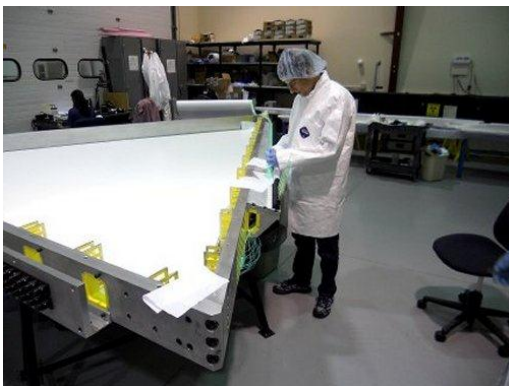
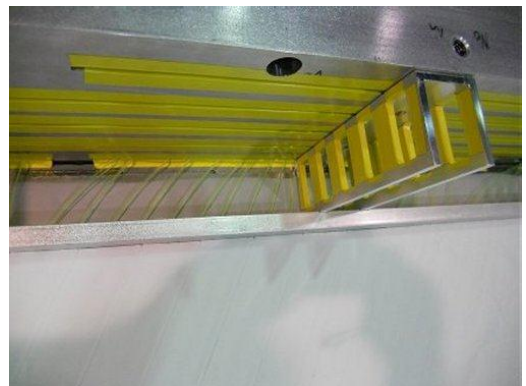
- May 5, fiber installation started, being finished for this layer on Saturday, May 7. In the meantime the second retainer bar was sent to the machine shop to machine 1 mm deep grooves on the opposite side to the scintillator where the retainer bars sits on the retaining support channels. (A mistake was made on the drawing for the location of

the grooves. It turns out that on the PCAL drawings the retaining assembly location of the channels was given from the edge, not from the center. Hakob removed a few mm from the end of the retaining bar in order to make it fit.)

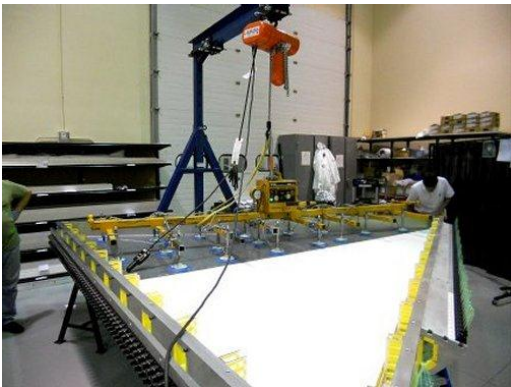
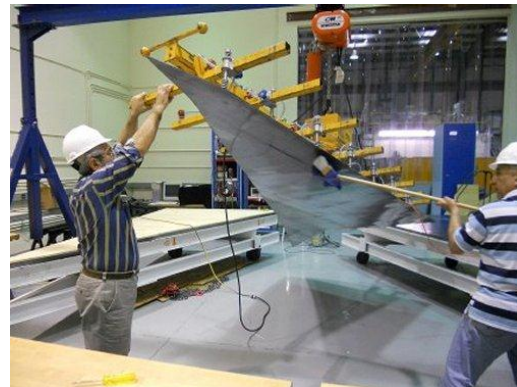
- May 10, the first test to verify the fit of the lead sheet in the box was performed. It did not fit. Several problems were found: the lifting fixture was out of balance, the suction cups were not well distributed, the Lead sheet and one corner sagged too much, on one side the frame touched the side wall (the fibers actually), and last but not least the hoist motion was too fast.

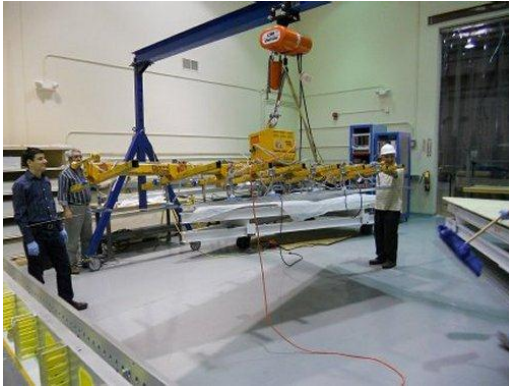
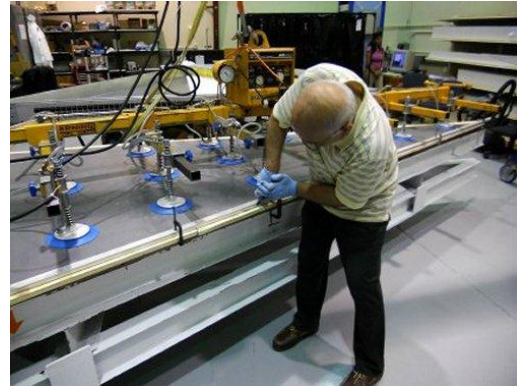
- Checking the Lead sides again, it was found that the hypotenuse of the triangle was not a straight line. It looked like the knife (or blade) used to cut the Lead followed a wavy path. Using a straight edge (a long steel ruler) and a box cutter, the edge of the left piece (looking from the back sidewall towards the tip of the PCAL triangle) were cut straight. Also, the suction caps of the lifting fixture were moved to the right side of the frame to solve the issue of interference of the frame with the fibers. On the

back side suction cups redistribution was done to solve the issue of the imbalance along the axis.

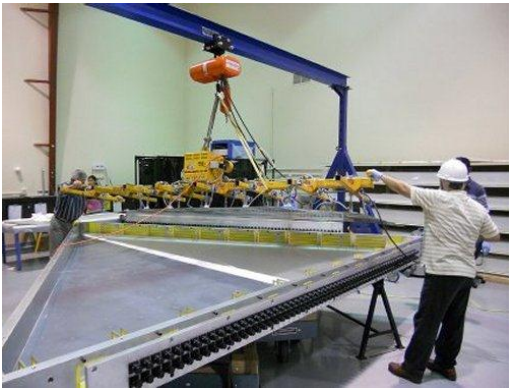
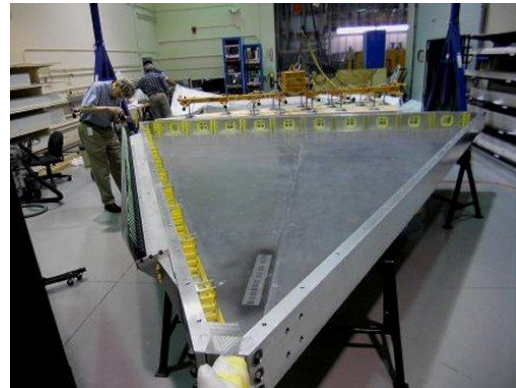
- May 11, the first (left) Lead sheet was set on top of the scintillators just before the “Run a round”. The trial fit of the second piece was again unsuccessful. There was about 2mm overlap, and again hypotenuse was not a straight line. Had to be re-cut straight as the previous one.
- May 12, after a few iterations the second piece was successfully installed.

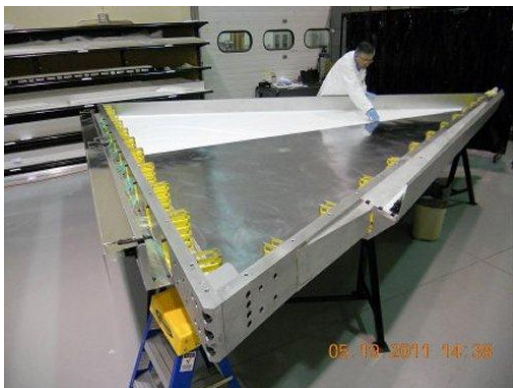
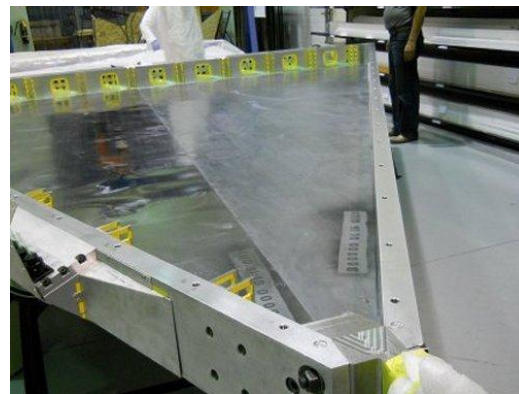
- May 18, the thicknesses of both lead sheets were measured on Tuesday. First piece (right piece) was prepared for installation by end of Wednesday (sides were measured and a cut was made to straighten the hypotenuse).
- May 18, in the early afternoon, the first Lead piece was installed; the second (left) piece did not fit. Trimming in a few places along the hypotenuse was required. After cutting three wiggles, the second sheet fitted well.

- It was decided to increase the number for support shims under the retaining bar on the V/W side. It is too thin and it sags between 5 supports. 4 more shims were added between each pair of original supports.
