PIC32MX534/564/664/764 Family Silicon Errata and Data Sheet Clarification

The PIC32MX534/564/664/764 family devices that you have received conform functionally to the current Device Data Sheet (DS61156F), except for the anomalies described in this document.

The silicon issues discussed in the following pages are for silicon revisions with the Device and Revision IDs listed in [Table 1](#). The silicon issues are summarized in [Table 2](#).

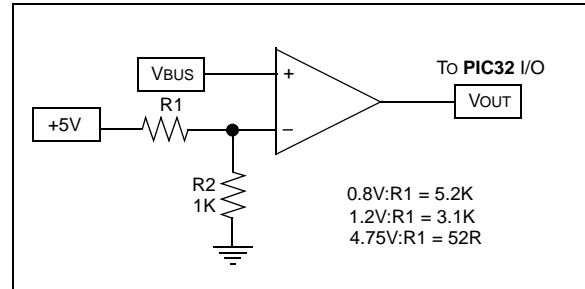
FIGURE 1: EXTERNAL COMPARATOR SCHEMATIC EXAMPLE

When the USB model is configured for OTG operation, it may not properly recognize all required OTG voltage levels on VBUS pin.

Use external comparator circuit to detect OTG specific voltage levels on VBUS pin.
