CERTIFICATION OF CIVIL STRUCTURAL WORKS

STRUCTURAL CONDITION REPORT OF 4 STORY BUILDING

Makola Medicare Hospital

No 332/1A, Makola South, Makola

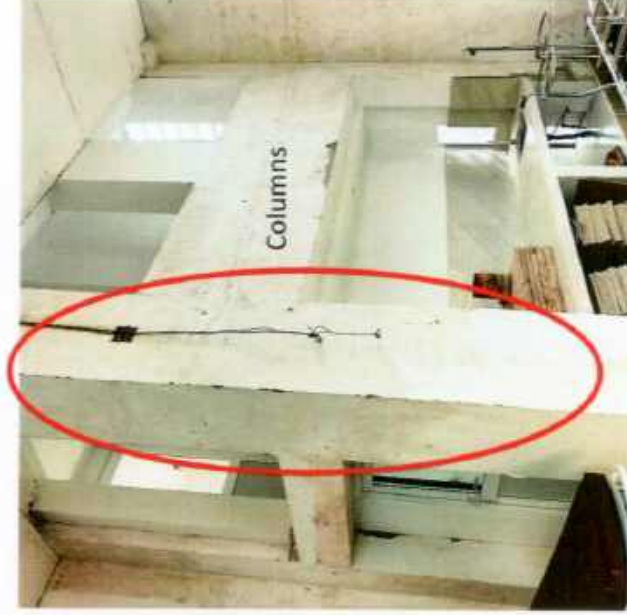
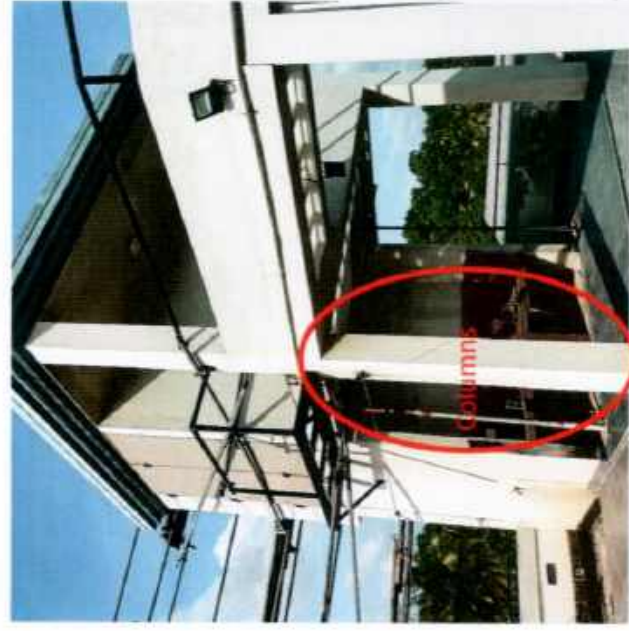
Figure 2 – Visible columns

The reinforced columns are essential structural elements that play a critical role in supporting the weight of a building and transferring loads to the foundation. The columns (9 inch x 9 inch & one foot by one foot size) are placed at the corners and intersections of walls, and at regular intervals along exterior and interior walls, to evenly distribute the loads and maintain stability.

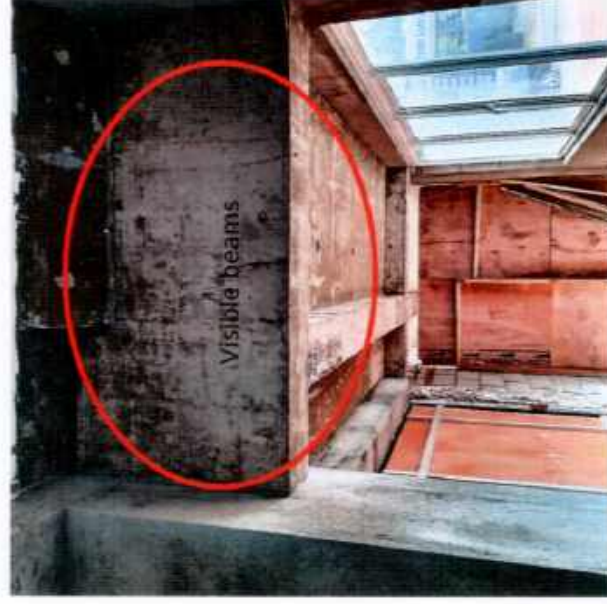
Figure 3 – Visible concrete beams

In general, the building is in good condition. The masonry walls are well-maintained and show no signs of decay. There are no visible indications of distress, damage, or deterioration in the structural elements of the building. Some hairline cracks are observed on the concrete beams of the ground floor, but they do not require immediate repair. The construction of the building exhibits good quality, with visible materials and workmanship of satisfactory standards. The exterior walls have a rough finish with architectural mouldings, contributing to the overall aesthetics. No significant defects or deficiencies were identified during the inspection.

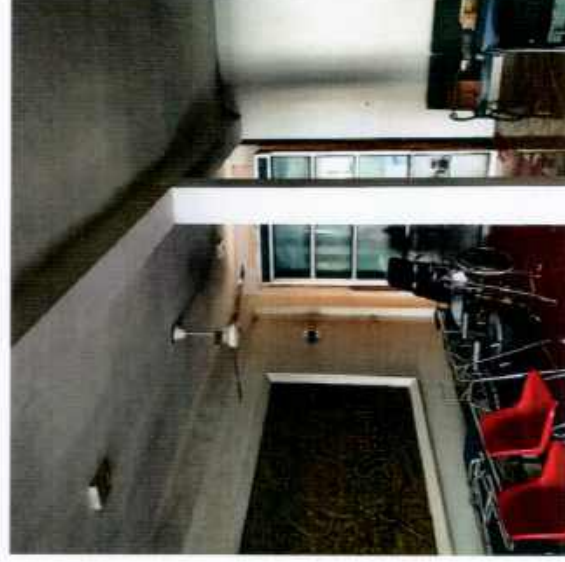
Figure 4 – Visible concrete slab

All concrete slabs are constructed as suspended slab. This type of concrete slab is used for upper floors in multi-story buildings. It is supported by beams and hangs above the lower level, creating open spaces.

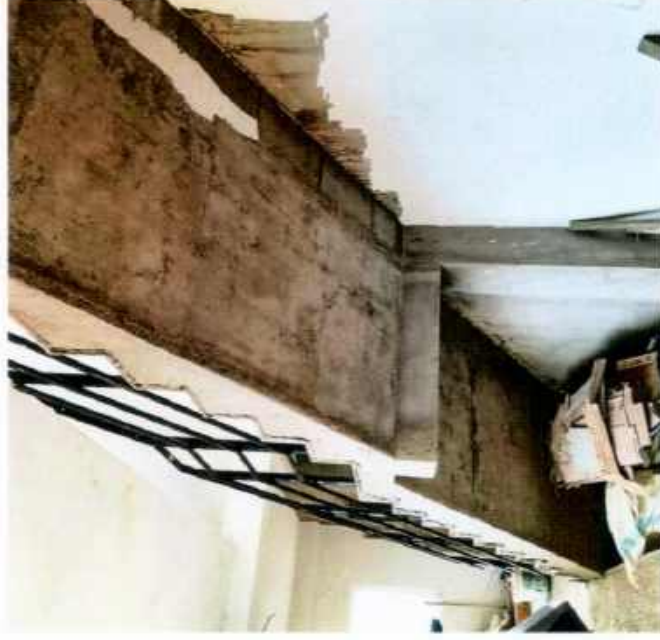
Figure 5 – Visible concrete staircase

The concrete staircase is straight Staircase, A simple and straightforward design with steps in a straight line from one level to another.
