# **LANKA HOSPITAL BUILDING CERTIFICATE**

**STATE ENGINEERING CORPORATION OF SRI LANKA**

**2021-02-08**

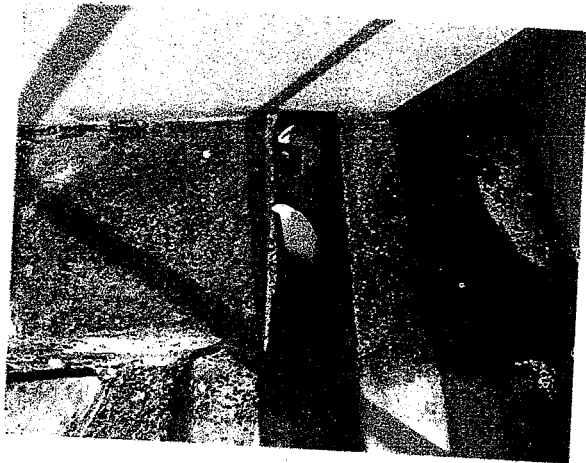
Issues concerning to structural elements were hardly noticed. In the roof drain areas some of the down pipes were observed to be clogged causing water to stagnate (Refer Plate 1). Steel staircase which provides access to helipad was observed to be corroded to a certain degree (Refer Plate 2 and 3). High tensile cables connected to the steel frame along the perimeter of the buildings to support the Gondola track were

Plate 01 Clogged down pipe

The main building is structurally safe for occupation and its purpose but attention should be drawn to rectify the issues related to water proofing since they could affect the structural elements of the building in long term. Further need to pay attention to the issues related to corroded areas of staircases and Gondola track

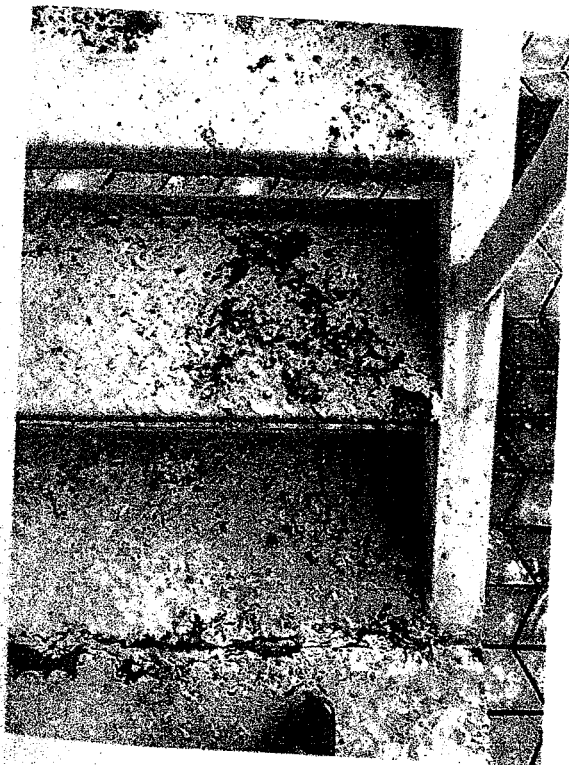
Plate 03 Corrosion visible in staircase

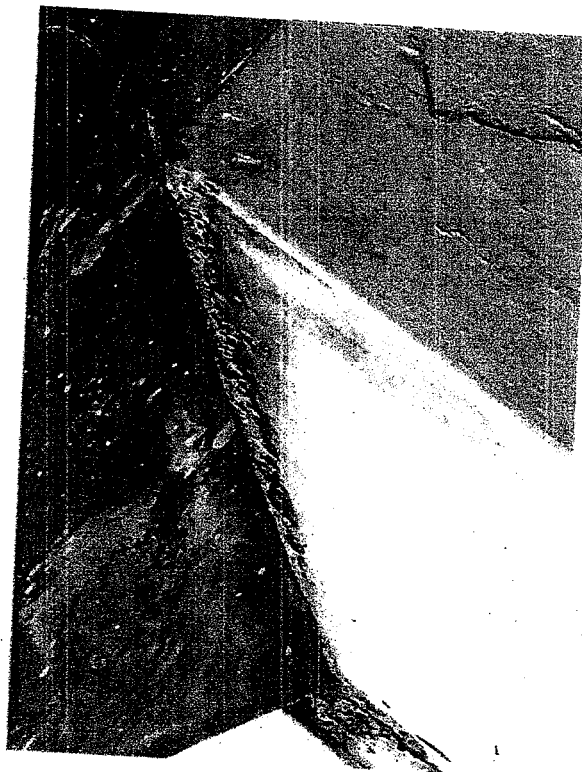
observed to be corroded at the connections to a certain degree. Dampness was observed at the Atrium roof slab (Refer Plate 4 and 5). Further dampness was observed in some areas along the walls of the fire staircase at Block C (Refer Plate 6)

Plate 04 Dampness below the Atrium roof slab

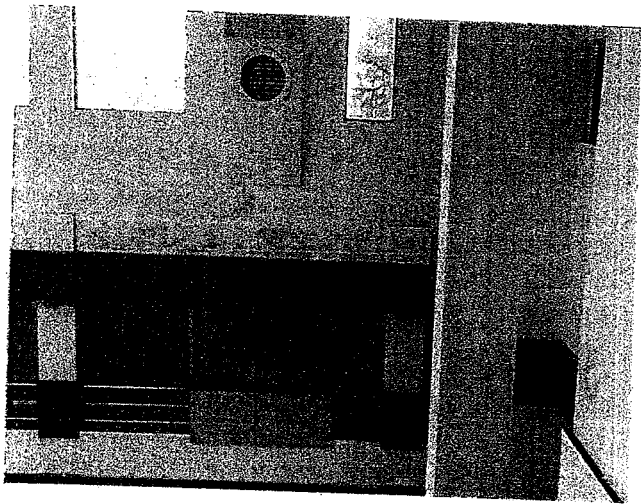
Plate 05 Dampness in the walls below the atrium roof slab

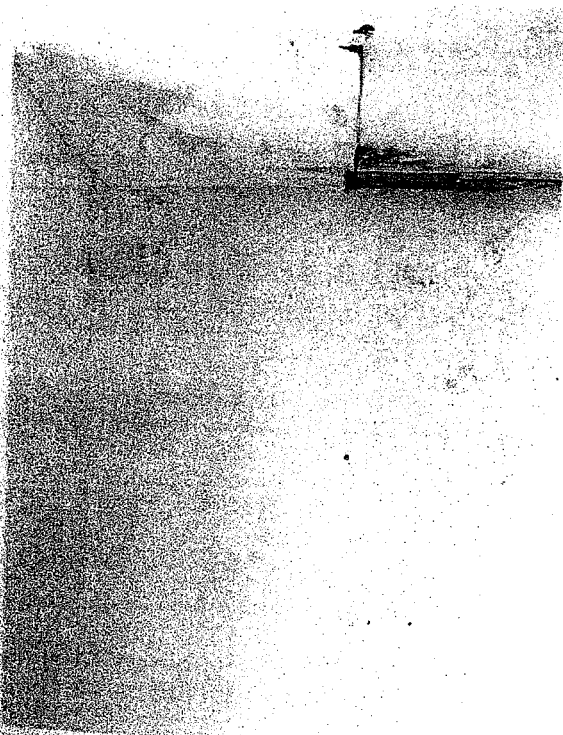
Plate 06 Dampness in the walls below the Fire staircase roof slab
