YETS Maintenance Update

January 26, 2023

Peter Camporeale, Jacky Li
On behalf of TileCal maintenance team

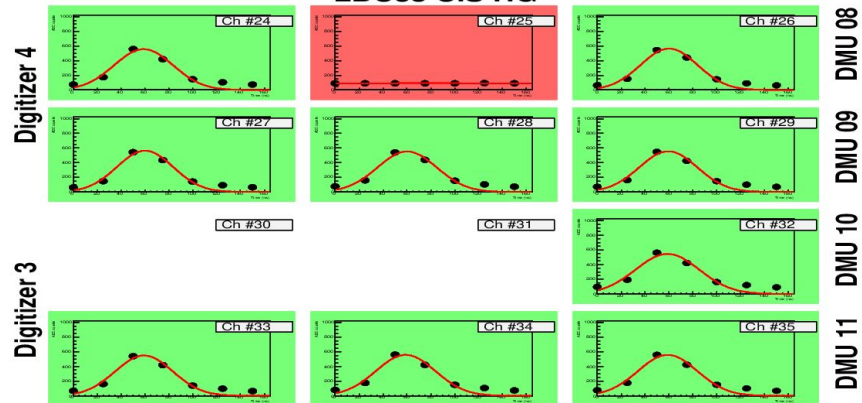
LBC38 CIS HG

Status: Drawer closed; DVS test performed; Channel 25 problematic in HG, LG, and integrator. Leak fixed.

LBC 38:
Problems in
channel 25
