YETS Maintenance Update

January 19, 2023

Peter Camporeale, Jacky Li
On behalf of TileCal maintenance team

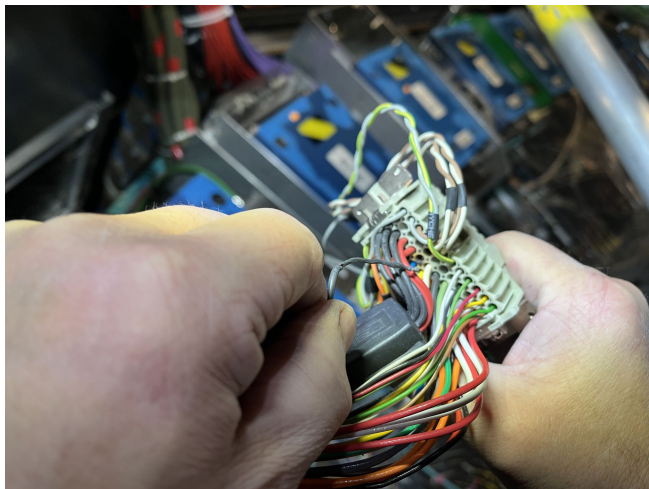
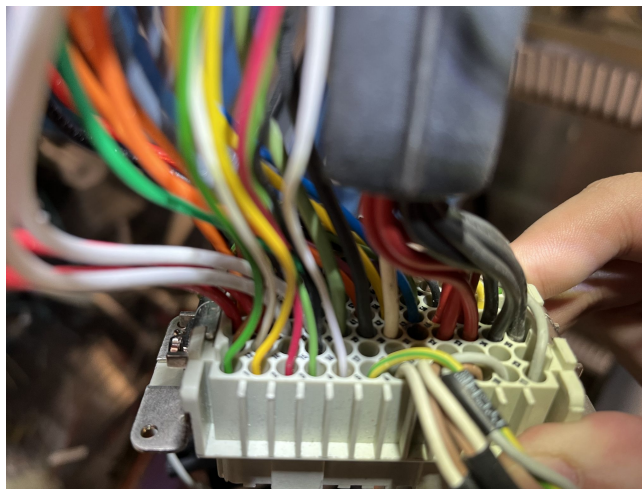
Problem: Trips on MB side; Harting connector pins were burned (pin 33) and had been soldered improperly

LBC 24: Burnt
Harting connector
and wire

Intervention: Replaced the Harting connector, burnt wire, and LVPS damaged

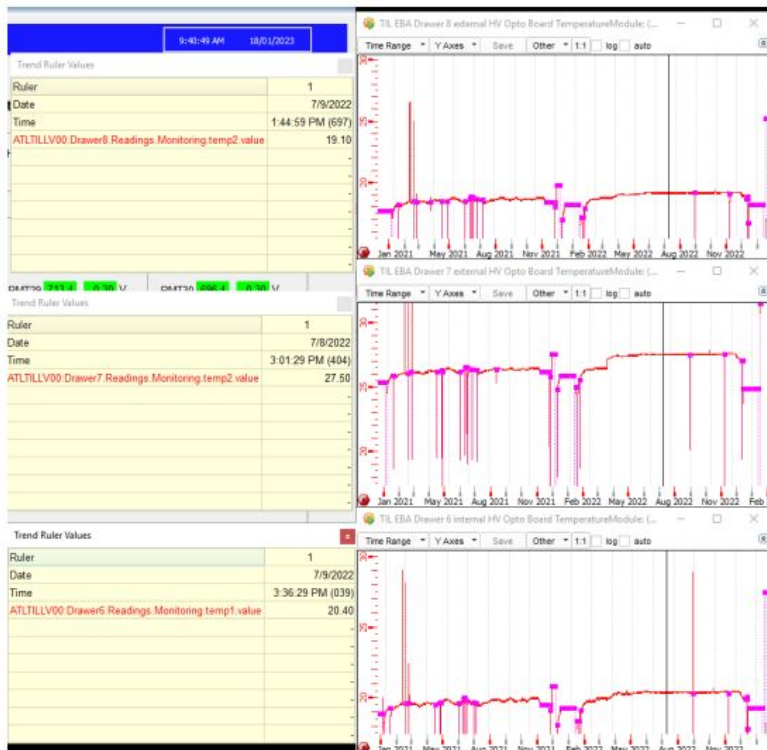
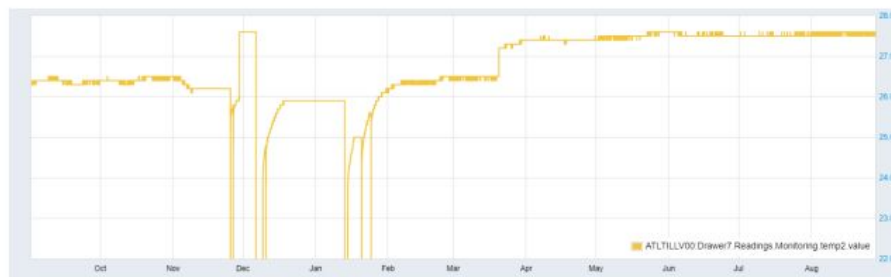
Monitored temperature HV_Opto-ext in EBA07
Jumped Up in 2022 by ~ 1 degree
Compare to 2021
