" Quality Alert "

2017 QA-010

RM292P-N

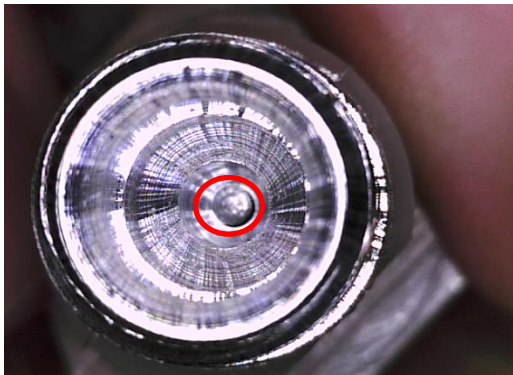
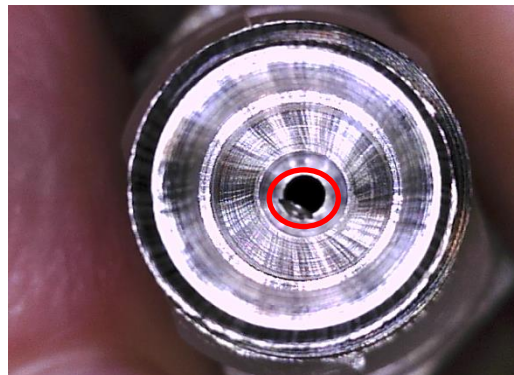
Burr in cross hole that is causing low flow at customer

De--burr all on hand inventory. Make sure to visually inspect parts for defect
