# " Quality Alert "

**ID #:** 2017 QA-005

**Part #:** FS12

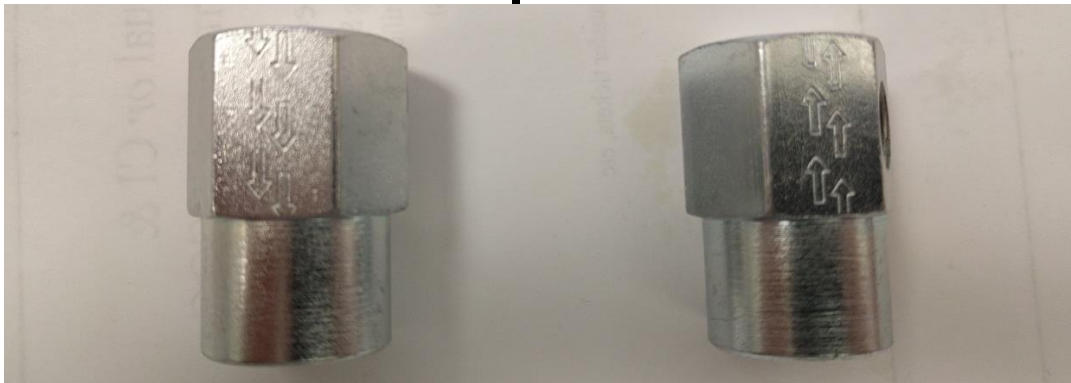
Flow arrow is pointing in the wrong direction.

**BAD**

**GOOD**

Parts need to be visually inspected when being made for correct arrow direction
