" Quality Alert "

2017 QA-003

CY Stems

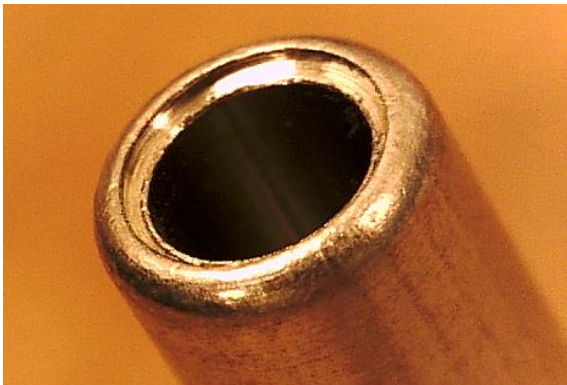
BAD

Under cut on CY stem can cause issues with tank filling

Make sure stem end is flush with standard corner break
