Log ID:

3934011

Incident Description:

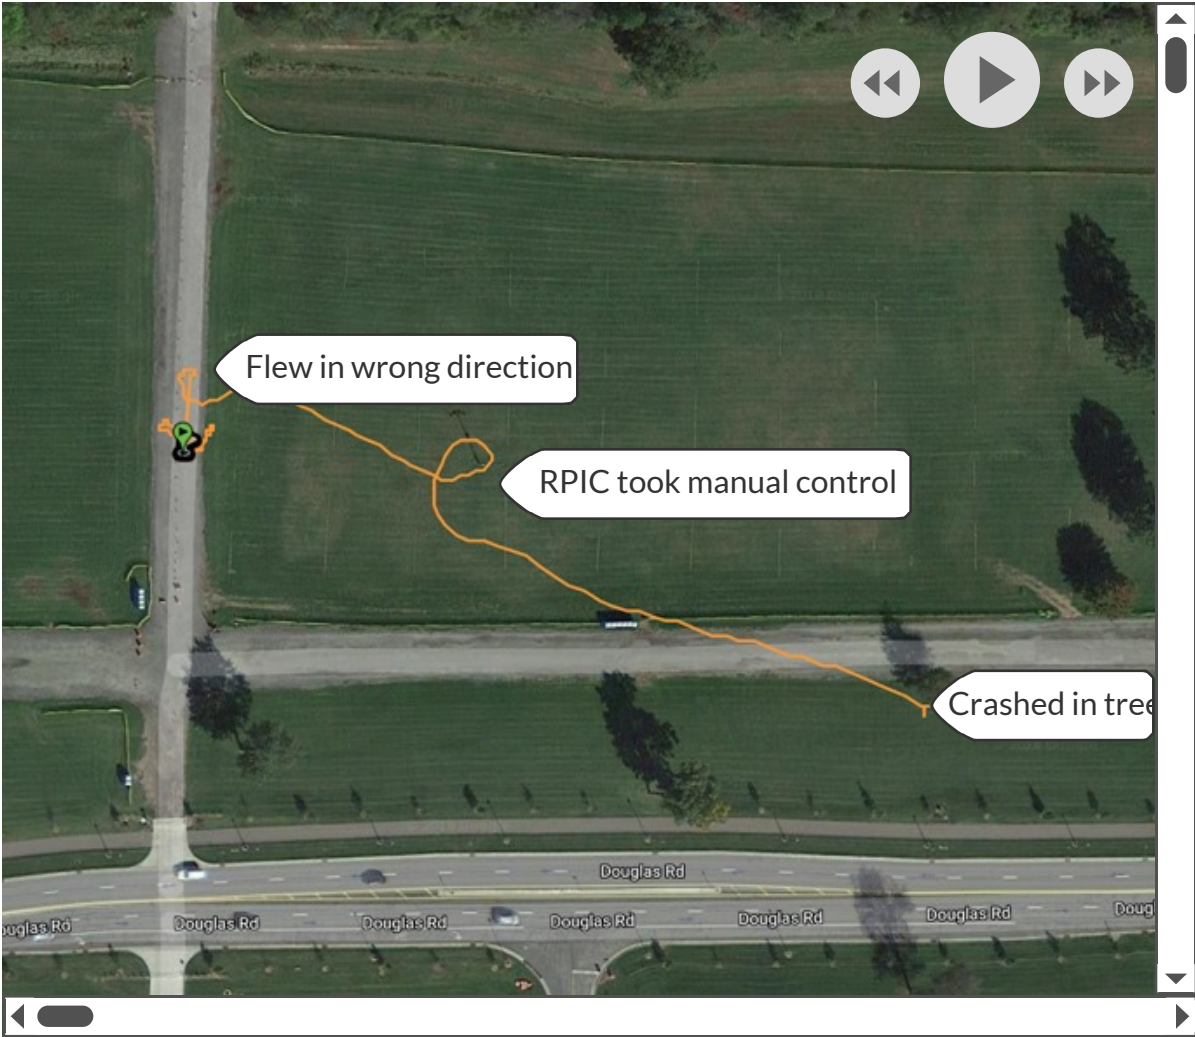
An America Hexcopter took off in GUIDED mode (red) and was directed to fly to a waypoint immediately North West of its launch position. Instead, after an initial attempt to fly North, it headed South East. At that point, the RPIC issued a LAND command (green) followed by a HOVER command (purple) both of which were ignored. The RPIC then attempted to take manual control of the sUAS, and again issued an RTL (blue) command followed by a land command (green) directly from the hand-held controller -- both of which

Unsure - but possibly a faulty magnetometer. Also the area we were flying in has strong interference from local airport radar.
