Log ID:

3934011

Incident Description:

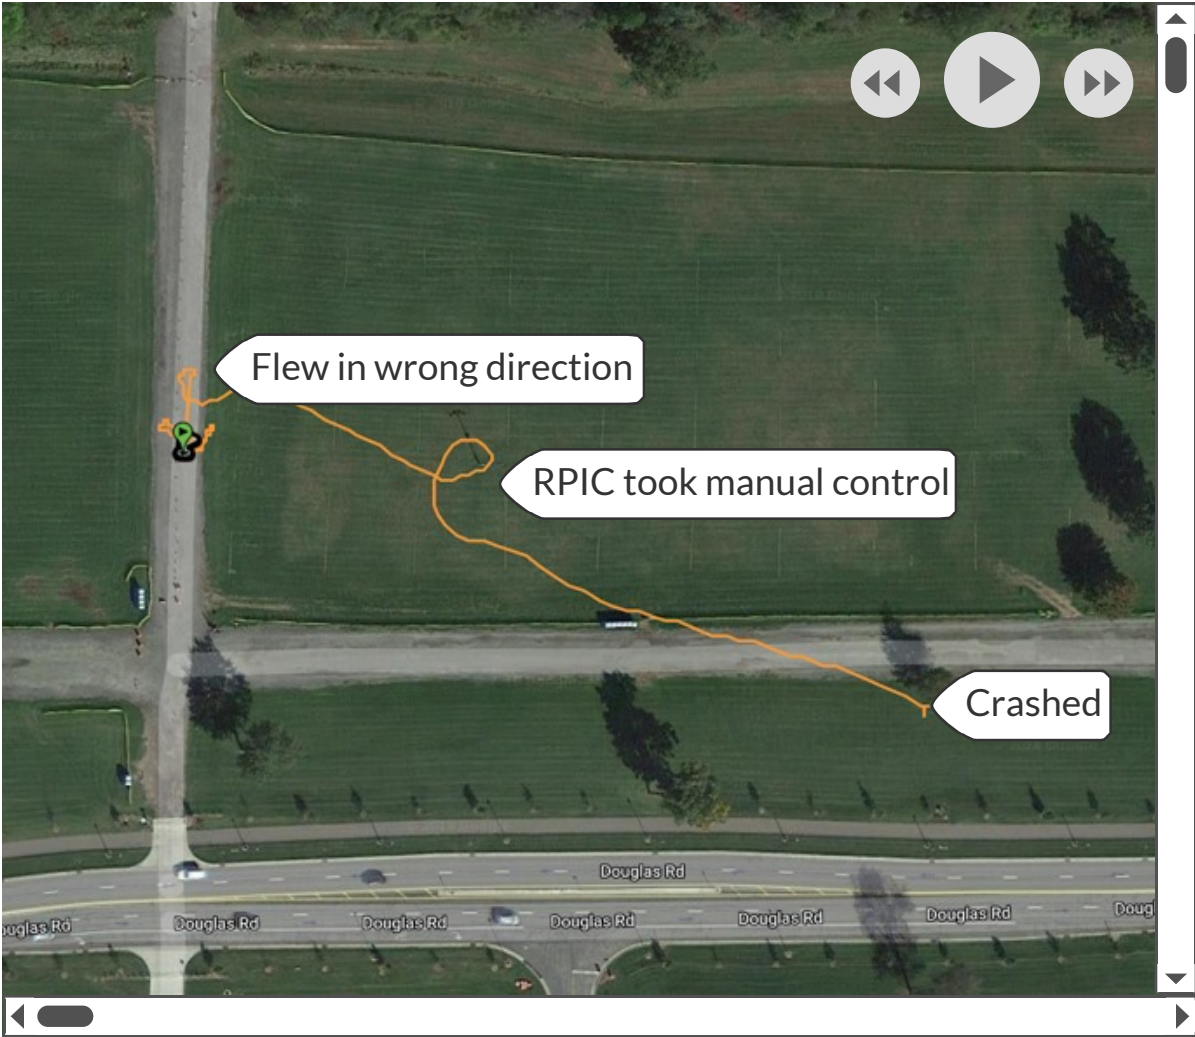
An America Hexcopter took off in GUIDED mode (red) and was directed to fly to a waypoint immediately North West of its launch position. Instead, after an initial attempt to fly North, it headed South East. At that point, the RPIC issued a LAND command (green) followed by a HOVER command (purple) both of which were ignored. The RPIC then attempted to take manual control of the

Unsure - but possibly a faulty magnometer. Also the area we were flying in has strong interference from local airport radar.
