DATE:	December 22, 2020	JOB #:	19031-0080
PROJECT:	Rockwood Apartments	WEATHER:	45 F, Cloudy
LOCATION:	783 Southeast 185th Ave, Portland, OR 97233		
GENERAL CONTRACTOR:	LMC Construction		
PRESENT:	Reed Ledbetter, LMC Construction Todd Young, PE SE DCI Engineers Sri Penmetsa, PE DCI Engineers

Scope of Observation: DCI was on site on December 22, 2020 upon receiving an email from LMC, who observed buckling of wall sheathing along corridor. The following items were noted during the site walk:

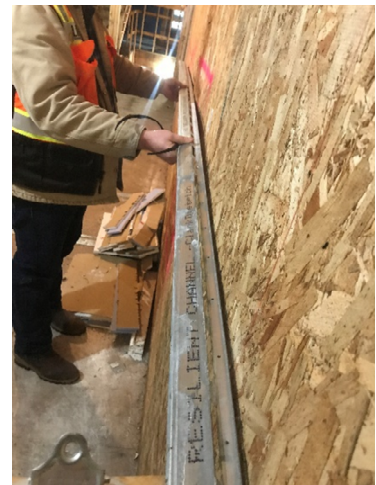
Item #1: When DCI was on site, we saw that the studs/blocking were still straight and the OSB was sucked in tight to those studs/blocking where attached. The buckling was observed between the studs. This is likely due to some sort of water damage. LMC noted that the OSB has been protected against excessive water exposure and as such, may be a problem with the way it was manufactured.

Action: LMC to coordinate with OSB manufacturer to better understand this issue and locally fix sheathing as needed
