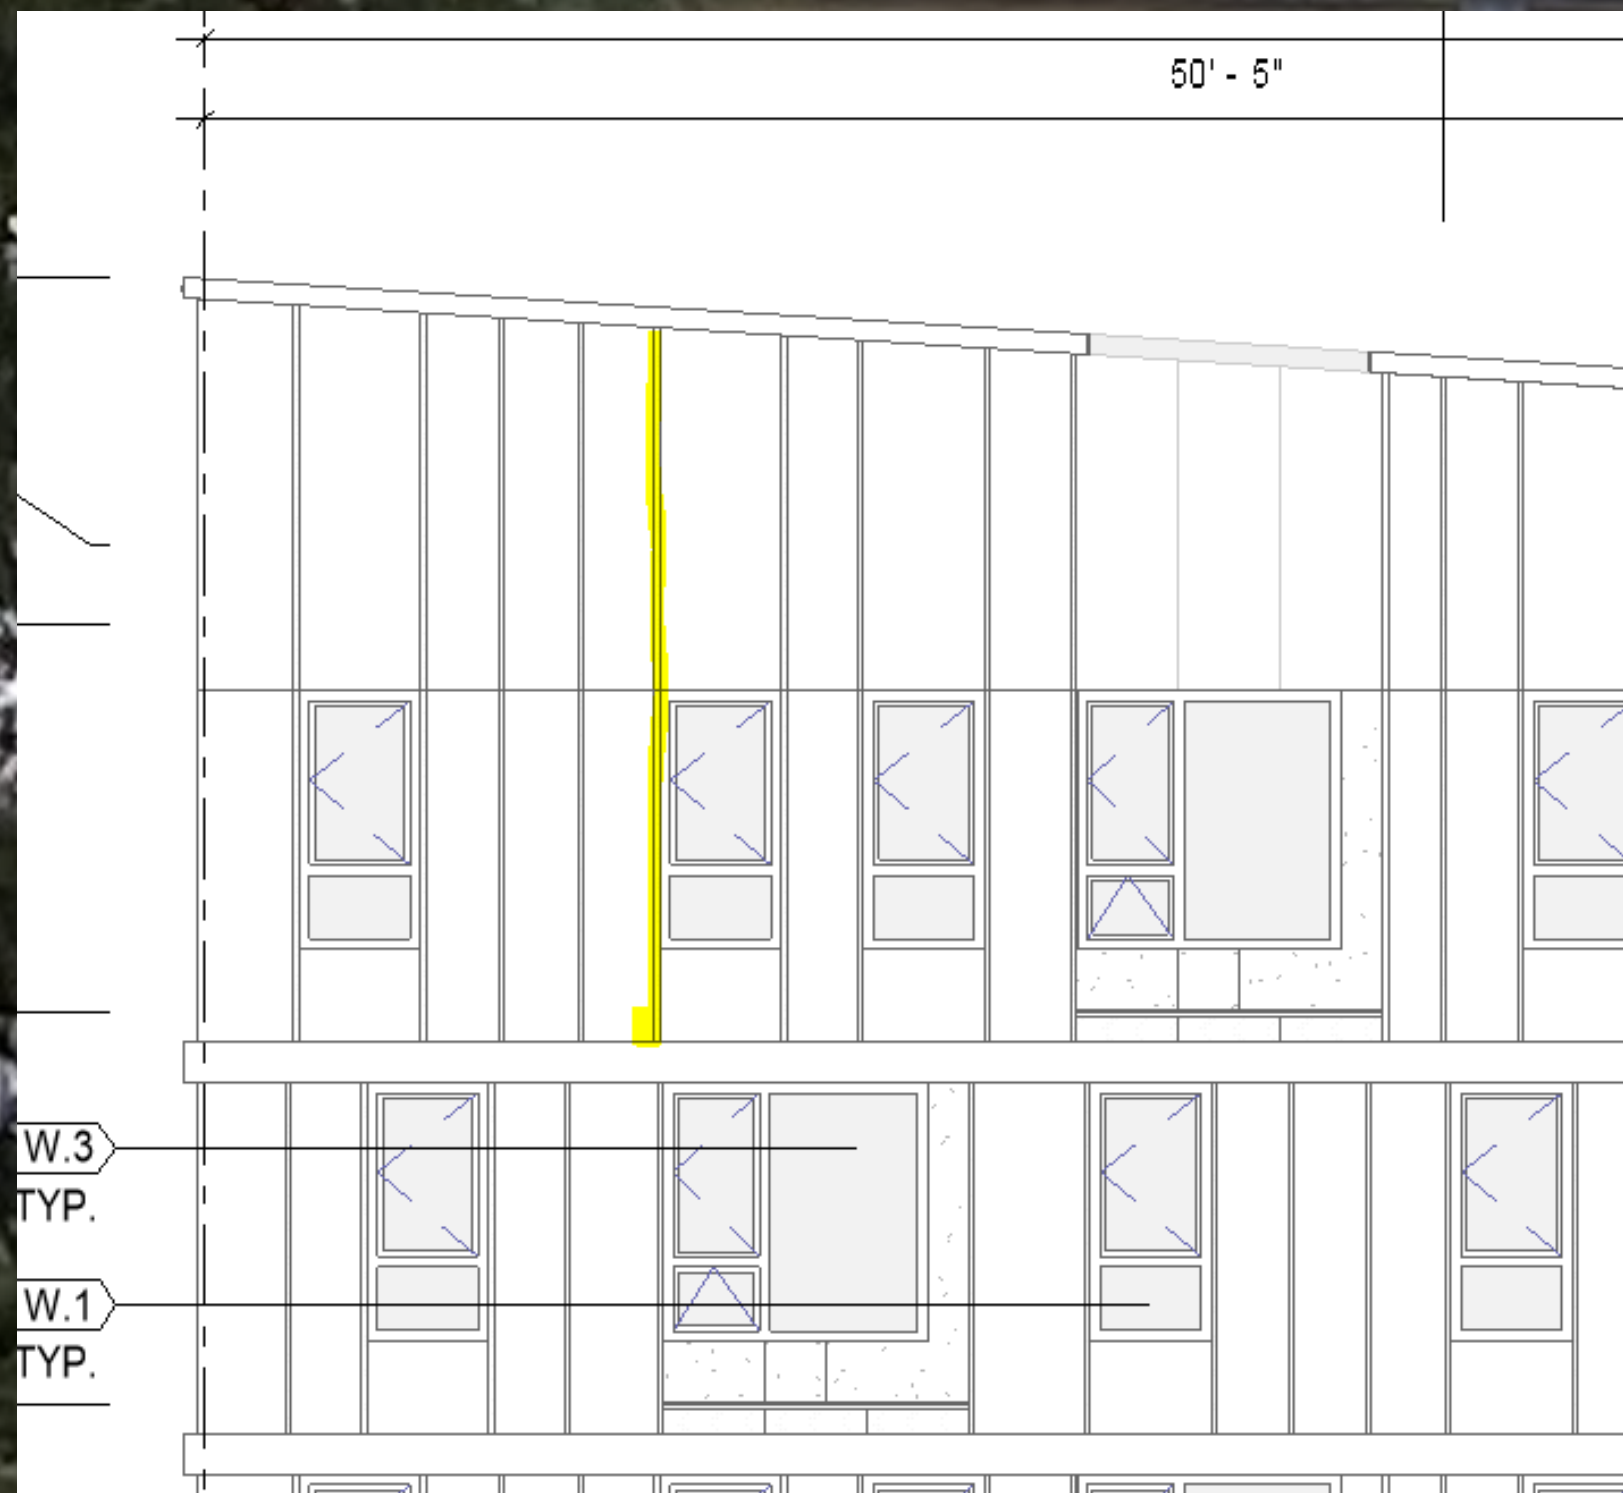
ON TOP FLOOR,
BATTENS SHOULD
NOT BE BROOKEN
BY HORIZONTAL
JOINT. BATTEN
SHOLD EXTEND UP
TO PARAPET.

OIL CANNED SECTIONS DO NOT
MEET DESIGN INTENT AND ARE
NOT ACCEPTABLE AS INSTALLED.
LMC AND INSTALLER TO WORK
WITH THE DESIGN TEAM TO
CORRECT.
OPTION 1 - FACE PANEL TO BE
BACKED WITH RIGID INSULATION;
OPTION 2 - FACE PANEL
REINFORCED WITH HONEYCOMB
PANEL.

WORK WITH
DESIGN TEAM
AND QED TO FIX
OIL CANNING.
