SITE ATTENDEES	PROJECT LOCATION	ENVIRONMENTAL CONDITIONS
Dylan Dalton, LMC Tom Michie, LMC Martin Houston, QEC	783 SE 185th Avenue, Portland, Oregon 97233	60F, 75% RH Overcast

SITE VISIT

The Rockwood 10 project is a new construction project located in NE Portland, Oregon. The requested site observations on July 14th, 2021 were related to the building enclosure components currently being installed. Areas of specific review included integration of MEP components, windows, and flashing with the WRB system.

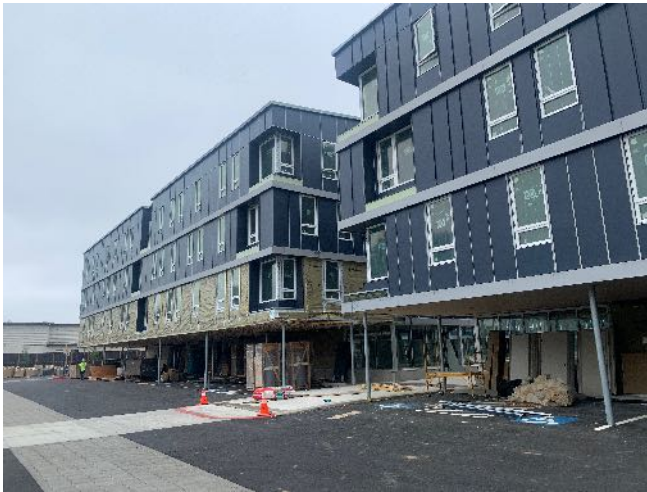
- 5 .01 WRB and window installation is complete at buildings A and B. Cladding and flashing installation is underway but has yet to be completed. Work on soffits in the tuck under parking is ongoing.

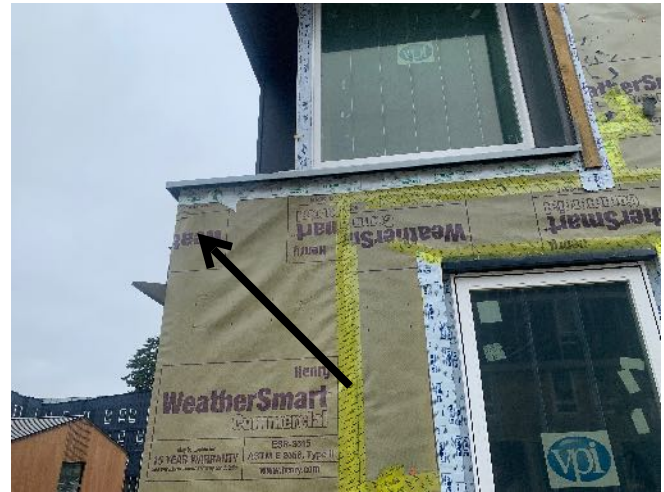
- 5 .02 Building A- Verify that all seams in WRB are properly integrated and sealed prior to installing cladding.

All WRB is and will be inspected and corrected with photo documentation prior to installation of siding. Inspections performed at each wall line/elevation as work progresses around buildings.

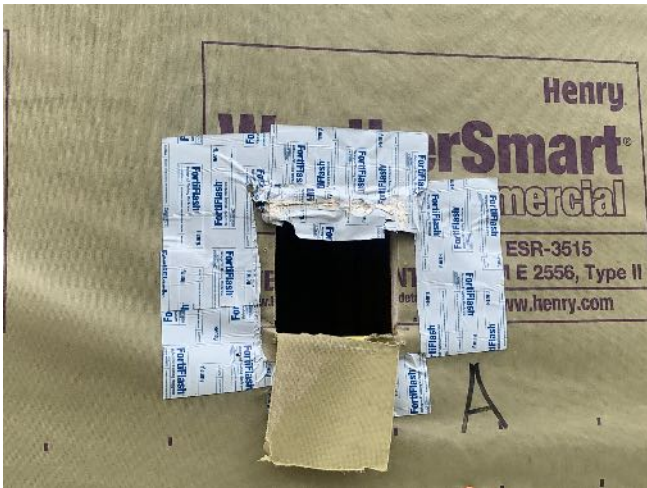
- 5 .03 Numerous penetrations have been removed and re-installed at different locations. Re-install sheathing and WRB as necessary, sequencing in a shingle lapped fashion.

Fire sprinkler access panels relocated. Sheathing repaired. WRB/SAM will be corrected prior to siding elevation.

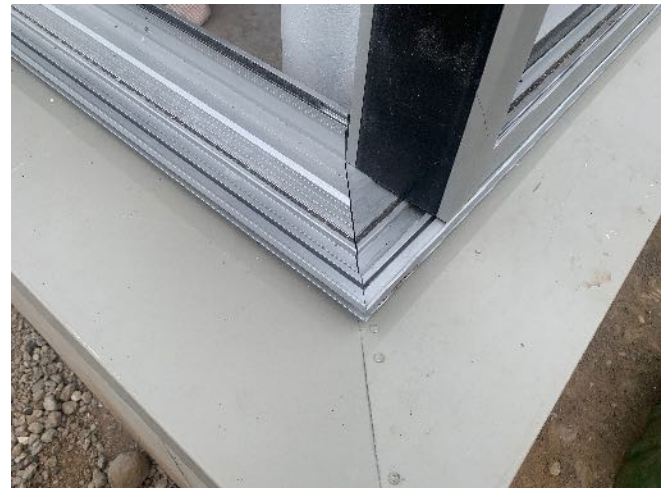
- 5 .04 Storefront sill can detailing should be completed prior to installation of storefront framing members. This miter joint needs to be detailed per manufacturer's instructions.

As per site walk 7/21/20 (LMC, QEC, Blackline) - sill can detailing installed as per Blackline storefront system submittal.

SAM install at these locations installed after window wrap sequence and in place only for the purposes of gasketing at rain screen nailing - no integration into window wrap sequence. Use of sealant in this manner approved by Henry. Acceptable as per phone conversation with Martin Houston 7/22/21.

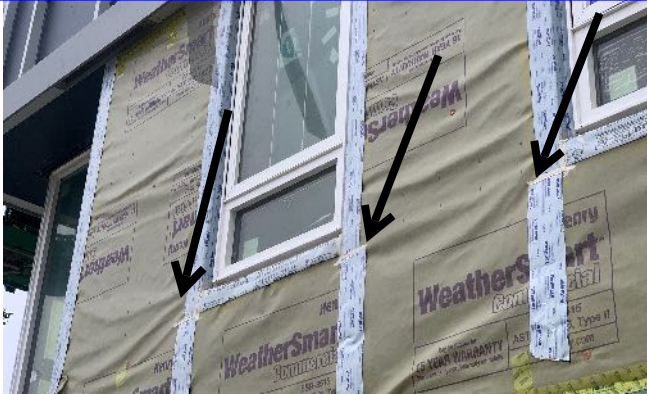
Buildings wrapped with WRB prior to mechanical ducting penetrations. Detailing will be performed prior to belly band install at these locations. Buildings C & D.

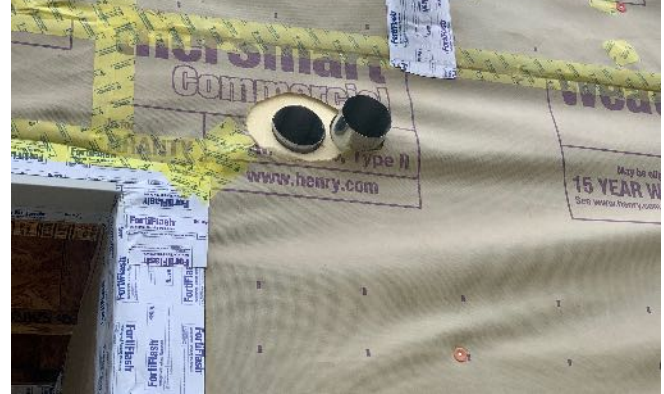
5 .05 There are numerous instances of reverse lapped SAM. While terminating the top edge of SAM with sealant is a repair to be used sparingly, it should not be confused as a basis of design detail. Properly sequence WRB and SAM components to prevent reverse laps.

5 .06 Detailing around exhaust ducts is incomplete. Detail using SAM cut slightly that the pipe diameter and complete detail with liquid flashing from SAM to duct.

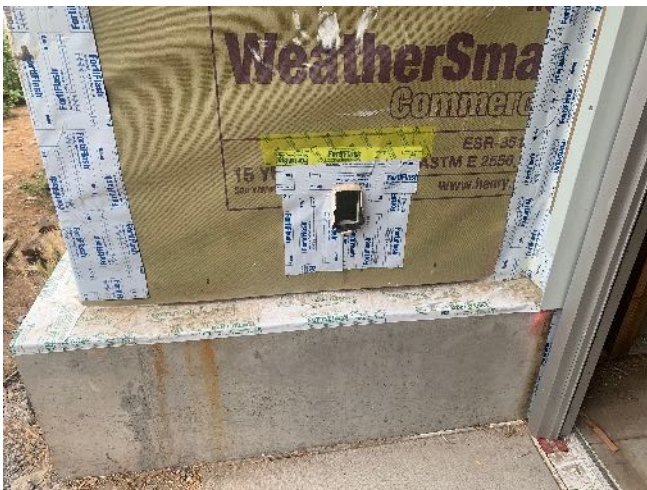
5 .07 Related to item 5.03. Detailing around this re-located electrical J box is incomplete.

Electrical J-box relocated to opposite wall at building C unit entries. Sheathing repairs complete as of 7/19/21. WRB corrections will be made prior to siding these areas.

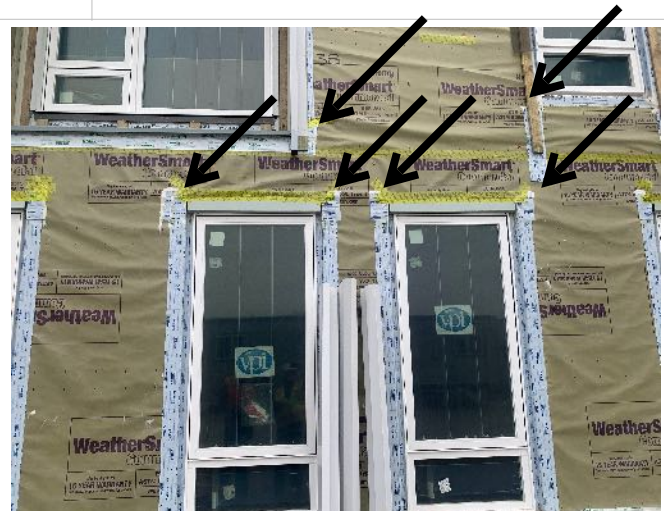
5 .08 The consistency of reverse lapped installations of SAM and WRB is far too consistent. WRB and SAM are to be properly shingled to shed water.

Building C - SAM reverse laps will be corrected prior to siding install. Photo documentation to follow at that time.

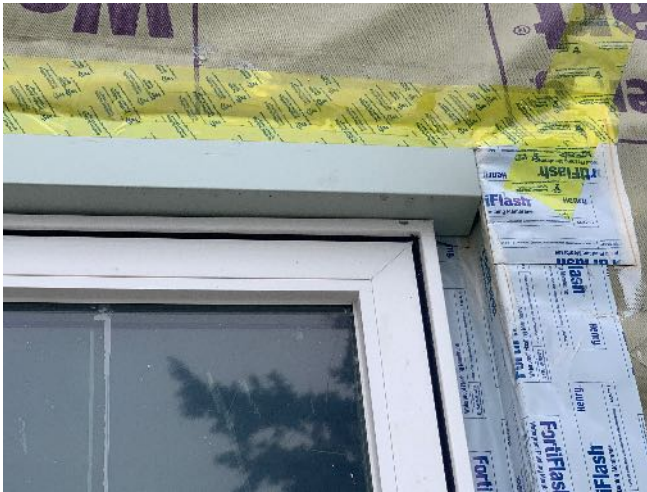
- 5 .09 Project specific details (11/A6.14) indicate a sealant joint from window head to flashing. Verify that minimum joint size of 1/4" had been provided at all window heads.

This condition will be corrected prior to siding 1st floor building C. Photo documentation to follow at that time.

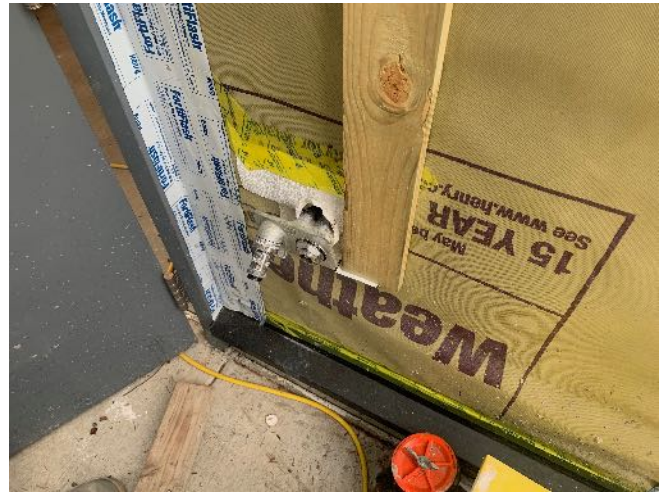
- 5 .10 Detailing of frost free hose bibs with flex wrap has resulted in poor adhesion to the pipes. This interface needs to be detailed with SAM and liquid flashing to properly integrate the hose bib with the WRB.

Corrected. This will be corrected on all locations going forward.

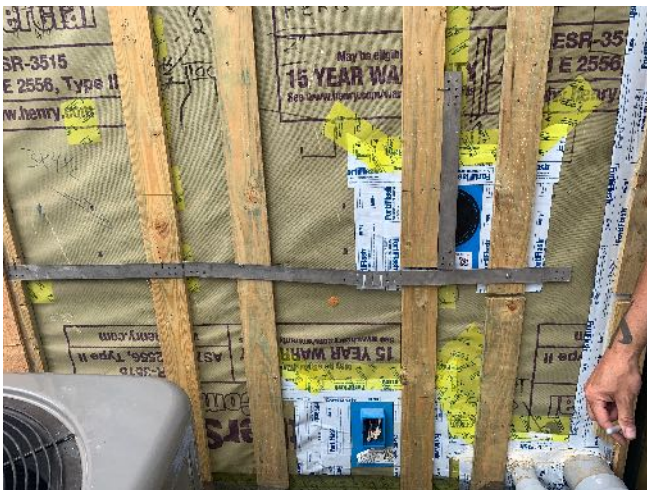
- 5 .11 Electrical wiring for HVAC equipment is being run through the rainscreen and protected with nailing plates. Verify that this meets electrical code requirements for the type of electrical conduit required in this location.

Inspected by COG on 7/13/21 -
Passed by inspector for cover.

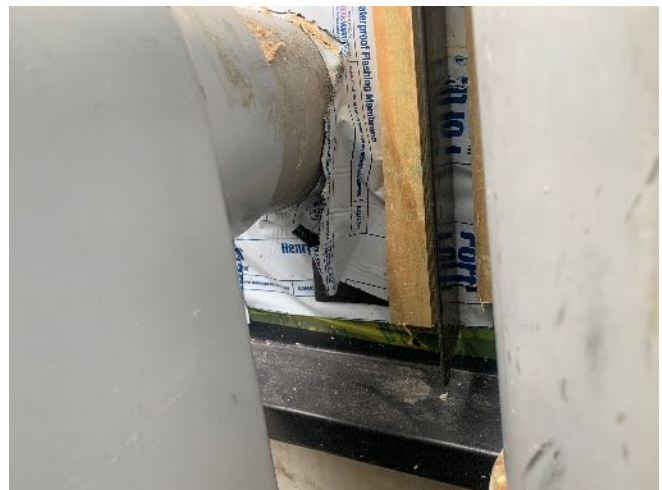
- 5 .12 Detailing of conduits on Building F appears incomplete or poorly installed. SAM should be fully adhered to sheathing substrate and carried out onto the conduit. Additional detailing can be completed using liquid flashing.

Item completed as of 7/22/21

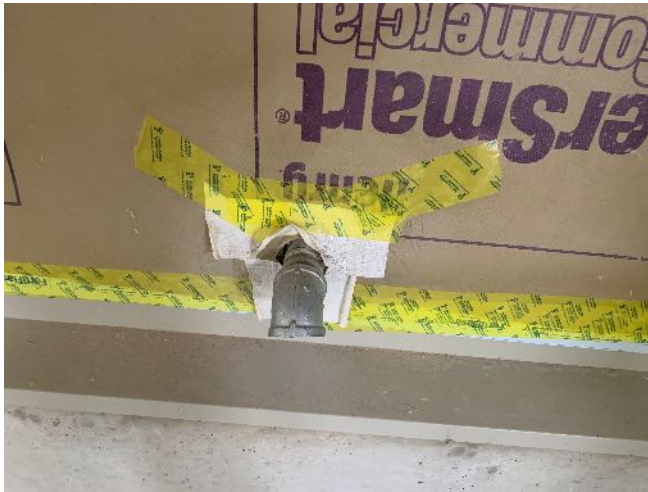
- 5 .13 Detailing of drain pipe with flex wrap has resulted in poor adhesion to the pipe. This interface needs to be detailed with SAM and liquid flashing to properly integrate the drain pipe with the WRB.

Corrected 07/21/21. This will be corrected on all locations going forward.

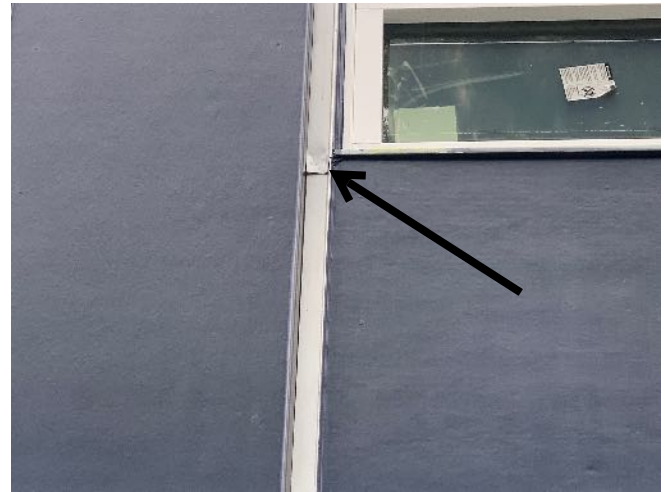
- 5 .14 It appears that sheet metal has been damaged during installation by impact from hammers. Damaged sheet metal shall be removed and replaced with undamaged sheet metal.

Corrections in progress as of 7/16/21 - ongoing.

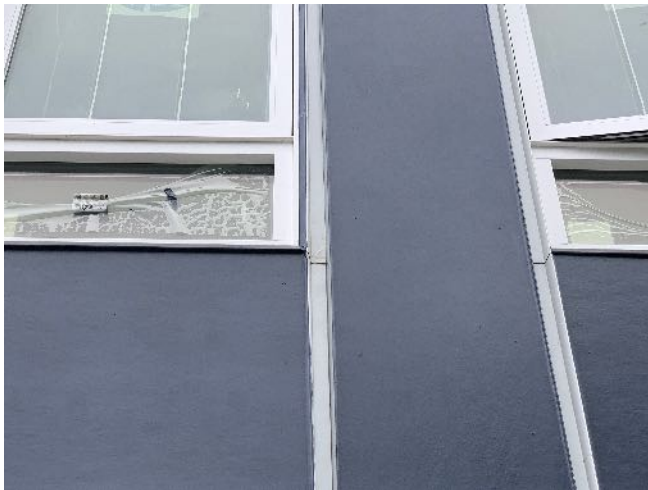
- 5 .15 It appears that sheet metal has been damaged during installation by impact from hammers. Damaged sheet metal shall be removed and replaced with undamaged sheet metal.

Corrections in progress as of 7/16/21 - ongoing.

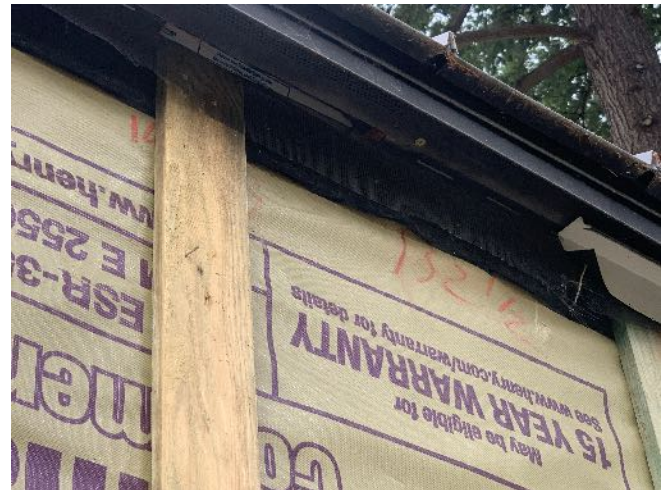
- 5 .16 Verify that completed roof venting details (Building F) are in line with project specific detailing.

As per QEC, LMC site walk 7/21/21, these details have been confirmed. Additional blocking added under eave to ensure adequate venting. Condition exists only on 1 wall line of south elevation due to offset gable/roof slope.

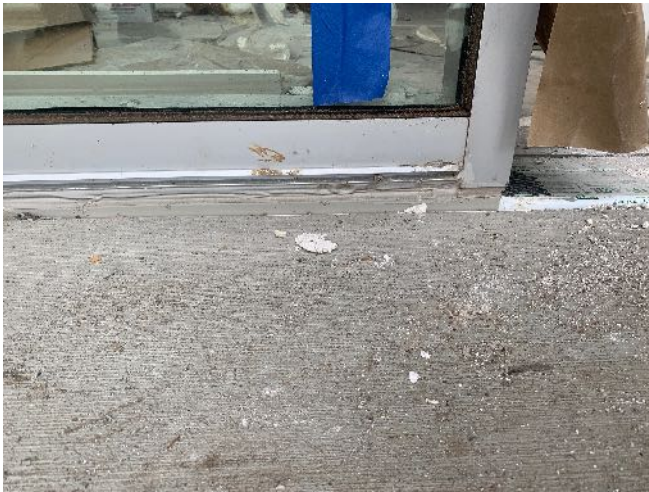
5 .17	<p>Building A- Sealant joints between storefront subsill and flashing appear to have been installed without proper tooling. Remove improperly installed sealants joints and replace following manufacturer's requirements for installation and tooling.</p> <p>Corrections in progress 7/22/21</p>	5 .18	Not Used
5 .19	Not Used	5 .20	Not Used
