Civil Site Visit Report– 1 (Phase 1 & 2)

PROJECT: 1800232 – Rockwood 10

LOCATION: SE Yamhill Street
Portland, OR, 97233

SITE VISIT DATE: July 16, 2021
TIME: 4:30-6:00 PM

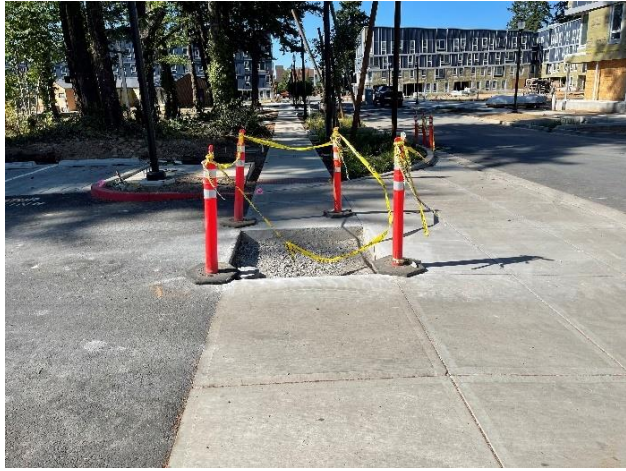
Item No.	Description	Image/Representative Image	Action Required
0	General close out.	Once site is stabilized, remove erosion control BMPs, including inlet protection. Clean out all storm structures without flushing downstream.	
1	Driveway to Phase one paver parking is missing large section of concrete.

Replace missing concrete.
2	Gap between paver and curb.

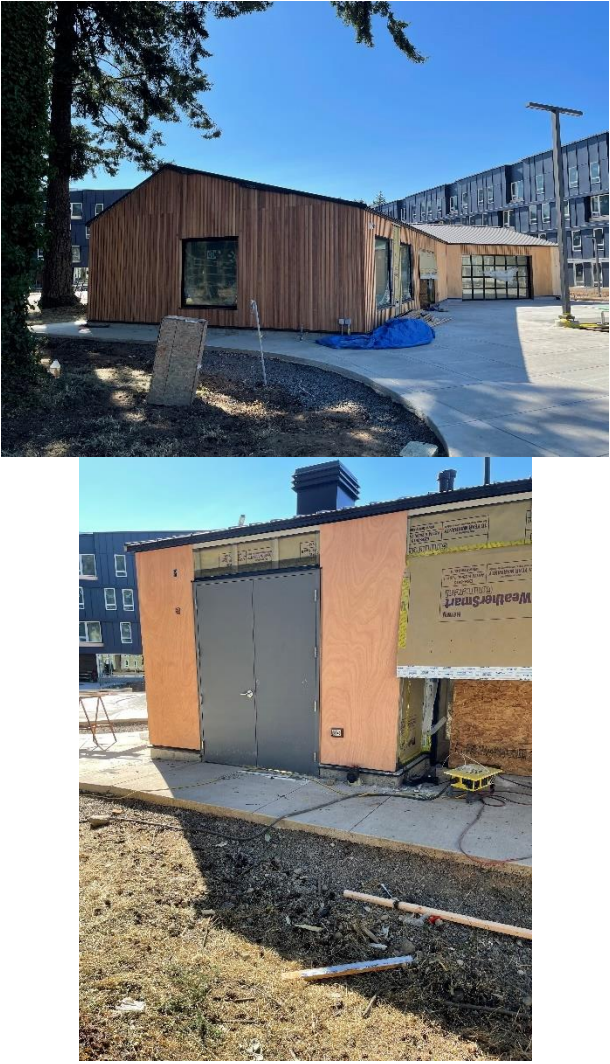
Item No.	Description	Image/Representative Image	Action Required
3	Tarps and construction material in phase 1 areas.

Clear tarps and construction material debris from site prior to phase completion.
4	Storm Area Drain AD-C2 is covered in soil.

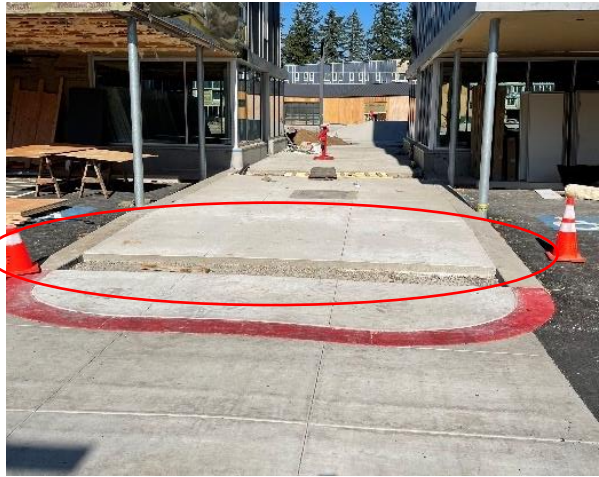
Item No.	Description	Image/Representative Image	Action Required
5	Incomplete concrete walk on west border of pedestrian path. Detectable paver strip missing.

Finish construction of pedestrian path and add detectable warning strip per Enlargement 1 on C2.0 of sheet plans.
6	Could not locate cleanout structure CO-C2 due to branches.
