DATE:	November 10, 2020	JOB #:	19031-0080
PROJECT:	Rockwood Apartments	WEATHER:	45 F, Cloudy
LOCATION:	783 Southeast 185th Ave, Portland, OR 97233		
GENERAL CONTRACTOR:	LMC Construction		
PRESENT:	Reed Ledbetter, LMC Construction Mikael Koiv, PE DCI Engineers Sri Penmetsa, PE DCI Engineers

Scope of Observation: DCI was on site on November 10, 2020 to observe the progress of wood framing on Buildings A & B. At the time of the visit, wood framing is in place upto Level 4 on Buildings A & B. Level 2 framing is in progress on Buildings C & D. Framing at Building F is almost complete, while framing at Building E is yet to start. The following items were noted during the site walk:

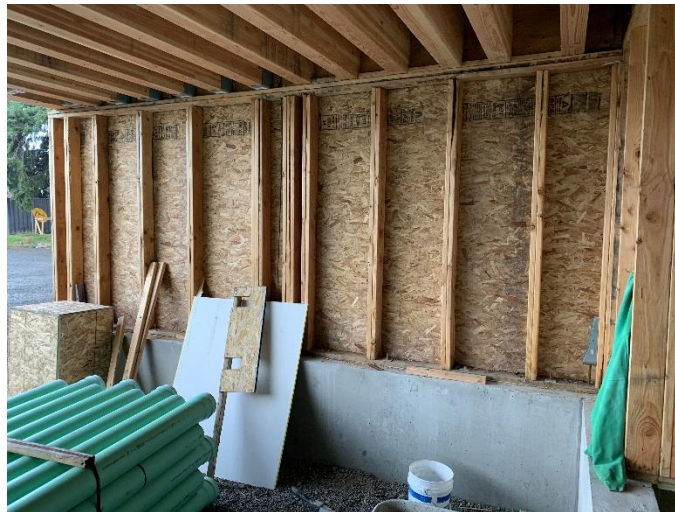
Item #1: On Building A, at wing wall located near the intersection of Grid A.a & B.a and Grid 12.a, wood framers found some sagging in the top plate due to load transfer from GL joists.

Action: There is no rim joist provided at this location, which typically helps to stiffen double top plate. DCI suggests adding additional studs (see response to RFI 261).

Additionally, there appears to be missing clips at shear wall at Level 1. LMC to ensure nailing from above (i.e. 2W3 requires two rows of screws to blocking) and clips at double top plate (i.e. W2 wall requires clips on ea side). See shear wall schedule for more information related to the spacing. This applies to all shear locations where is no rim joist

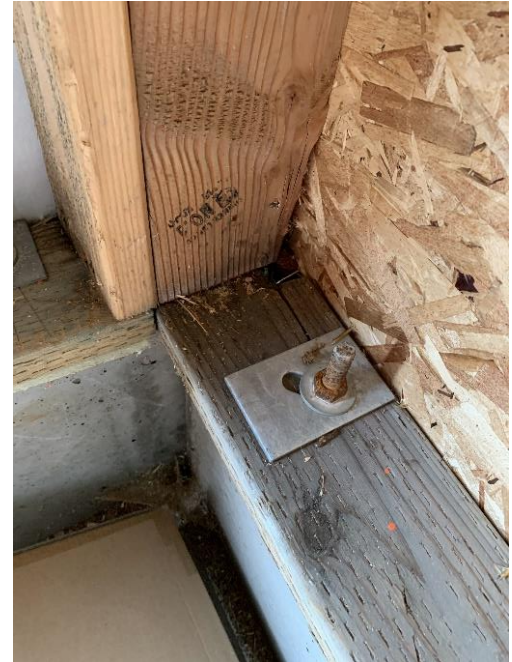
Item #2: On Building A, at location Grid A.a and Grid 4.a, there appears to be a missing HDU11 anchor rod at the end of the shear wall

Action: At this location, a dual HDU 5 with epoxy anchor rods need to be installed to bypass the missing HDU 11. LMC to follow up with an RFI to formalize the required fix.

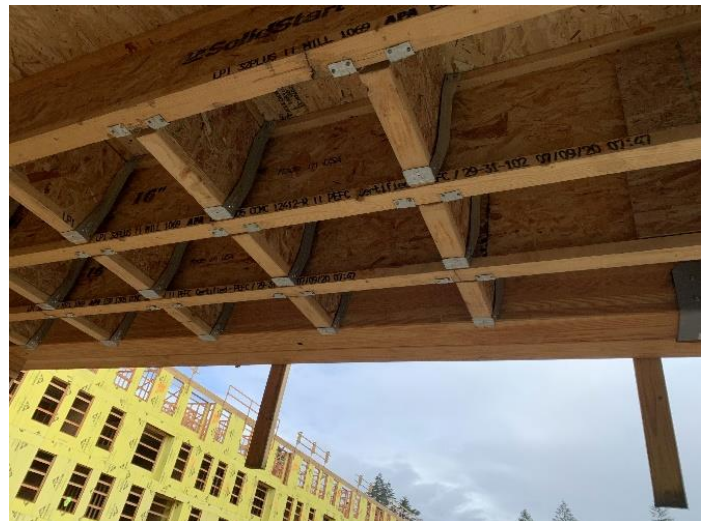
Item #3: On Building A, at location between Grid F.a-E.a and Grid 4.a, there is a certain area at storefront where detail 17/S5.03 applies. This detail indicates inclusion of LSL 3 1/2"x16 beams with inverted BA hangers for 3 bays. Instead, it appears there are i-joists with joist hanger with blocking extending for 3 bays. This does not meet structural intent

Action: LMC to issue an RFI to correct the condition

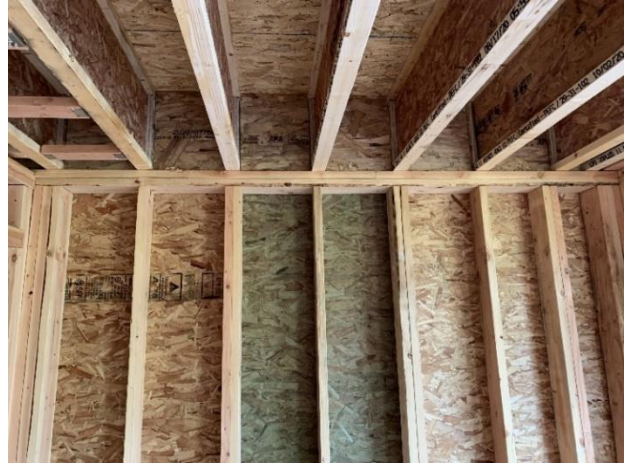
Item #4: On Level 3 Building B, there are several shear wall locations with missing clips between blocking & double top plate

Action: LMC to coordinate the shear wall type per plan & incorporate clips as required per shear wall schedule. This note applies to all buildings

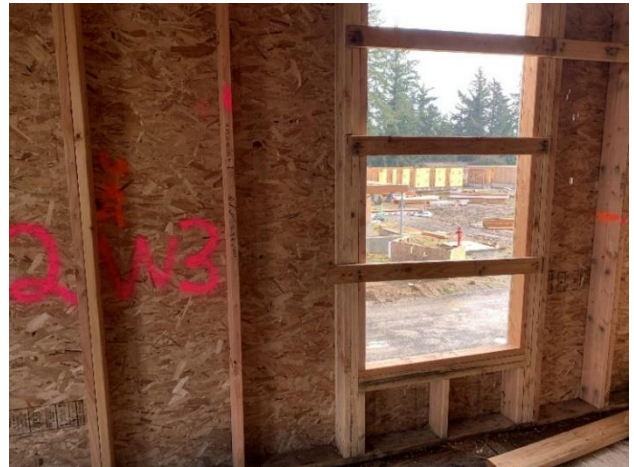
Item #5: There is "Force Transfer" shear wall at Grid 12.a on Building A. This will require horizontal straps with blocking at corners of the openings.

Action: LMC to follow up with an RFI to clarify this requirement. DCI will provide a general detail that will apply to all force transfer wall.

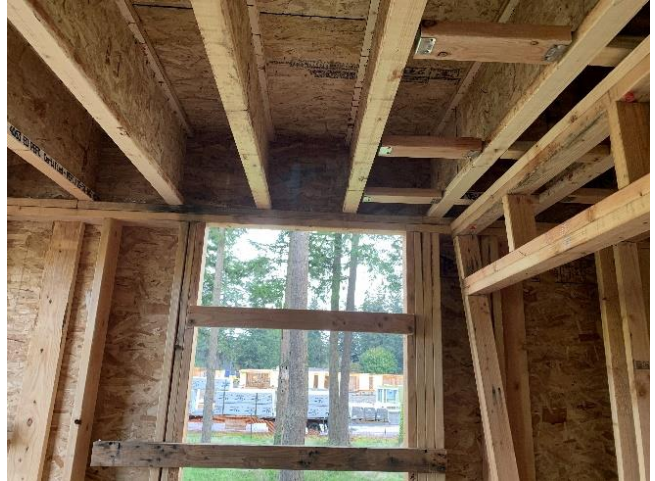
Item #6: There are few locations where I-joists land on double top plate over the window without a hanger connecting to rim joist

Action: LMC to install IUS joist hangers at rim joists. Rim joists to span the opening at window. This applies to all load bearing walls with full height window openings (without dropped headers)

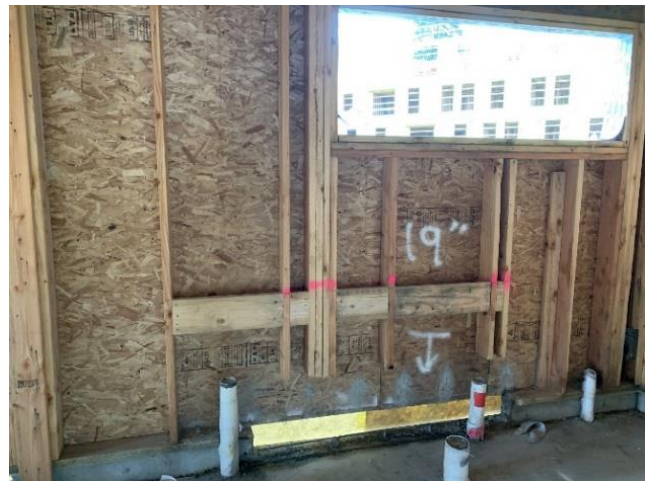
Item #7: On Building F, between grid B.f & C.f along 1.f, a certain portion of concrete stem wall has been removed to accommodate toilets to meet ADA requirements. The studs will require a member to transfer the load to the stem wall

Action: DCI to respond to this issue via an RFI

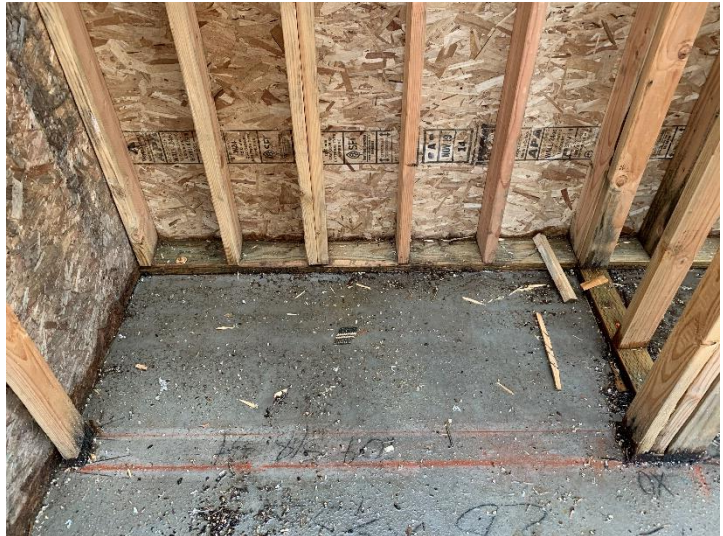
Item #8: On Building C, b/t Grid 2.c & 3.c, there is full length W4 shear wall at Level 1, there appears to be missing post installed anchor bolts going into the foundation

Action: DCI is aware LMC is in the early stage with respect to installing wood framing on Building C. This note is just to bring to the contractor's attention the need for post installed anchors at shear wall to meet structural intent
