SUBMITTED TO	DISTRIBUTED TO	SITE VISIT #
Wendy Klein, CDP	Wendy Klein, CDP Robert Wait, LMC Mark Carrick, LMC Quinten McElvain, Waechter Judson Moore, Waechter Reed Ledbetter, LMC Dylan Dalton, LMC	3

SITE VISIT

The Rockwood 10 project is a new construction project located in NE Portland, Oregon. The requested site observations on June 11th, 2021 were related to the building enclosure components currently being installed. Areas of specific review included hollow metal doors, storefront, and integration of HVAC components. Observations were made of the condition of the roof on Building C.

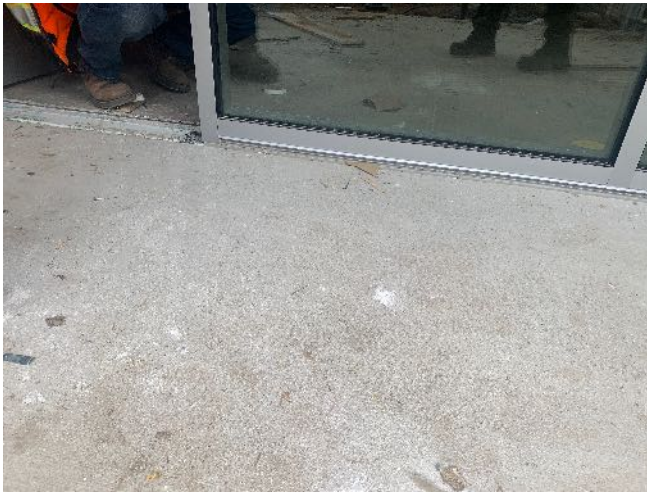
- 3 .01** Building B, 1st floor. Weeps have not been drilled in the sub sill of the storefront sill. Verify that weeps are installed per manufacturer's spacing recommendations.

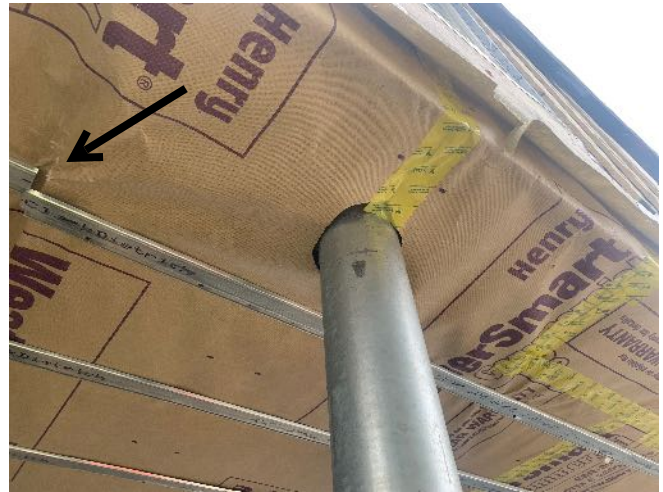
- 3 .02** Building A, West soffit. WRB/AB component detailing is incomplete in some areas and exhibits damage in other areas throughout both soffits. Complete detailing where needed and repair or replace damaged WRB/AB components.

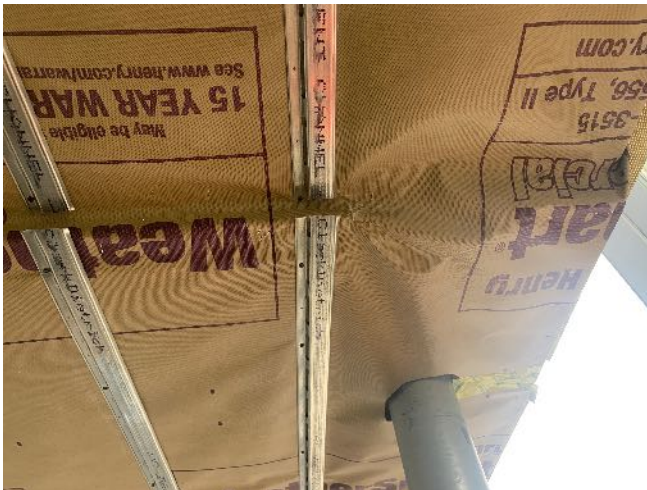
- 3 .03** Building A, West soffit. WRB/AB component detailing is incomplete in some areas and exhibits damage in other areas throughout both soffits. Complete detailing where needed and repair or replace damaged WRB/AB components.

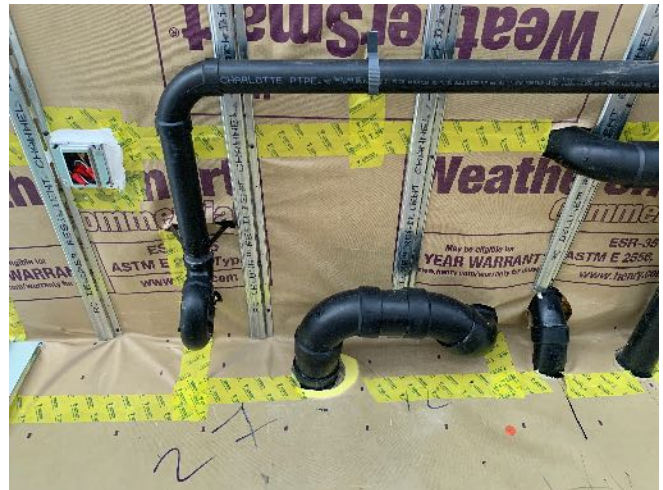
- 3 .04** Building A, West soffit. WRB/AB component detailing is incomplete in areas throughout both soffits. Complete detailing where needed prior to installing gypsum soffits.

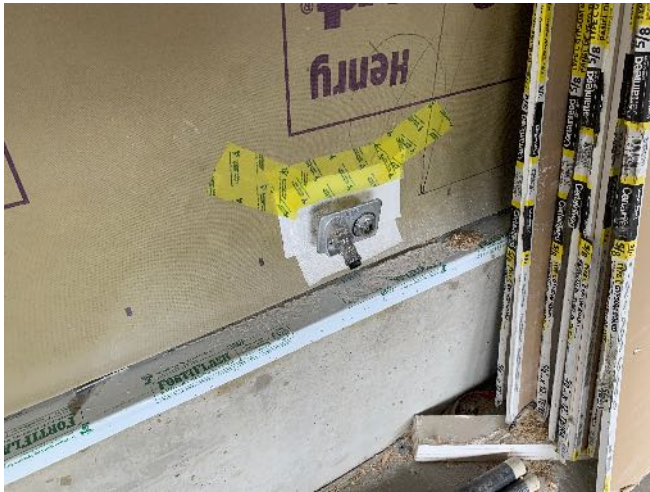
- 3 .05 Building A, West elevation. This hose bib requires a solid block behind the hose bib to properly support the hose bib. The block doesn't need to be much larger than the face of the hose bib and should be protected by a head flashing, attached to the rainscreen, not back to the WRB.

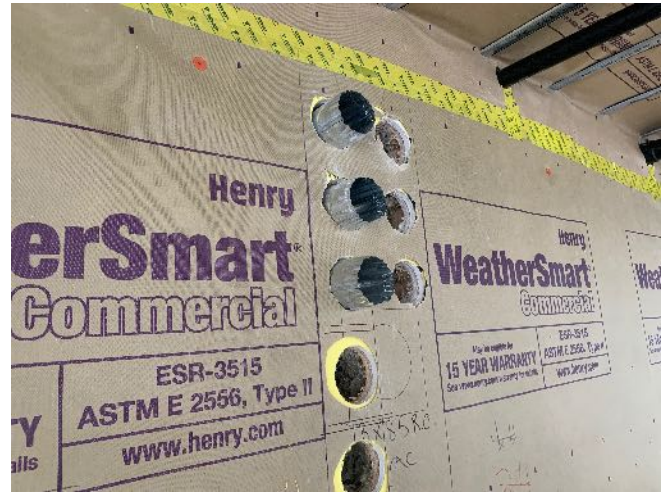
- 3 .06 Building A, West elevation. Detailing of HVAC components is incomplete. See SVR 04 for more detail on this condition.

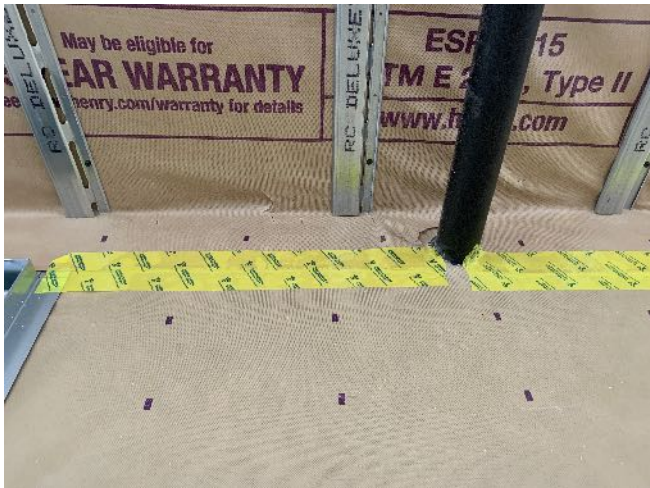
- 3 .07 Building A, West soffit. WRB/AB component detailing is incomplete in some areas and exhibits damage in other areas throughout both soffits. Complete detailing where needed and repair or replace damaged WRB/AB components.

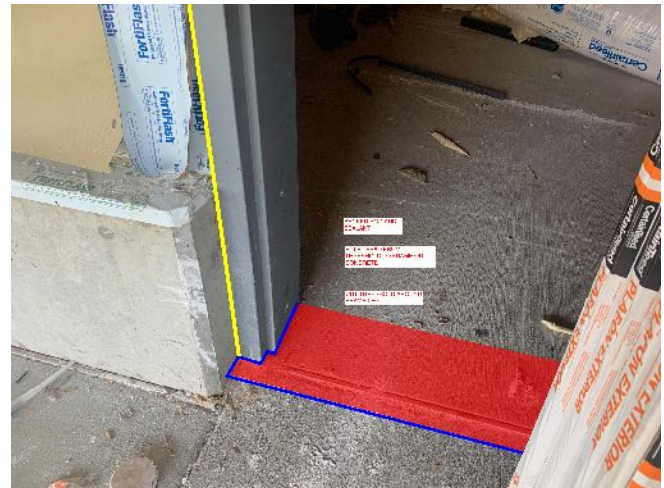
- 3 .08 Building A, west elevation. The hollow metal door sills have not been detailed as indicated in the drawings. For these doors under significant protective cover (low exposure), a face sealed approach can be used. Source a larger threshold, and seal it to the HM door frame and concrete while also sealing the HM door frame jamb to concrete and cladding using a backer rod and sealant.

There are issues identified with hollow metal doors on building A that need to be addressed. On buildings A and B where installation has progressed significantly- and where the door is located under the tuck under parking, a face sealed approach can be used. On exposed locations, doors must be removed to provide proper detailing of the hollow metal sill condition.

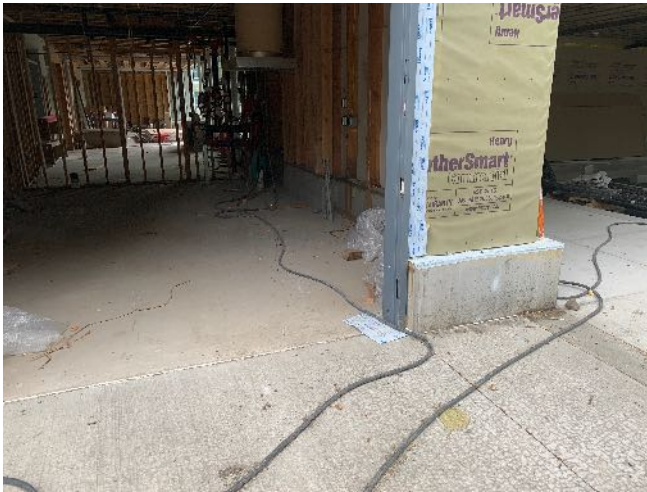
- 3 .09 Building A, South elevation. Hollow metal doors at exposed locations that have not been correctly detailed at the sill must be removed to allow for correct application of the sill detail.

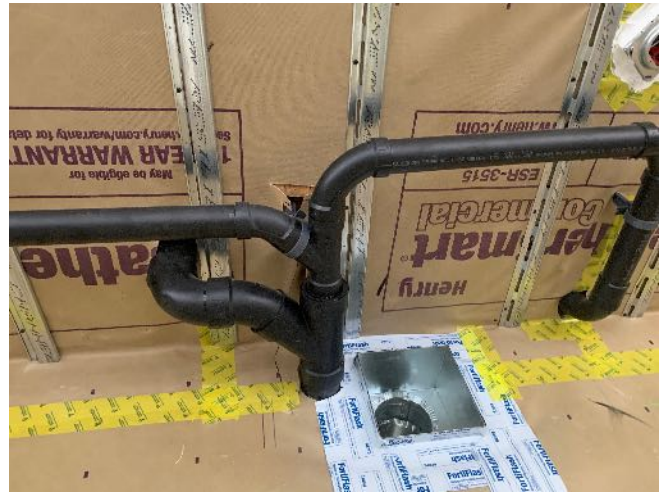
- 3 .10 Building A, South soffit. WRB/AB component detailing is incomplete in some areas and exhibits damage in other areas throughout both soffits. Complete detailing where needed and repair or replace damaged WRB/AB components. This condition was evident while the drywall subcontractor was installing the gypsum soffit at this area. Verify that all WRB/AB detailing is complete prior to cover.

There is a good amount of detailing to be completed on the building A and B soffit WRB/AB prior to the application of the gypsum soffit.

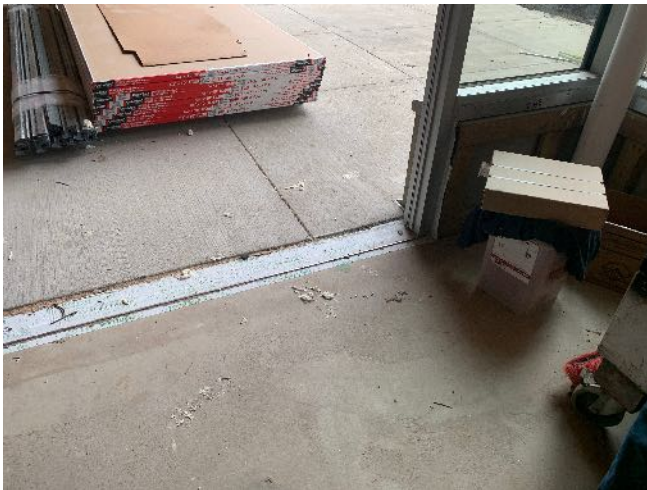
- 3 .11 Building A, North storefront entrance. The elevation of the storefront sill has been poured below the elevation of the adjacent exterior slab. The storefront framing will need to be removed to allow for a solid shim to be placed in the sill to provide a 1/4" drop from the sill to the adjacent exterior concrete. The solid shim will be stripped in with SAM per the original detail.

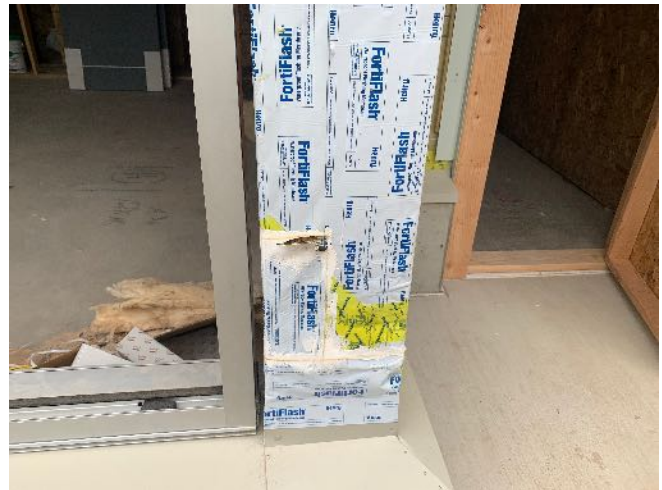
- 3 .12 Building A, East elevation. Repair damaged SAM at storefront corner.

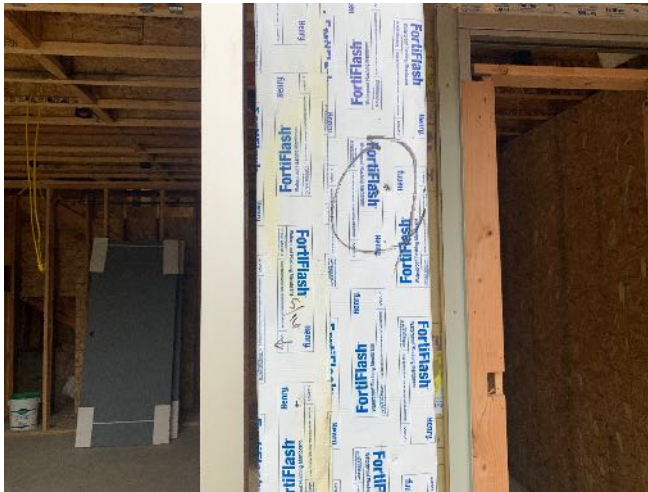
3 .13 Building A, East elevation. Repair damaged SAM at storefront corner.

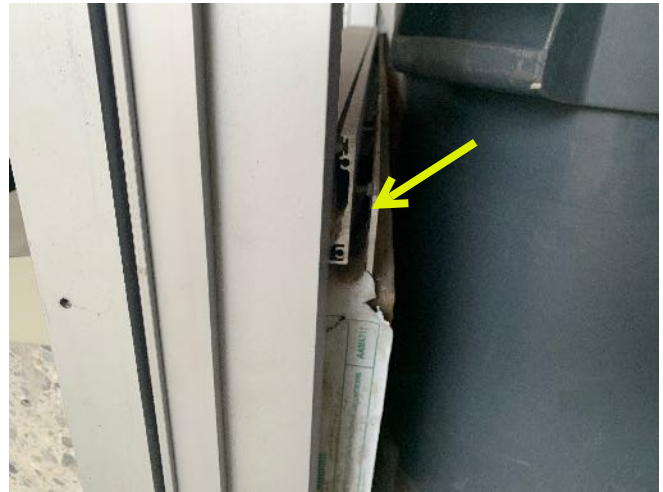
3 .14 Building A, East elevation. Storefronts have been installed with a shim between the structural back angle and storefront subsill. This is in accordance with Waechter's mark up of the shop drawings but not what was installed on the mock up. Verify that shim drainage below sill flashing was installed per our mock up discussions.

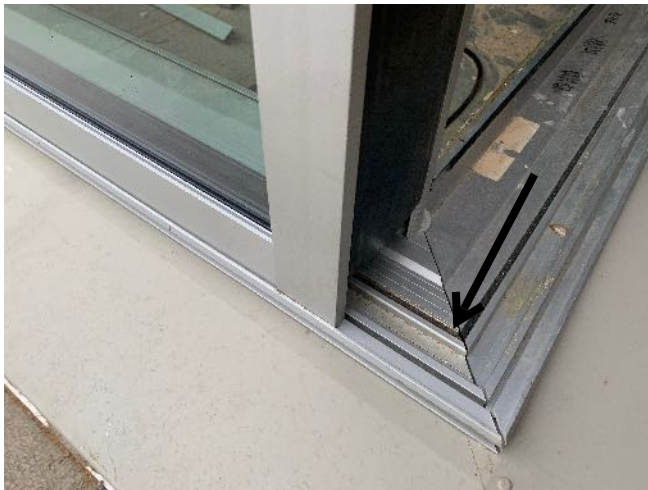
3 .15 Building A, East elevation. Storefront subsill. Complete sealant detailing at mitered corner of subsill prior to installing storefront sill can components.

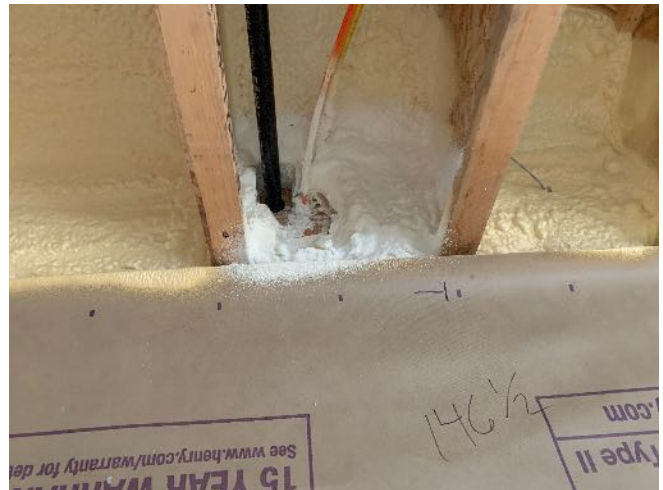
3 .16 Building A, East elevation. Repair areas of SPF damaged by installation of out of sequence work.

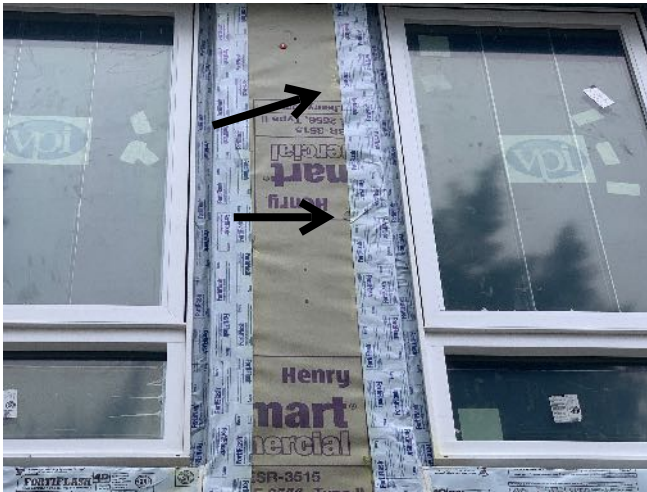
3 .17 Building B, South elevation. Repairs damaged areas of WRB prior to covering with furring and cladding.

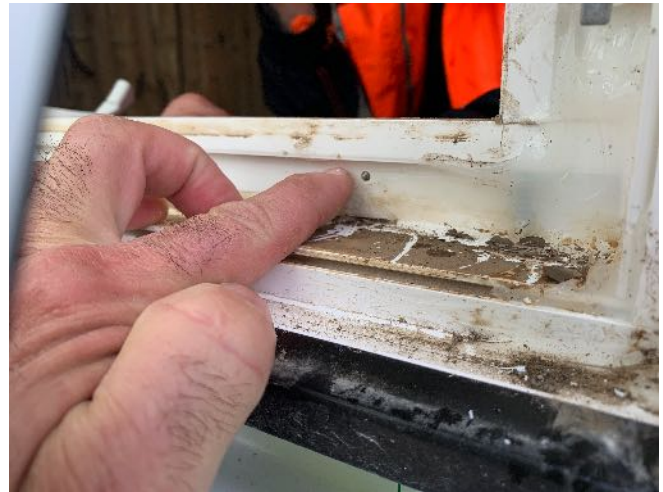
3 .18 Typical condition. Fasteners are seen protruding through the wall of the vinyl window frame. LMC to discuss with VPI if this condition is acceptable or if remedial work to the window will be required.

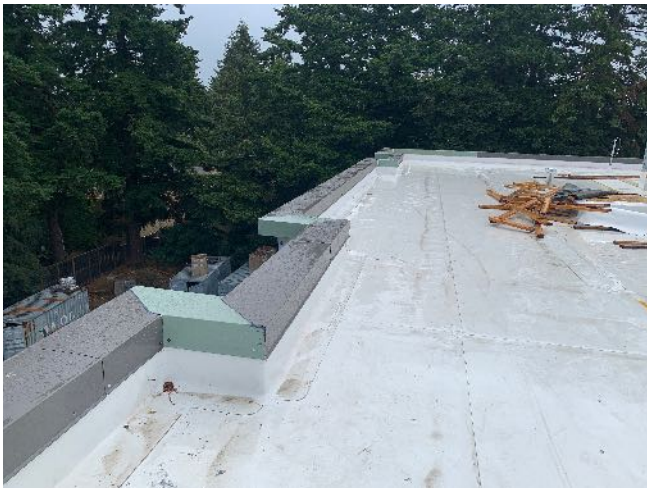
3 .19 Building C, Roof. The roof installation is largely complete. These observations will focus on issues with the current installation.

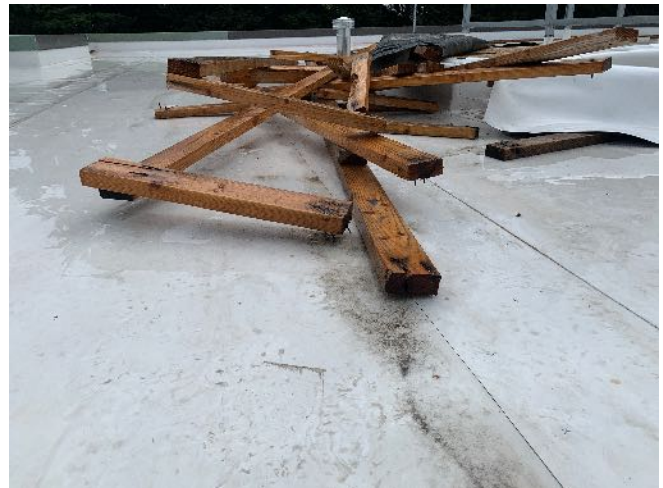
3 .20 Building C, Roof. Wood debris with fasteners protruding from the wood (likely from temporary guardrails) has been left on the roof without protecting the membrane. This debris should be removed in the presence of the roofer so they can accurately locate and identify areas of damage.

Additional due diligence is needed to protect installed product from trade damage. This is certainly the case with the building C roof, which likely has many punctures from the nails in the ends of boards left on the roof. It would be prudent to remove those board sin the presence of the roofer so that they can accurately identify and assess the damage. This same damage may have occurred on other buildings, which should be reviewed for similar conditions.

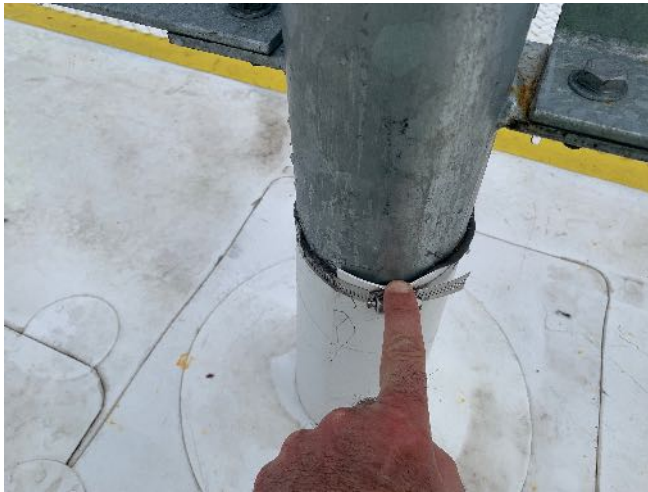
- 3 .21 Building C, Roof. Verify that water cut off mastic has been applied behind the top of the TPO membrane continuously around the pipe.

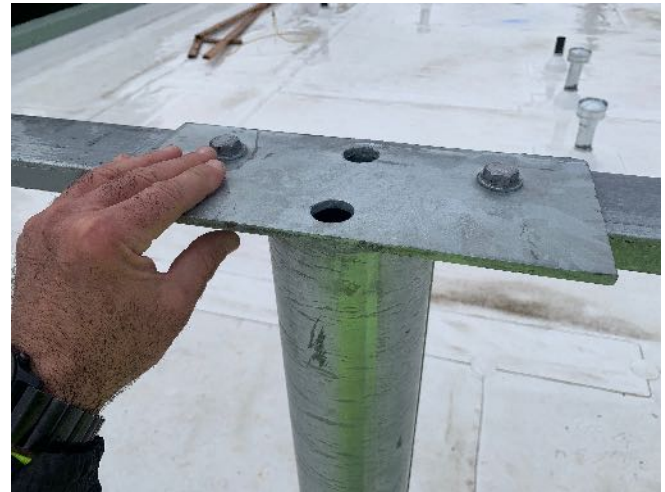
- 3 .22 Building C, Roof. These round pipes are the structural support for the mechanical screen. There are two holes in the plate on top of the pipe that provide a clear path for water into the roof assembly. These need to be plugged to prevent water ingress into the roof assembly. This needs to be remediated on all buildings in the project.

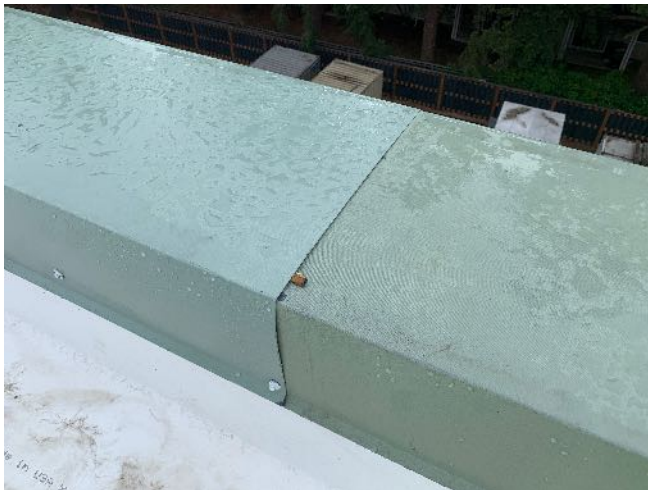
- 3 .23 Building C, Roof. Specifications section 076000 2.4.G.1 calls for standing seam metal at roofs. The parapet metal submittal does not indicate that seams would not be fabricated using standing seams. Please verify that the proper seam detail has been used and that the two pieces of metal have been properly sealed.

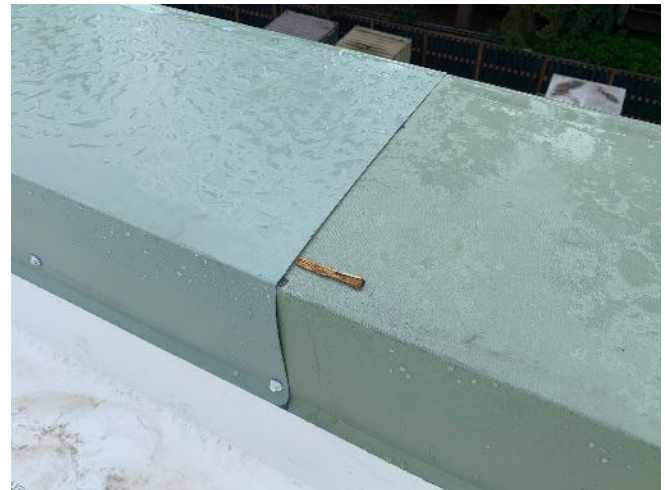
- 3 .24 Building C, Roof. Please verify that the proper seam detail has been used and that the two pieces of metal have been properly sealed.

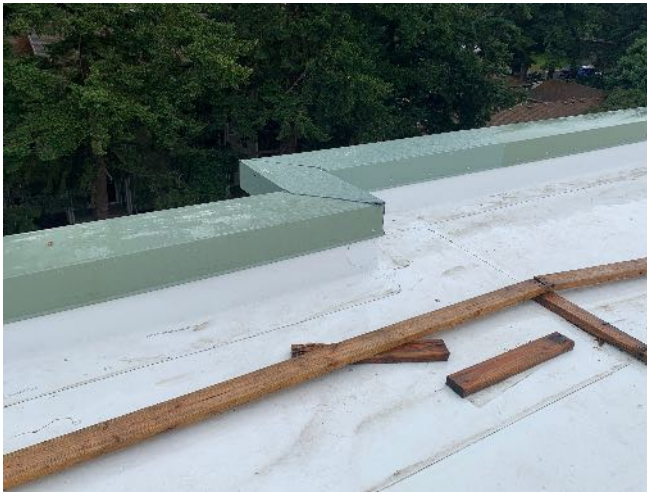
- 3 .25 Building C, Roof. The parapet metal in the right side of this image has been fastened approximately 12" O.C. The parapet metal in the left side of the image has a total of 2 fasteners holding it in place. Verify uplift requirements for fastener spacing and install consistently around all roof parapets.

The parapet metal on Building C is problematic in several respects. The first issue is the lack of fasteners on the interior face of the parapet metal. A number of 10' sticks of metal were fastened with only 2 fasteners. Fastener type and spacing to meet wind uplift requirements need to be verified and installed properly. The second and third issues are connected: the parapet coping metal appears to be installed without slope and the joints are fabricated as laps. Best practice suggests that standing seam joints be created in parapet coping metal and that the metal slope to shed water. The material installed dead flat with a lap seam using cladding sealant is at high risk for water intrusion at the seams. The specification calls for standing seam joints while the specification, architectural drawings and submittals call for the metal to slope. If this does not meet those project criteria, it will need to be removed and replaced.

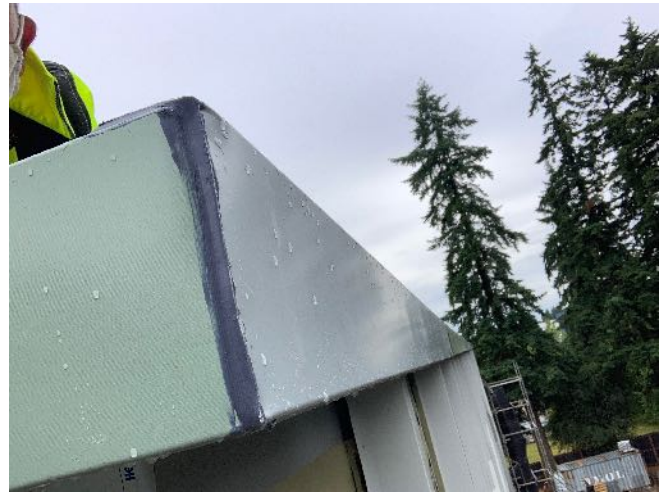
- 3 .26 Building C, Roof. This outside corner detail is completely sealant dependent. There are not mechanical fasteners holding the corner together. When the metal expands and contracts, this corner will open up. Fabricate corners with 18" legs per 076000 2.4 H.

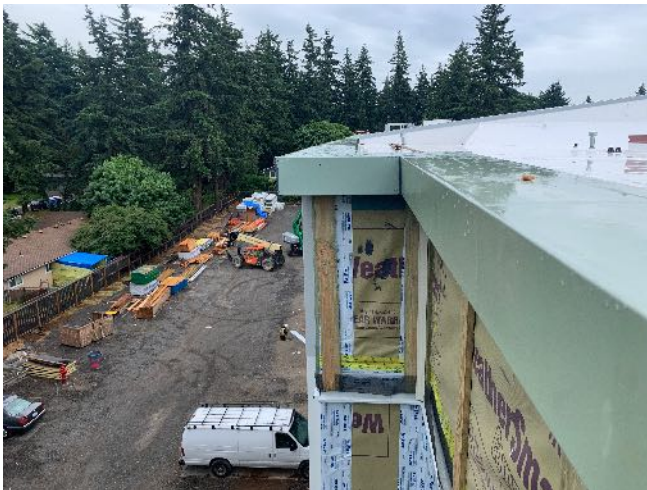
- 3 .27 Building C, Roof. This parapet metal has no slope as currently installed. Parapet metal must be sloped per SMACNA standards, the specification and submittal documents. The flatness combined with flat seams provides a risk for water intrusion at the seams.

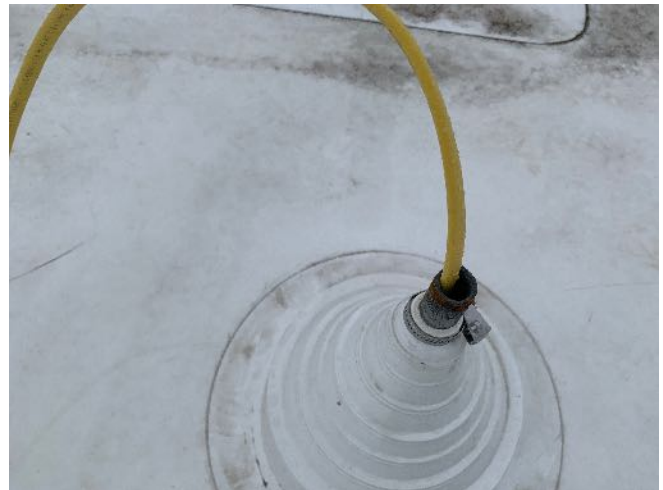
- 3 .28 Building C, Roof. Pre fabricated pipe boots have been installed for electrical penetrations. The annular space between the conduit and the Romex is unsealed, providing a clear path for water into the roofing system. Correct this at all locations at all roofs.

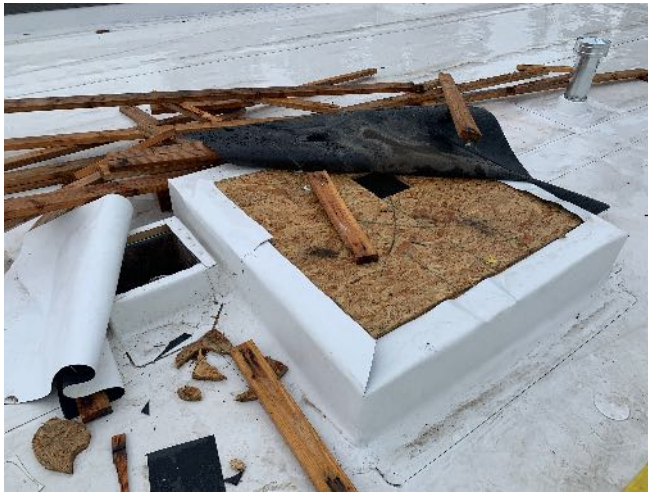
- 3 .29 Building C, Roof. Two curbs have been left without weather protection, allowing water ingress into the building. Provide temporary waterproof coverings (a piece of TPO properly fastened over the curb and draping down the sides would suffice) over these curbs until the equipment is permanently installed.

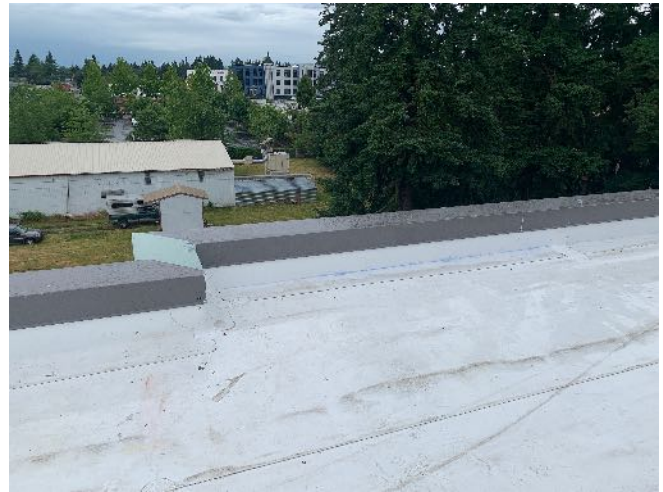
- 3 .30 Building C, Roof. These lengths of parapet metal are fastened only by 2 fasteners in each 10' piece of metal. Verify uplift requirements for fastener spacing and install consistently around all roof parapets.

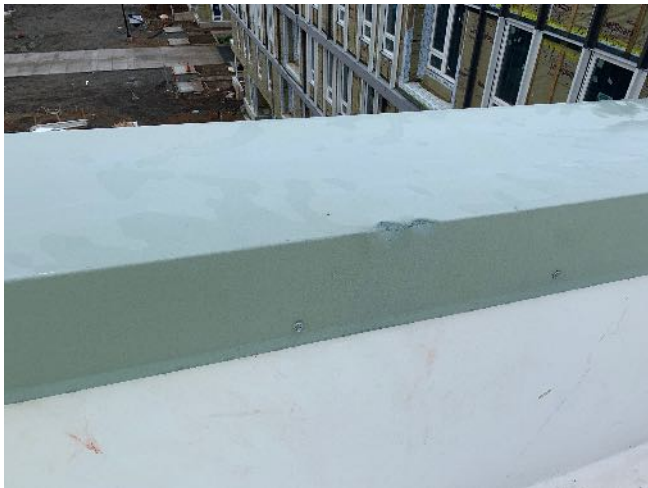
- 3 .31 Building C, Roof. Parapet metal has been damaged prior to or during installation. Replace as directed by Waechter.

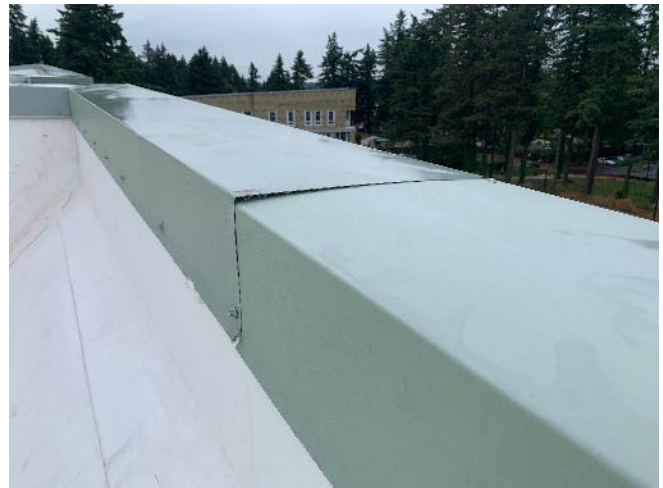
- 3 .32 Building C, Roof. Please verify that the proper seam detail has been used and that the two pieces of metal have been properly sealed.

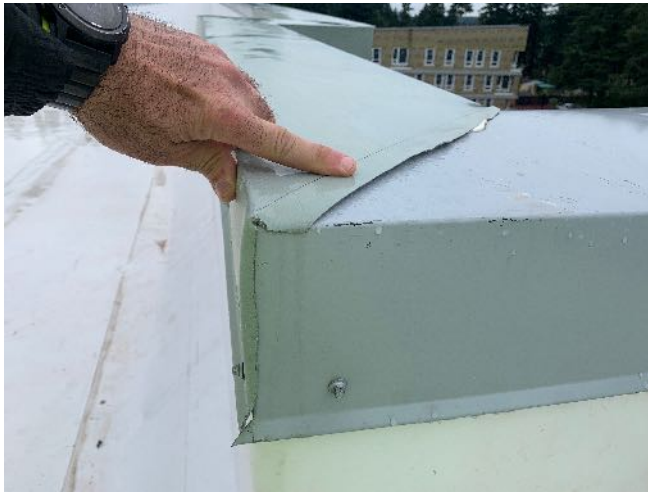
3 .33 Building C, Roof. This work is unacceptable and must be removed and replaced.

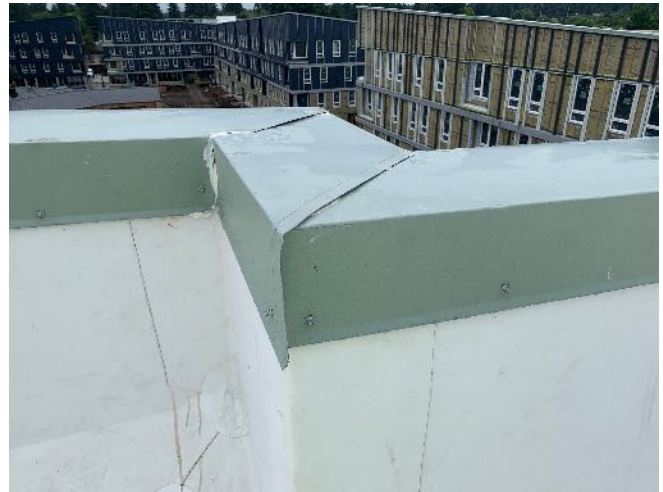
3 .34 Building C, Roof. This work is unacceptable and must be removed and replaced.

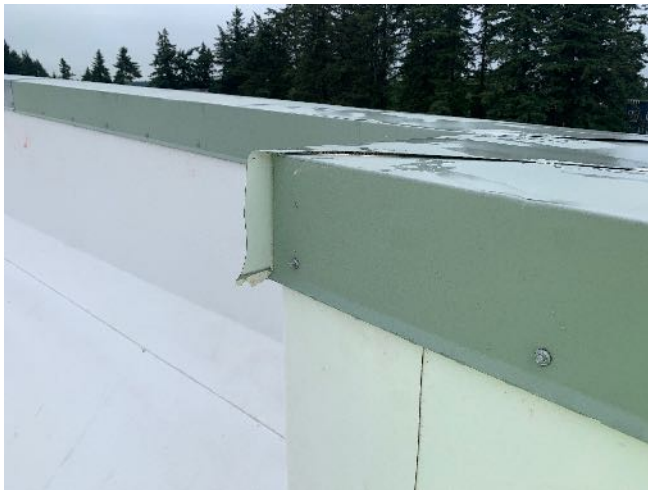
3 .35 Building C, Roof. This work is unacceptable and must be removed and replaced.

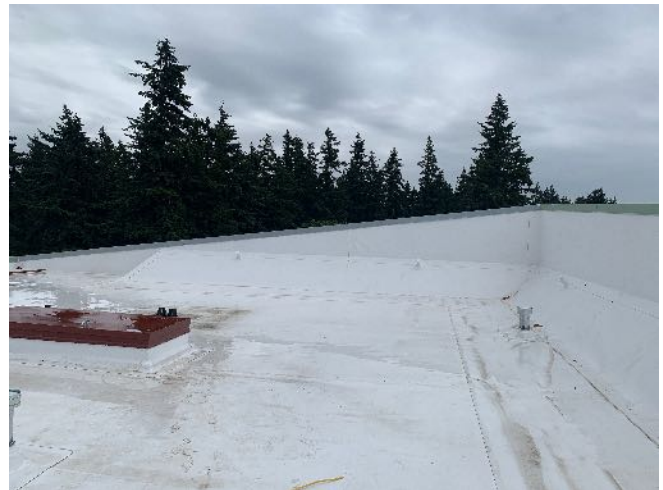
3 .36 Building C, Roof. These lengths of parapet metal are fastened only by 2 fasteners in each 10' piece of metal. Verify uplift requirements for fastener spacing and install consistently around all roof parapets.

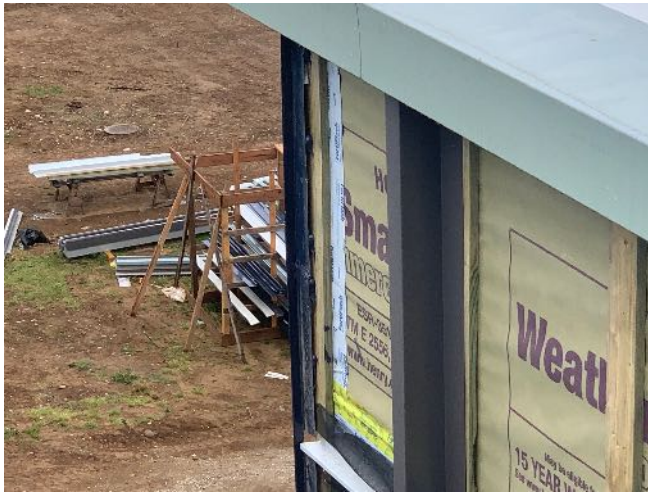
- 3 .37** Building C, inset on South elevation. Sealant is apparently being used behind the metal cladding components. Verify that metal cladding components are adequately structurally attached to the furring.

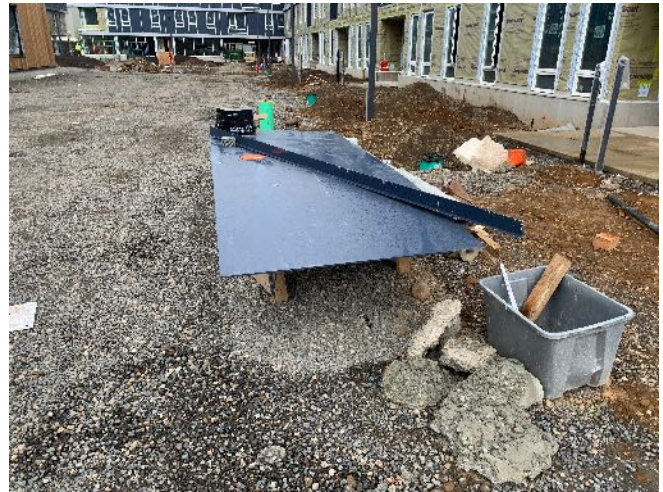
- 3 .38** Building B, South elevation. Hardie Panel products should not be stored in the rain or allowed to become saturated prior to installing on the building. If Panels become saturated, place them inside to completely dry out before installing on the building.
