SITE ATTENDEES	PROJECT LOCATION	ENVIRONMENTAL CONDITIONS
Dylan Dalton, LMC Tom Michie, LMC Martin Houston, QEC	783 SE 185th Avenue, Portland, Oregon 97233	60F, 75% RH Overcast

SITE VISIT

The Rockwood 10 project is a new construction project located in NE Portland, Oregon. The requested site observations on July 14th, 2021 were related to the building enclosure components currently being installed. Areas of specific review included integration of MEP components, windows, and flashing with the WRB system.

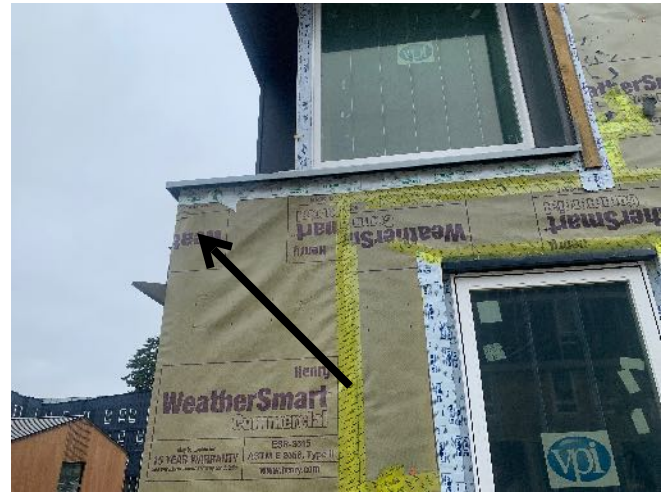
- 5 .02 Building A- Verify that all seams in WRB are properly integrated and sealed prior to installing cladding.

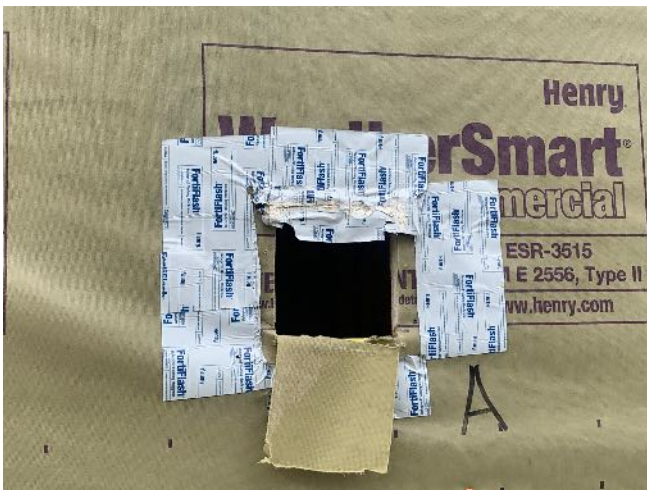
- 5 .03 Numerous penetrations have been removed and re-installed at different locations. Re-install sheathing and WRB as necessary, sequencing in a shingle lapped fashion.

Relocation of MEP penetrations appears to be occurring consistently across the project and creates challenges for proper sequencing of WRB, SAMs and flashings. Coordinate installation of MEP components to avoid removal and re-installation.

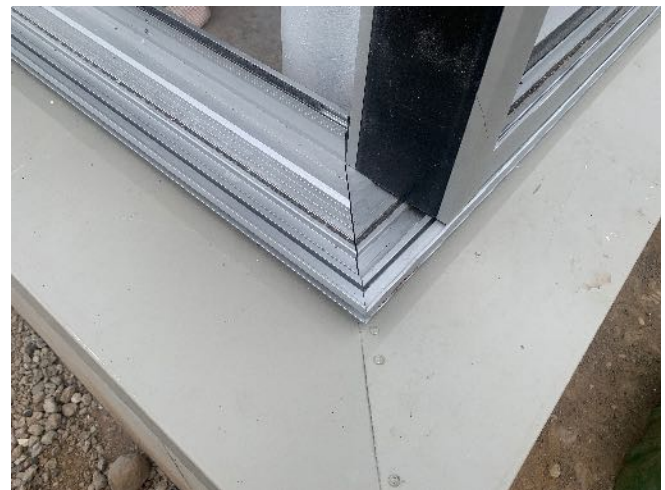
- 5 .04 Storefront sill can detailing should be completed prior to installation of storefront framing members. This miter joint needs to be detailed per manufacturer's instructions.

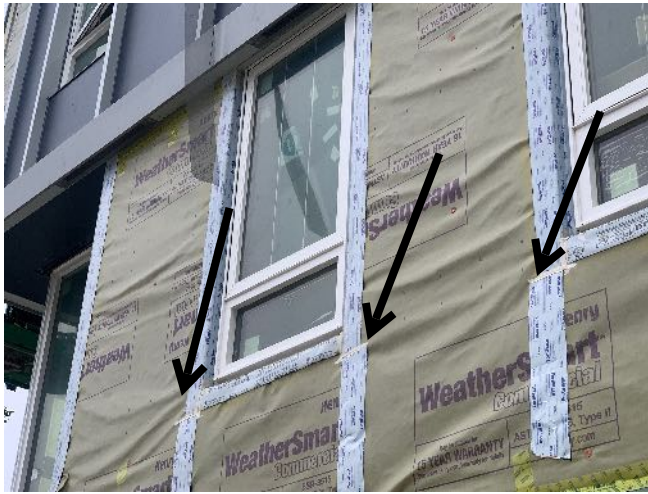
- 5 .05 There are numerous instances of reverse lapped SAM. While terminating the top edge of SAM with sealant is a repair to be used sparingly, it should not be confused as a basis of design detail. Properly sequence WRB and SAM components to prevent reverse laps.

The frequency of reverse laps in the WRB system is far too common. Reverse laps indicate a misunderstanding of sequence and should be the exception rather than the rule. Treating a reverse lap with sealant should be the approach of last resort, as the WRB /SAM system needs to properly shingle.

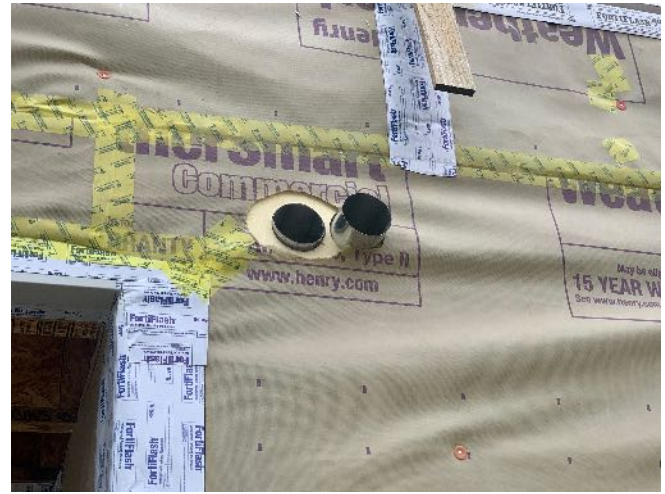
- 5 .06 Detailing around exhaust ducts is incomplete. Detail using SAM cut slightly that the pipe diameter and complete detail with liquid flashing from SAM to duct.

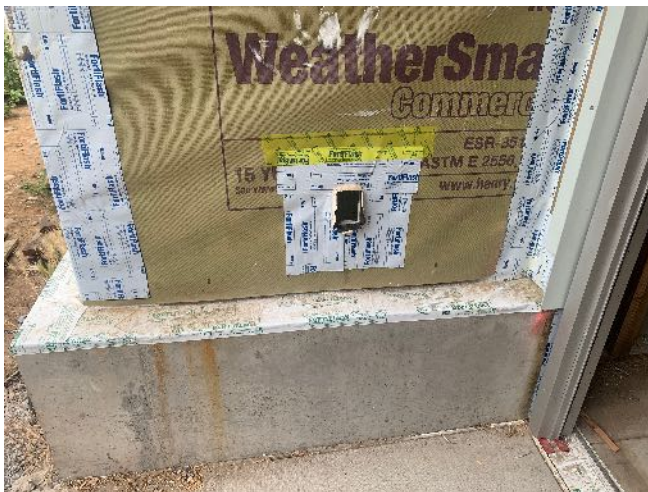
- 5 .07 Related to item 5.03. Detailing around this re-located electrical J box is incomplete.

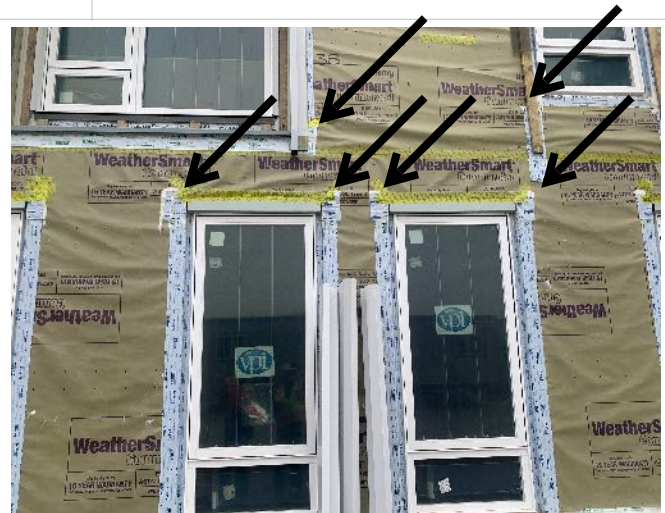
- 5 .08 The consistency of reverse lapped installations of SAM and WRB is far too consistent. WRB and SAM are to be properly shingled to shed water.

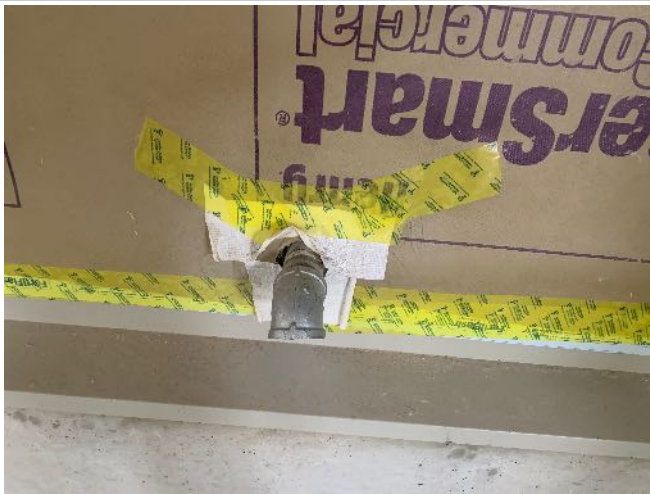
- 5 .13 Detailing of drain pipe with flex wrap has resulted in poor adhesion to the pipe. This interface needs to be detailed with SAM and liquid flashing to properly integrate the drain pipe with the WRB.

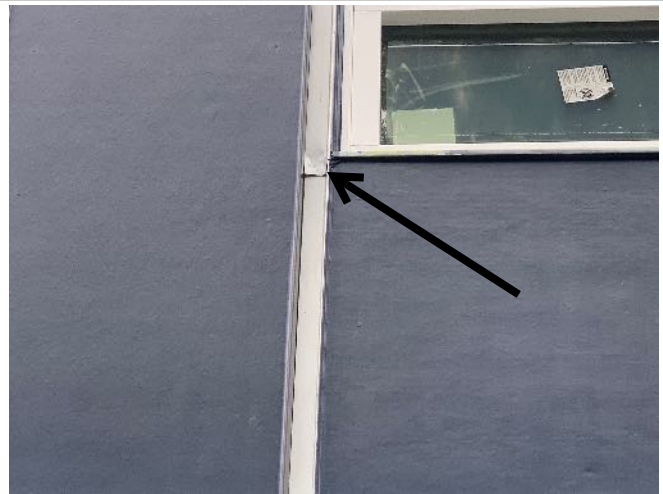
- 5 .14 It appears that sheet metal has been damaged during installation by impact from hammers. Damaged sheet metal shall be removed and replaced with undamaged sheet metal.

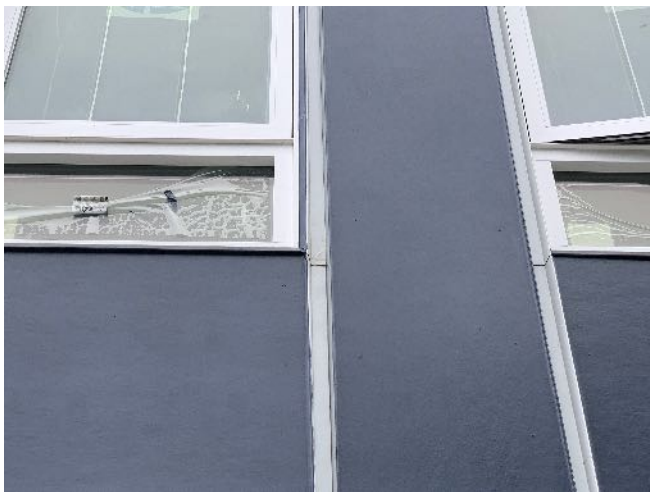
- 5 .15 It appears that sheet metal has been damaged during installation by impact from hammers. Damaged sheet metal shall be removed and replaced with undamaged sheet metal.

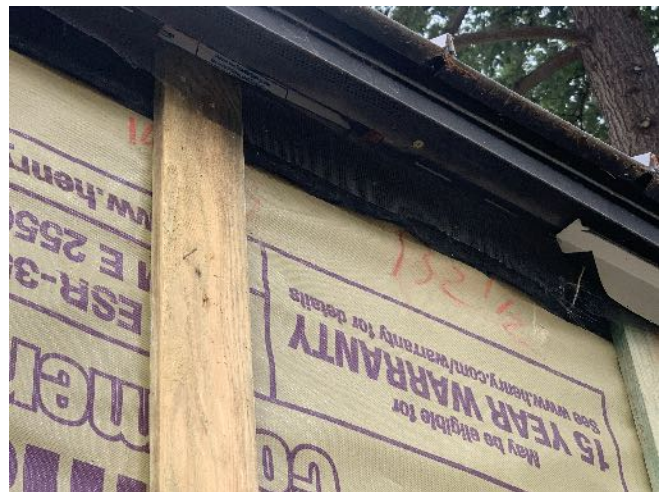
- 5 .16 Verify that completed roof venting details (Building F) are in line with project specific detailing.
