SUBMITTED TO	DISTRIBUTED TO	SITE VISIT #
Wendy Klein, CDP	Wendy Klein, CDP Robert Wait, LMC Mark Carrick, LMC Quinten McElvain, Waechter Judson Moore, Waechter Reed Ledbetter, LMC Dylan Dalton, LMC	4

SITE ATTENDEES	PROJECT LOCATION	ENVIRONMENTAL CONDITIONS
Dylan Dalton, LMC Tom Michie, LMC Martin Houston, QEC	783 SE 185th Avenue, Portland, Oregon 97233	56F, 77% RH Light Cloud Cover

SITE VISIT

The Rockwood 10 project is a new construction project located in NE Portland, Oregon. The requested site observations on June 16th, 2021 were related to the building enclosure components currently being installed. Areas of specific review included integration of HVAC components and sill flashing on Building E.

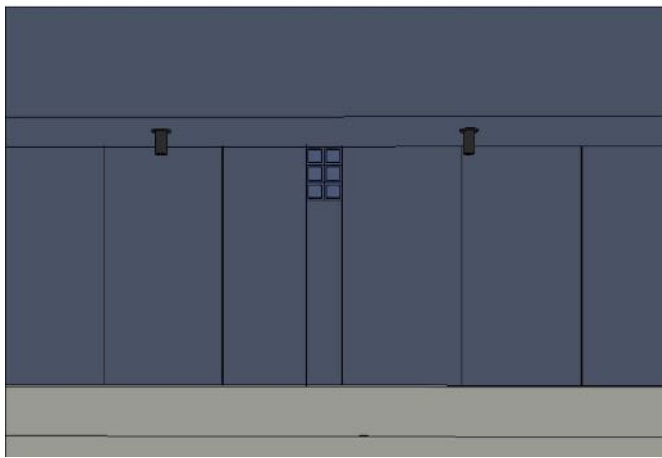
4 .01 Waechter response to RFI 357 called for dryer vents to be arranged with three vents vertically and two rows of vents horizontally at the West wall of Building A at the tuck under parking.

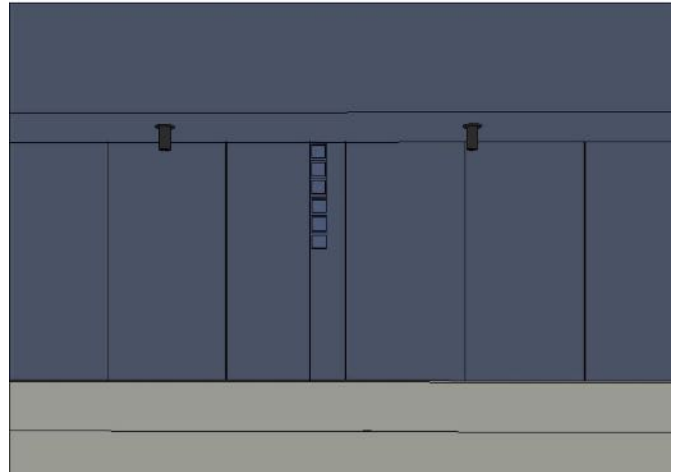
4 .02 Vents will need to be arranged as shown above due to conflicts with framing members in the exterior wall.

The dryer vent penetrations on Building A cannot be arranged as indicated on RFI 357 due to conflicts with framing members. Additionally, the detailing proposed works well for most penetrations other than dryer ducts. See suggested revised detailing in Item 4.05.

Please see responses to SVR 03: 3.06. All exhausts reconfigured to work around structural framing constraints as noted by QEC.

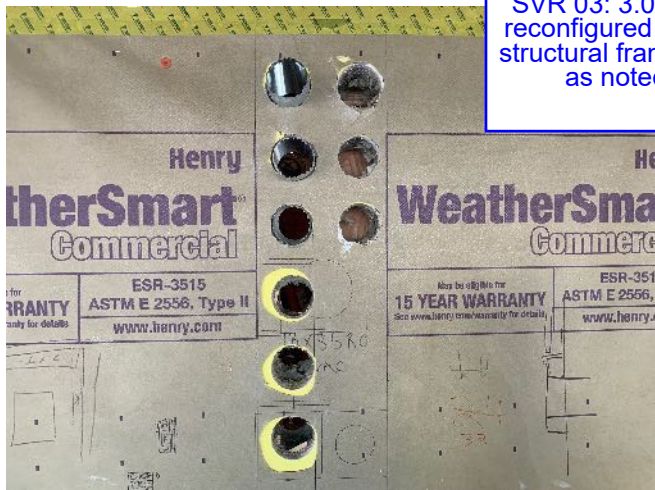
4 .03 This image indicates the installation of the six vertically stacked vents. The three holes to the right will need to be filled in and WRB repaired. Note solid framing in the three holes to the right.

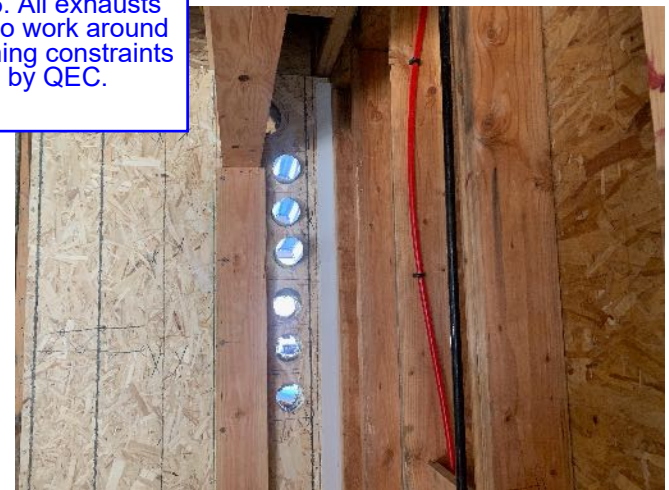
4 .04 This image taken from the interior shows the conflict with a structural post on the left and the intersecting wall to the right. The six holes as shown are the only practical location for the dryer vents.

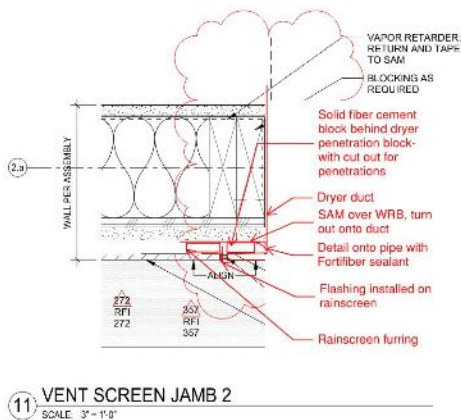
4 .05 The original detail for the dryer vent indicates a pre wrap of the rough opening (not realistic with a round penetration). Proposed revised detailing includes no pre-wrap of rough opening, SAM installed over WRB and onto duct work, additional detailing using Fortifiber sealant from SAM to ductwork, and a solid block behind the six vent covers. The solid block is used to flush out the vent cap with adjacent claddings. Due to the location of these vents well under cover, a head flashing is not required.

RFI #465 (pending WA response) and SVR 03: 3.06 addresses this detail - photo's attached to SVR 03 responses.

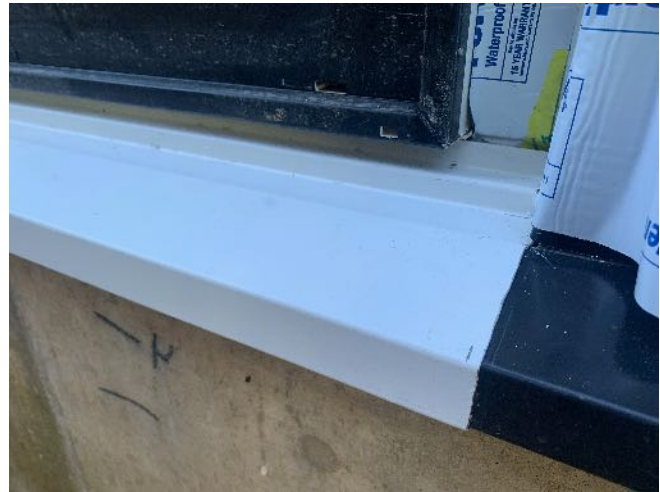
4 .06 LMC team has mocked up alternate window sill flashing for Building E. This alternate is due to differing dimensions between concrete stem wall and window sill (Reduced from original design). There is a small area of the flashing which has no slope. While not ideal, it does not appear that an alternate flashing configuration is possible. Proceed with configuration of flashing reviewed on site.

The originally designed sill flashing for windows at the stem wall is proving problematic due to differences in dimension between stem wall and window sill. That dimension in the field is reduced from the original design, requiring an alternate flashing configuration. LMC Has nocked up the flashing proposed for this application, noted in Item 4.06. It does appear that consistent sloped flashing may not be possible due to dimensional limitations. LMC may proceed with this alternate flashing configuration pending review from Waechter.

RFI #445 for reference.
