SITE VISIT

The Rockwood 10 project is a new construction project located in NE Portland, Oregon. The requested site observations on February 25th, 2021 were related to the installation of the above grade WRB/AB installation, window installation and the preliminary installation of flashings and claddings. The intent of the inspection and observations is to determine compliance with manufacturer's requirements and installations instructions as well as project specific details.

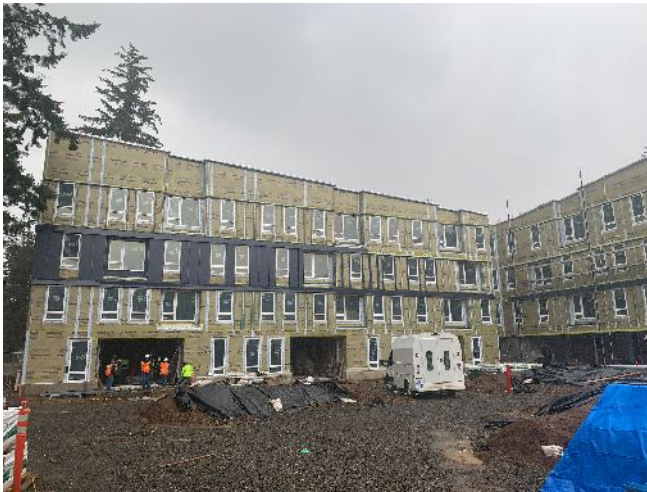
- 1 .01** This is the North elevation of building B. WRB/AB installation is nearing completion and all windows have been installed.

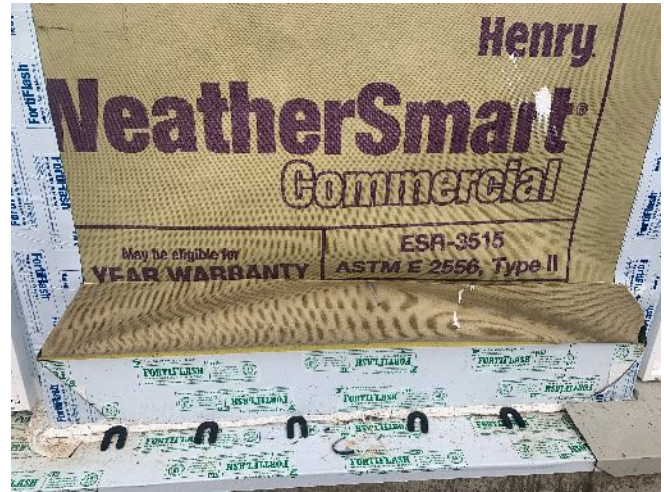
- 1 .02** Building B- using fasteners to hold the WRB/AB up for integration with through wall flashing leaves several large holes in WRB/AB. Use tape for this purpose which won't result in such damage.

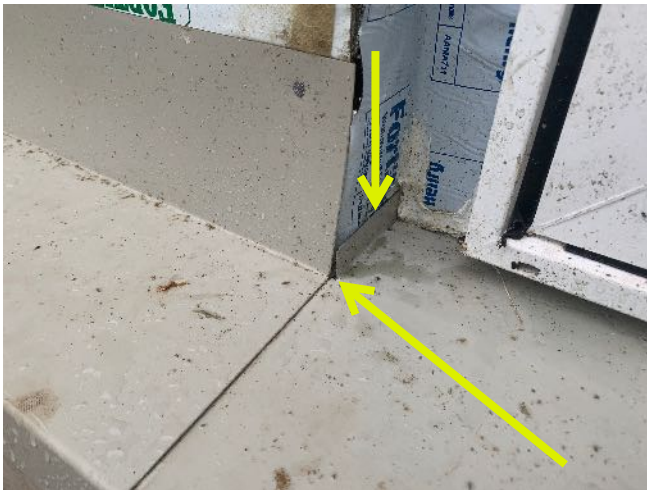
- 1 .03** Building B- Flashing installation is incomplete around window. If this flashing is to be stripped into WRB, back leg height will need to be taller. How will pinhole at outside corner be sealed?

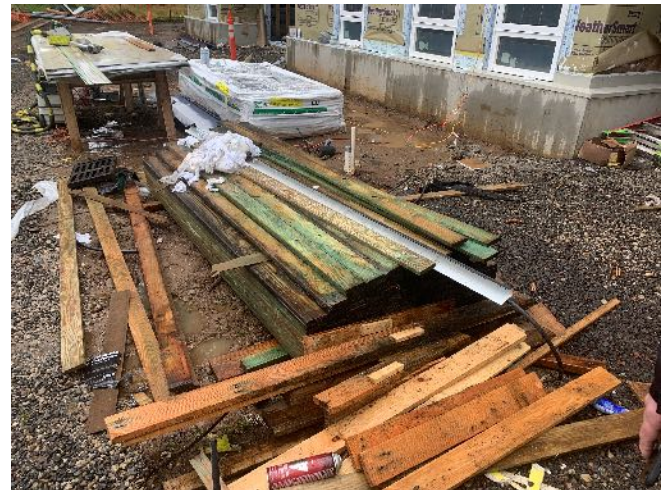
- 1 .04** Borate treated lumber needs to be stored out of the rain. Heavy rains can wash borate salts out of the wood. Provide protection for borate treated furring (plastic tarp) or move under cover.

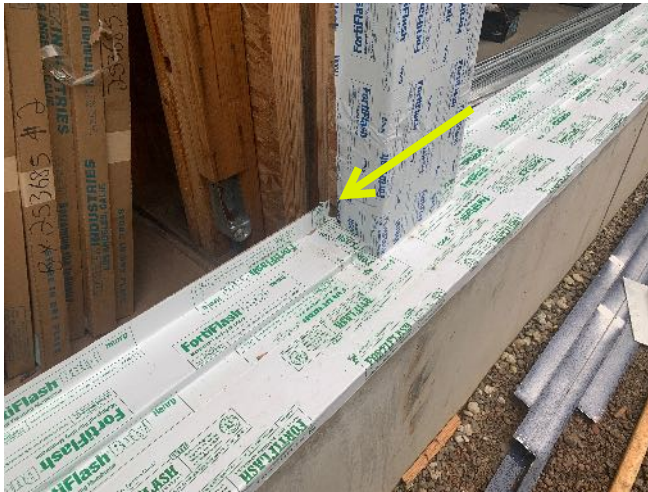
- 1 .05** Building A- there is a large gap between the jamb and the back dam. Additional framing will be necessary at the back of the jamb and the additional framing must be wrapped with SAM. Connect the jamb wrap to the back angle wrap.

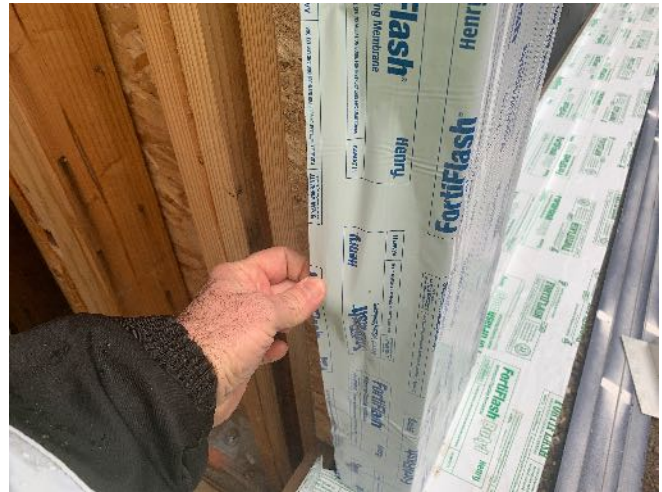
- 1 .06** Building A- there are a number of locations with fairly poor adhesion of SAM. Substrate must be primed (sufficient time must be allowed for the primer to flash), and then installed SAM must be rolled for proper adhesion. Remove and replace SAM that is not adhered to the substrate.

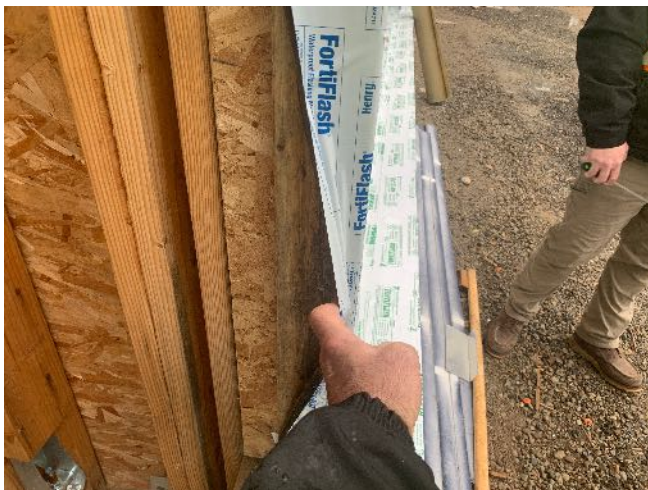
- 1 .07** Building A- there are a number of locations with fairly poor adhesion of SAM. Substrate must be primed (sufficient time must be allowed for the primer to flash), and then installed SAM must be rolled for proper adhesion. Remove and replace SAM that is not adhered to the substrate.

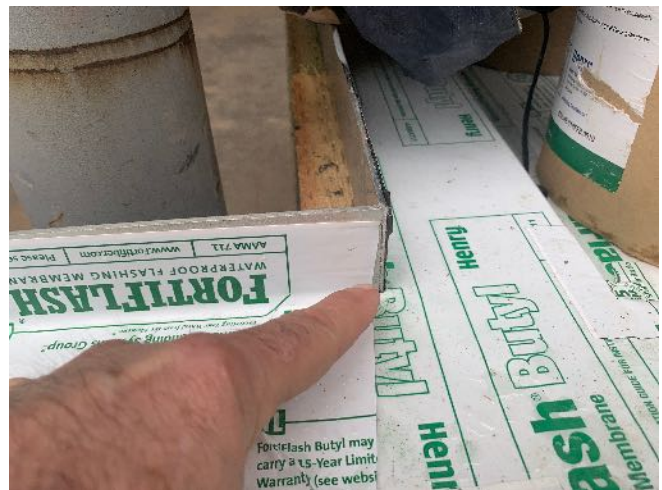
- 1 .08** Building A- Outside corner of back dam- SAM installation is discontinuous. SAM must be continuous around the corner and must extend to full height of back dam.

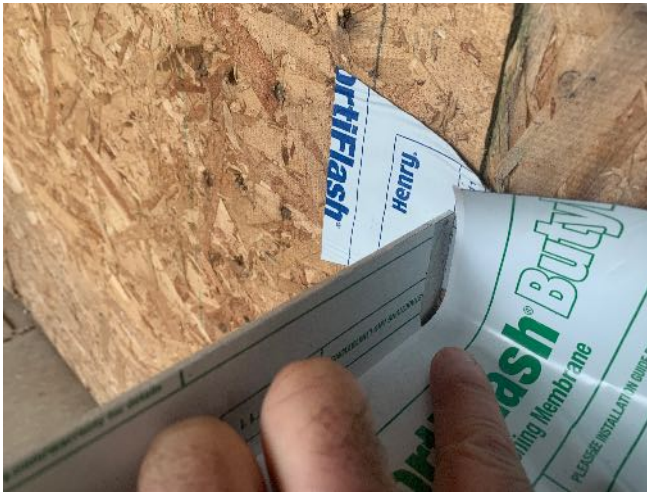
- 1 .09 Building A- Sill pan waterproofing is discontinuous. Jamb and sill SAM must form continuous sill pan.

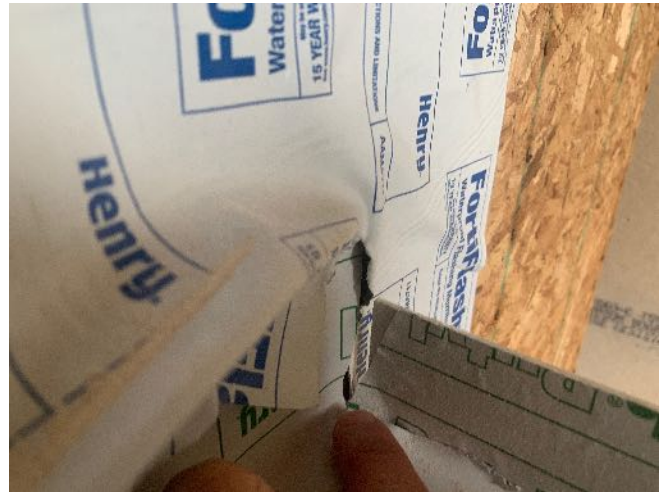
- 1 .10 Building A- Sill pan waterproofing is discontinuous. Jamb and sill SAM must form continuous sill pan.

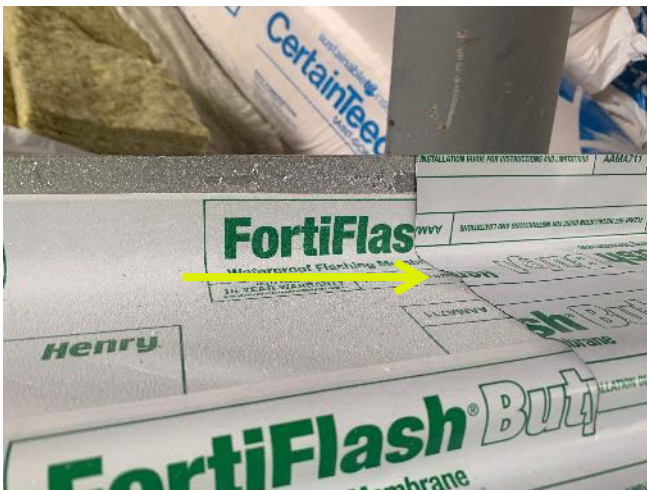
- 1 .11 Building A- SAM installation is discontinuous. SAM must be continuous and must extend to full height of back dam. Remove and replace SAM which is not well adhered to other SAM at sill.

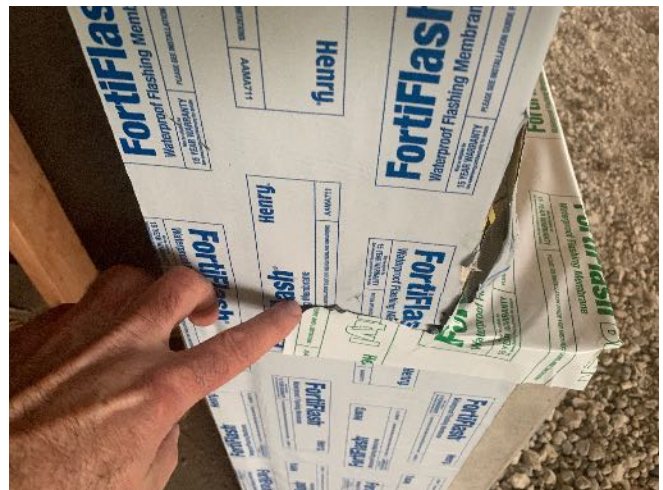
- 1 .12 Building A- SAM is reverse lapped around jamb. This needs to be replaced with properly sequenced materials.

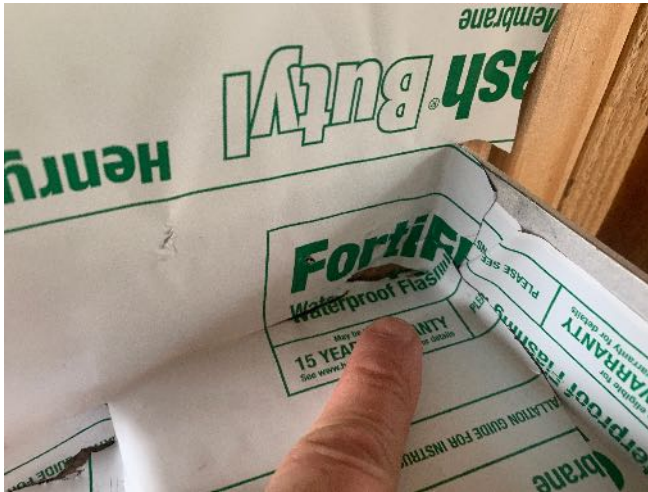
- 1 .13 Building A- There is a hole in the insider corner of the sill pan SAM. Remove and replace.

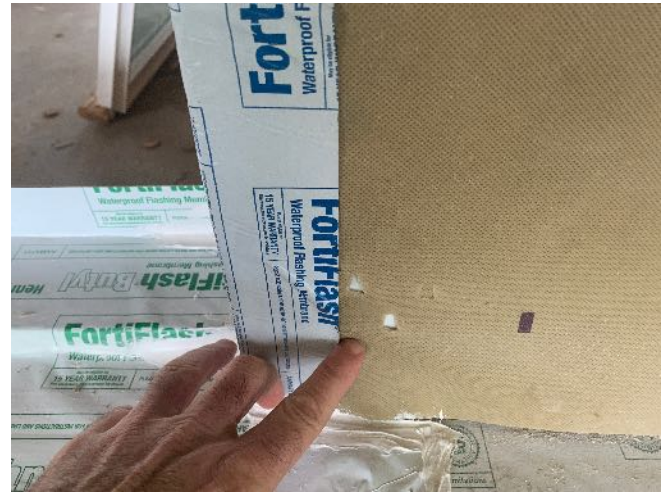
- 1 .14 Building A- Repair damage to WRB around rough opening.

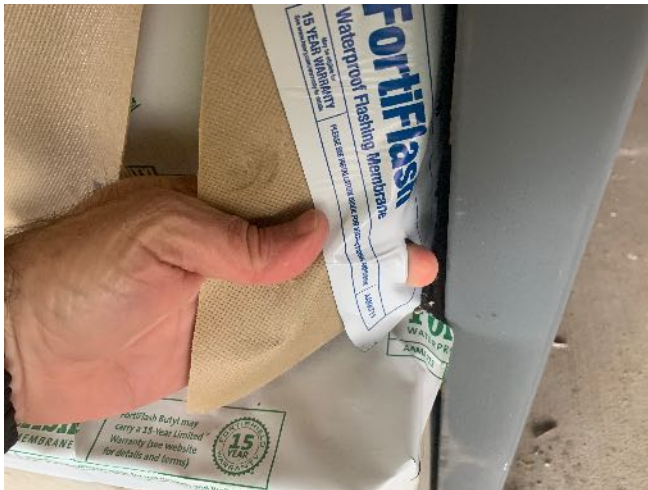
- 1 .15 Building B- There is a a clear void in the SAM pre-wrap. Repair or replace.

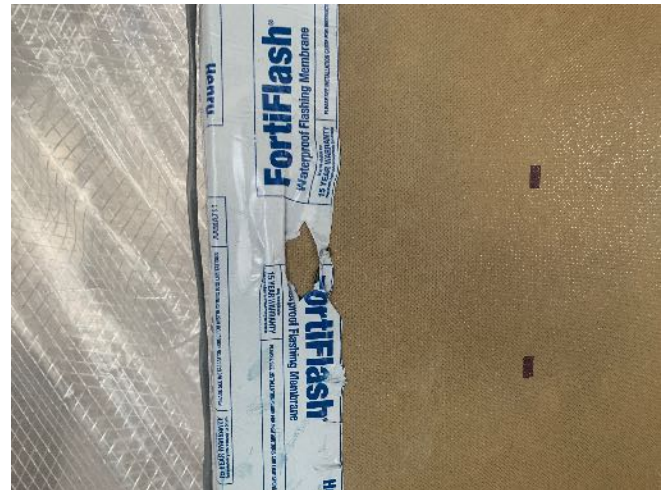
- 1 .16 Building B- There is a a clear void in the SAM pre-wrap. Repair or replace.

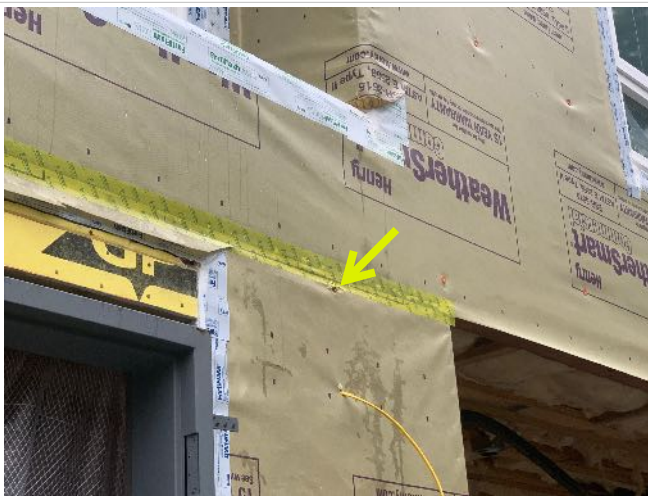
- 1 .17 Building B- WRB is damaged just below the seam tape. Repair using WRB and WRB tape.

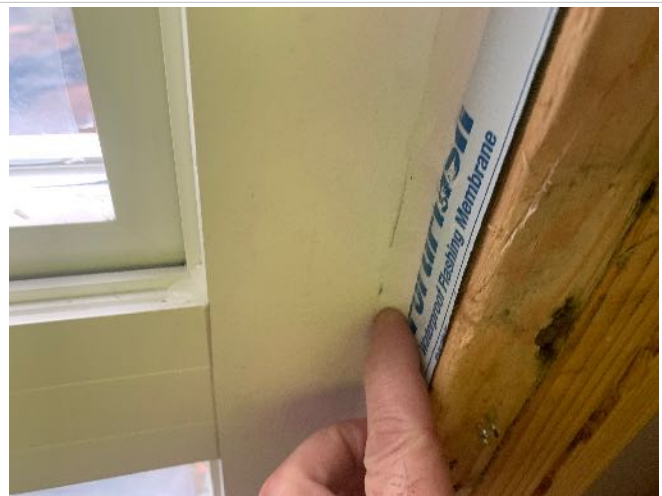
- 1 .18 Building B- Second floor window on East elevation. Air seal has visible voids at bond line with window. Repair air seal using the originally installed sealant.

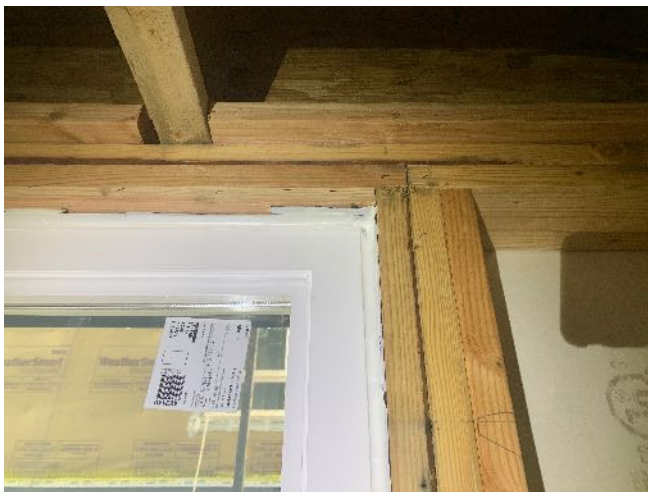
- 1 .19 Building B- Second floor window-backer rod is visible through the sealant joint. Verify that backer rod has been placed far enough back to allow for minimum depth of sealant. Repair this joint.

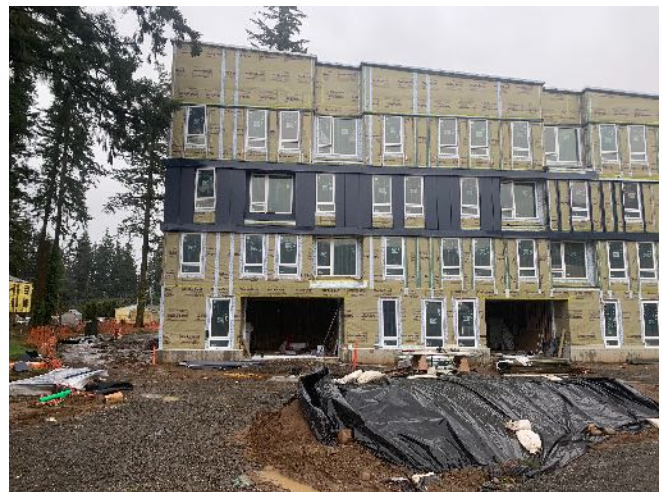
- 1 .20 Building B- North elevation, cladding installation has begun and the floor line flashing detail is exhibiting significant oil canning. Options to minimize or eliminate oil canning include fabricating flashing with pencil ribs, using ACM or a honeycomb backed product such as Skyline's Skycore product.
