# FIELD NOTES

DATE: 7/22/2021

PROJECT: Rockwood 10

SUBJECT: Existing Tree Area – Arborist Walk

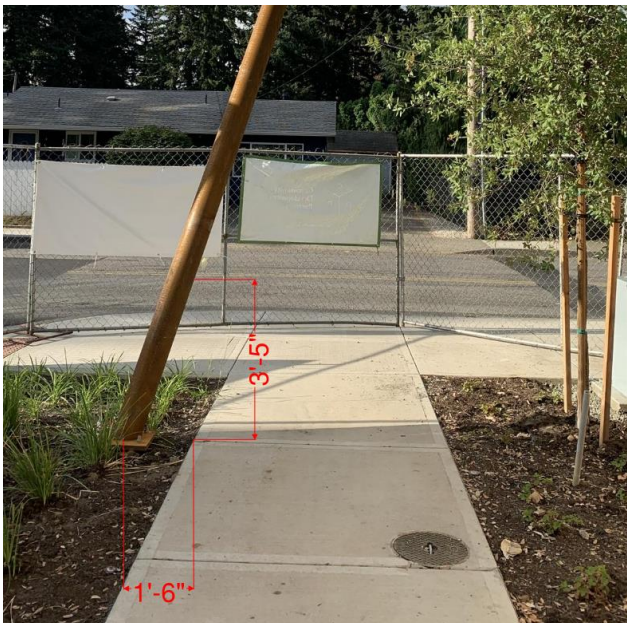
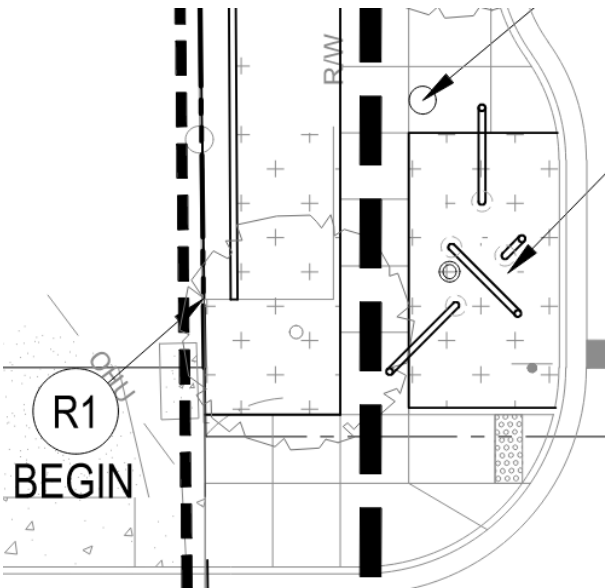
- a. Southern most art location conflicts with sidewalk. Art is overhanging sidewalk at approximately 3.5' - 4' above concrete elevation and therefore presents a safety concern.
  - i. Drawing shown art at 3.5' O.C. from sidewalk edge but install location appears to be closer to 1.5' O.C.
  - ii. Rotating 90 deg clockwise would place art parallel to adjacent art piece. Therefore, baseplate may need to be rewelded to achieve rotation less than 90 deg. A 45 deg clockwise rotation would orient art piece toward south, parallel to walk. PLACE and LMC to confirm this approach is acceptable and does not conflict with Yamhill ROW clearances.
