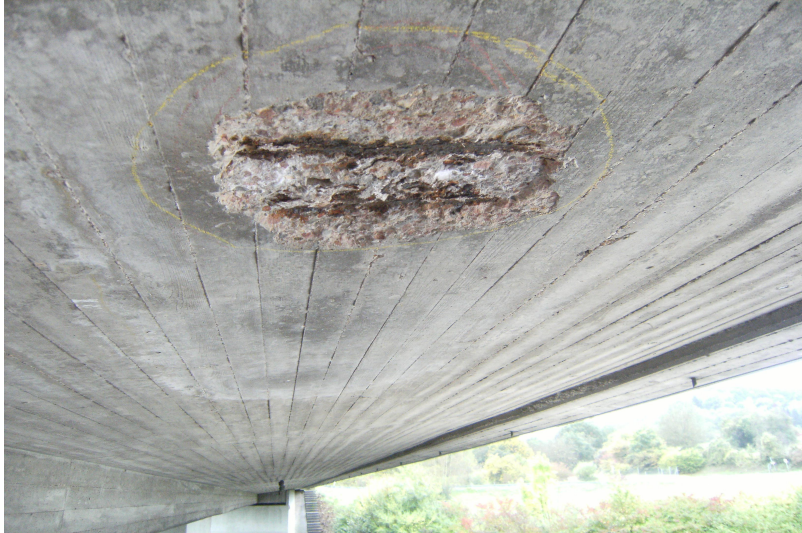
Category	Details
Project Name	x
Project ID	x
Project Location	x
Company Name	ICoM GmbH
Inspector Name	Max Mastermann
Date of Inspection	02/04/2025
Damage & Object Type(s)	JTape (Joint Tape), Weathering, Rust
Impact	The rust staining on the concrete surface and the joint tape (17) on the bridge structure.
Size	The rust staining appears to be relatively small, possibly in the range of 10-20 cm².
Direction	Horizontal (along the joint tape).
Possible Reasons	The rust staining could be attributed to environmental factors such as exposure to moisture and sunlight, which are common causes of rusting in concrete structures.
