Provisional Acceptance Verification Report

La Vendimia PV Plant

June 28, 2024

Prepared for:
Matrix – TPG

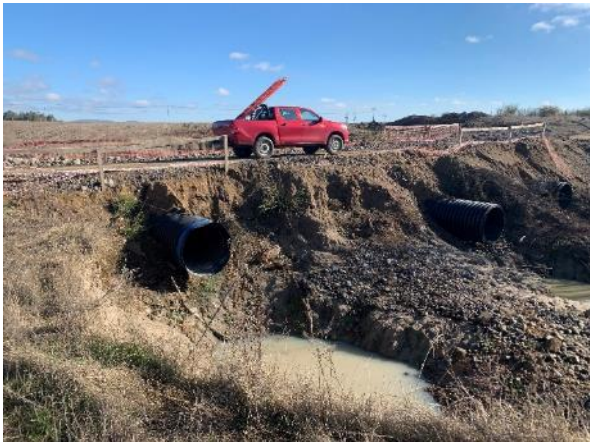
<p>Figure 5.1 Access to the Project site. Source: Google Earth.</p>	
<p>A bridge needs to be crossed just before reaching the Plant access gate (Figure I.1). The access gate was in good conditions and with the corresponding warning signs (Figure I.2) and grounded (Figure I.3). There were works going on at the bridge during the visit.</p>	
<p>The internal roads were found in good condition (Figure I.4). The main road is made of compacted and treated soil in accordance with the design. It gives access to the power stations control room and warehouse containers. The secondary roads were marked, and a track was visible.</p>	
<p>A parapet was under construction at the time of the visit, along the site perimeter (Figure I.5, Figure I.6 and Figure I.7).</p>	
<p>Comment: The unpaved road is in decent conditions. Enertis raises no issues.</p>

Figure I.1. Bridge just outside of the Plant perimeter.

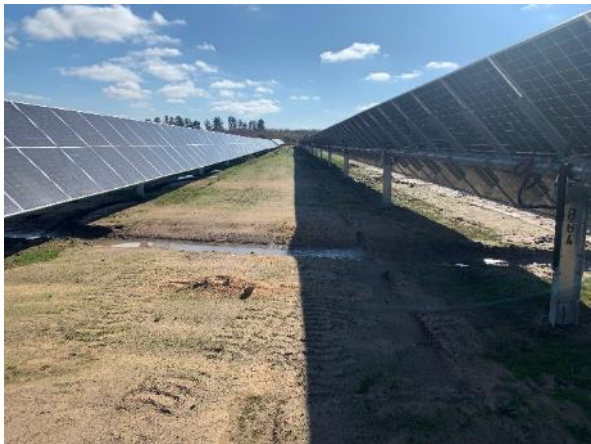
Site visit findings (May 23, 2024)	
	PV modules
<p>Based on a sample of tables inspected, PV modules have been installed per design documentation (Figure I.8). Enertis checked the nameplates and found them consistent with design specifications: Module Trina Solar TSM DEG21C.20.</p> <p>Modules are attached to purlins using four bolts and nuts. The purlins are in turn affixed to the torque tube with brackets. The torque tube rests on several piles; the mechanical connection is achieved via a slew drive and bearings installed on the piles.</p> <p>The PV module frame and support structures are made of aluminum and galvanized steel, respectively. This means that there is no risk of bimetallic corrosion between the two. Each module is grounded through metallic contact between the brackets, torque tube and piles. A cable ensures continuity between the torque tube and pile. The modules were clean due to recent rains.</p>

Figure I.8. PV module rows.

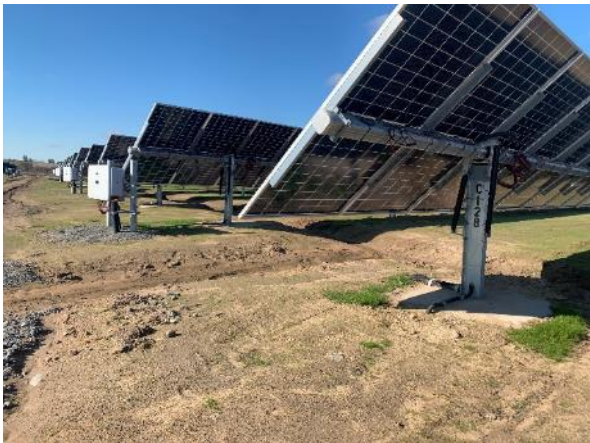
Comment: Enertis raises no issues.	
	Trackers
<p>Enertis inspected the trackers and associated parts such as piles, purlins, torque tubes, brackets, screws, bearings and dampers (Figure I.9). This structure is equipped with a geared motor powered by the Trina Smart Controller. Self-sufficiency is achieved by supplying power through links to the strings.</p> <p>All torque marks are applied. No signs of corrosion or degradation were observed. The tracker is grounded through a copper wire fixed at the last pile of each row which connect to the earthing mesh.</p> <p>The tracker number is visible on the external pile near the internal road (Figure I.10).</p> <p>Some tracker piles have concrete foundations (Figure I.11 and Figure I.12).</p> <p>Met stations with anemometers and wind vanes communicate with the tracker control unit (TCU) of each tracker. Met stations are grounded, as can be seen in Figure I.13 and Figure I.14.</p>

Figure I.9. Trackers.

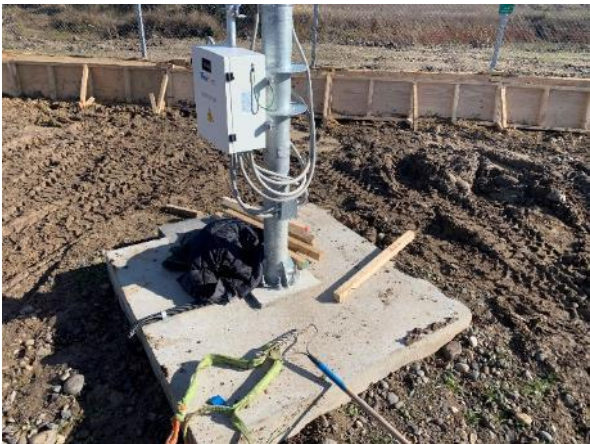
Figure I.13. Met station foundation.

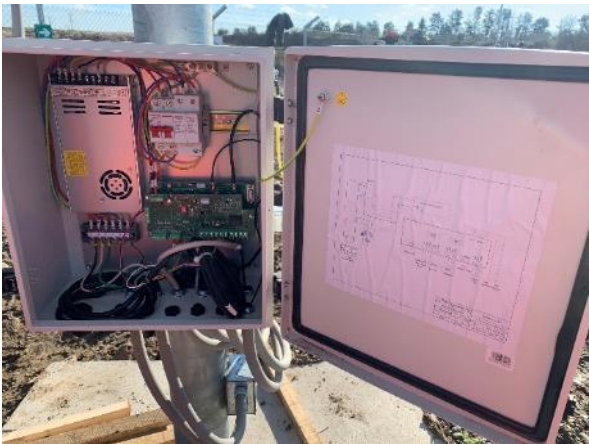
Figure I.14. Met station cabinet.

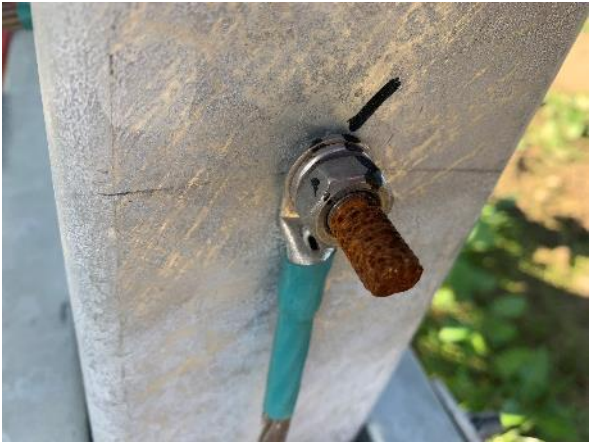
Figure I.18. Corroded bolt on inverter pile.

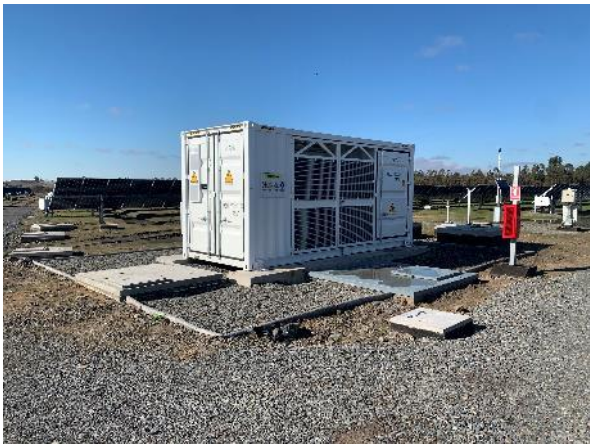
Site visit findings (May 23, 2024)	
	Power stations
<p>Two medium-voltage stations (MVS) supplied by Huawei are used at the Plant (Figure I.19). The MVS include the following equipment:</p> <ul style="list-style-type: none"> Transformer used for stepping up the voltage from 800 V to 13.2 kV (the grid voltage). LV and MV switchgear. MV cables connecting to the PoC. An auxiliary transformer to power the auxiliary services. <p>Warning signs and labels indicating the presence of live parts have been installed on the equipment. A steel plate was welded to the foundation and fixed with bolts to the power station container. Torque marks on the anchor bolts are applied.</p>	
<p>Comment: Enertis checked the oil level (Figure I.20), fire extinguisher (Figure I.21), and MVS grounding (Figure I.22) with no issues arising.</p>	
	MV line and grid connection
<p>Enertis inspected the MV line between the Plant and the PoC. The PoC consists of several poles holding the following equipment:</p> <ol style="list-style-type: none"> Cables emerging from the ground, within the Plant perimeter (Figure I.23). Current transformer used for metering purposes, and associated cabinet (Figure I.24). Automatic circuit recloser and associated cabinet, transformer for auxiliary services (Figure I.24). Cables connecting to the distribution line.

Figure I.19. MVS.

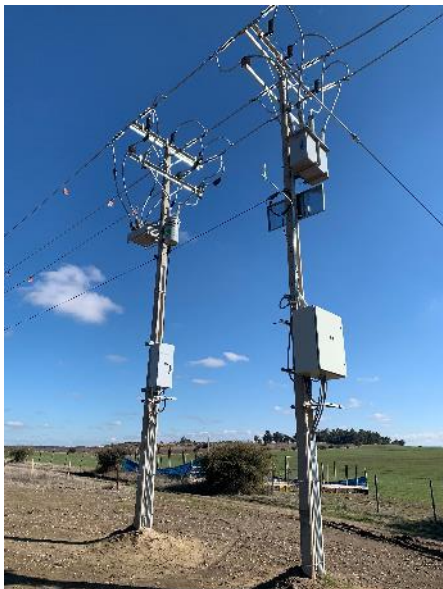
Figure I.24. PoC.

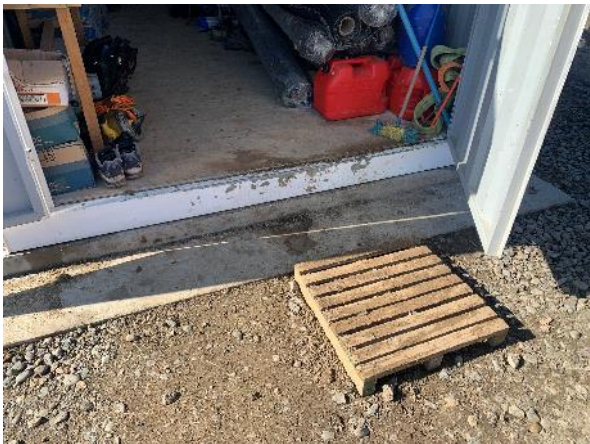
<p>Comment: Enertis raises no issues.</p>	
	Spare parts
<p>The spare parts are stored in a container joint to the control room. The container is in good conditions, grounded and anchored via welding to the foundations (Figure I.25).</p> <p>At the time of the visit, the warehouse was disorganized, and several spare parts were missing.</p>	
<p>Comment: The point mentioned above was added to the Punch List.</p>	
	Security system
<p>The security system comprises a fence with barbed wire, an entrance gate and security cameras equipped with video analytics software.</p> <p>The poles holding the security cameras are affixed to the concrete foundations by four bolts and nuts. The poles are grounded. Poles No.8 and 9 are shown in Figure I.27 and Figure I.28, respectively.</p>	
<p>Comment: A part of the fence with collapsed barbed wire was identified (Figure I.26). This was fixed during the site visit.</p>

Figure I.25. Entrance to spare parts container.

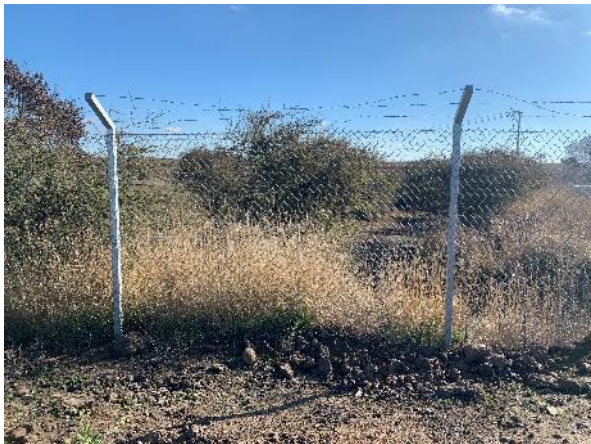
Figure I.26. Fence with collapsed barbed wire.

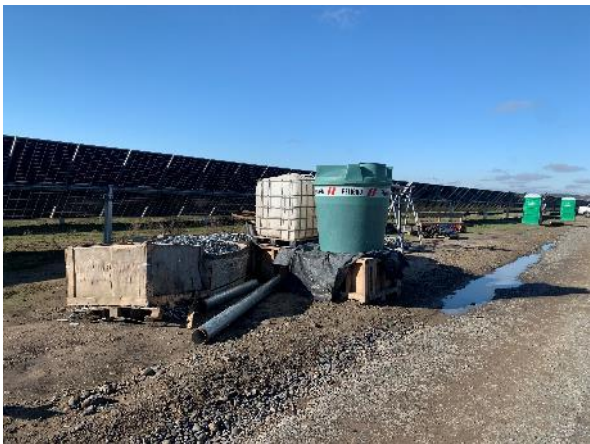
General site condition
<p>The Plant was found to be in decent condition considering the recent rainfalls. Some temporary facilities and construction materials were yet to be removed (Figure I.35). Enertis inspected the interior of manholes (Figure I.36) with no issues arising but found two manholes with damaged lids (Figure I.37 and Figure I.38).</p>	
<p>Comment: The points mentioned above were added to the Punch List.</p>

Figure I.35. Accumulated construction material.

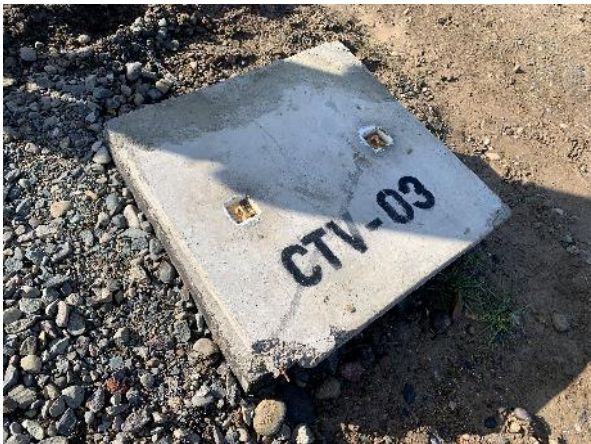
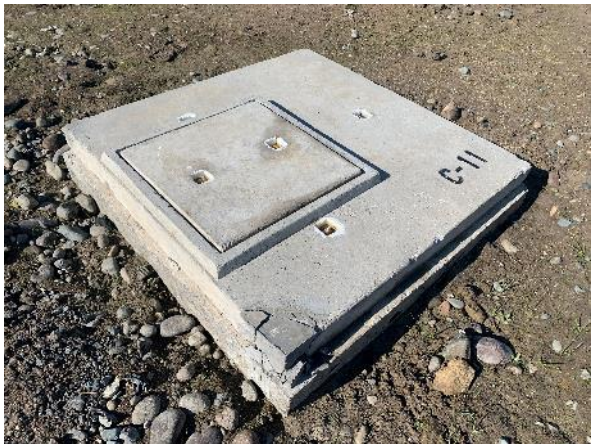
Figure I.37. Damaged manhole lid.

Figure I.38. Damaged manhole lid.
