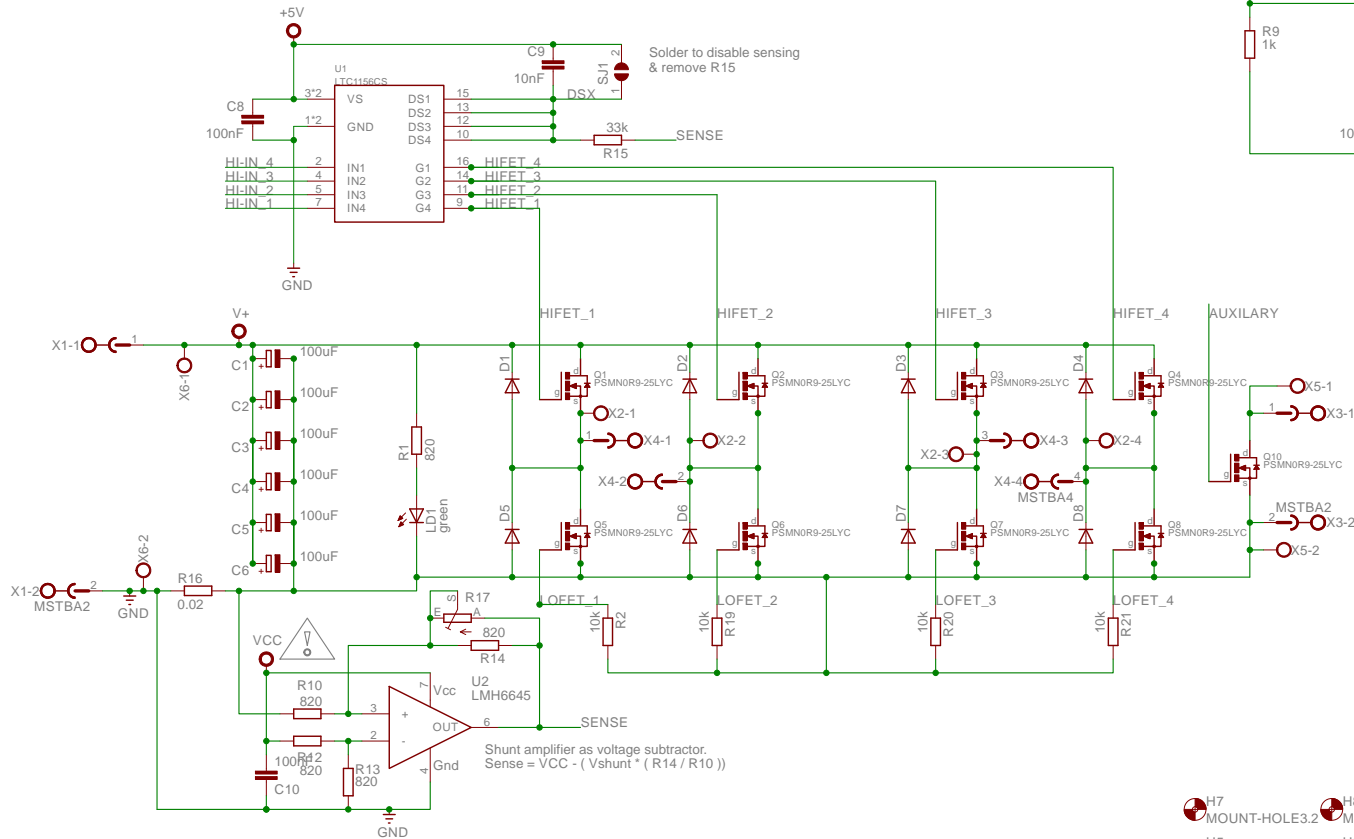
Bug: LOFET signals to CT32B0 timer, only 3 concurrent PWM outputs possible

Bug: Opamp Vcc should be 5v, manual re-trace required

Improvement: Pull down termination on HI_FET gate signals
