# dsPIC33EPXXXGP50X, dsPIC33EPXXXMC20X/50X and PIC24EPXXXGP/MC20X

## dsPIC33EPXXXGP50X, dsPIC33EPXXXMC20X/50X and PIC24EPXXXGP/MC20X Family Silicon Errata and Data Sheet Clarification

The dsPIC33EPXXXGP50X, dsPIC33EPXXXMC20X/50X and PIC24EPXXXGP/MC20X family devices that you have received conform functionally to the current Device Data Sheet (DS70000657J), except for the anomalies described in this document.

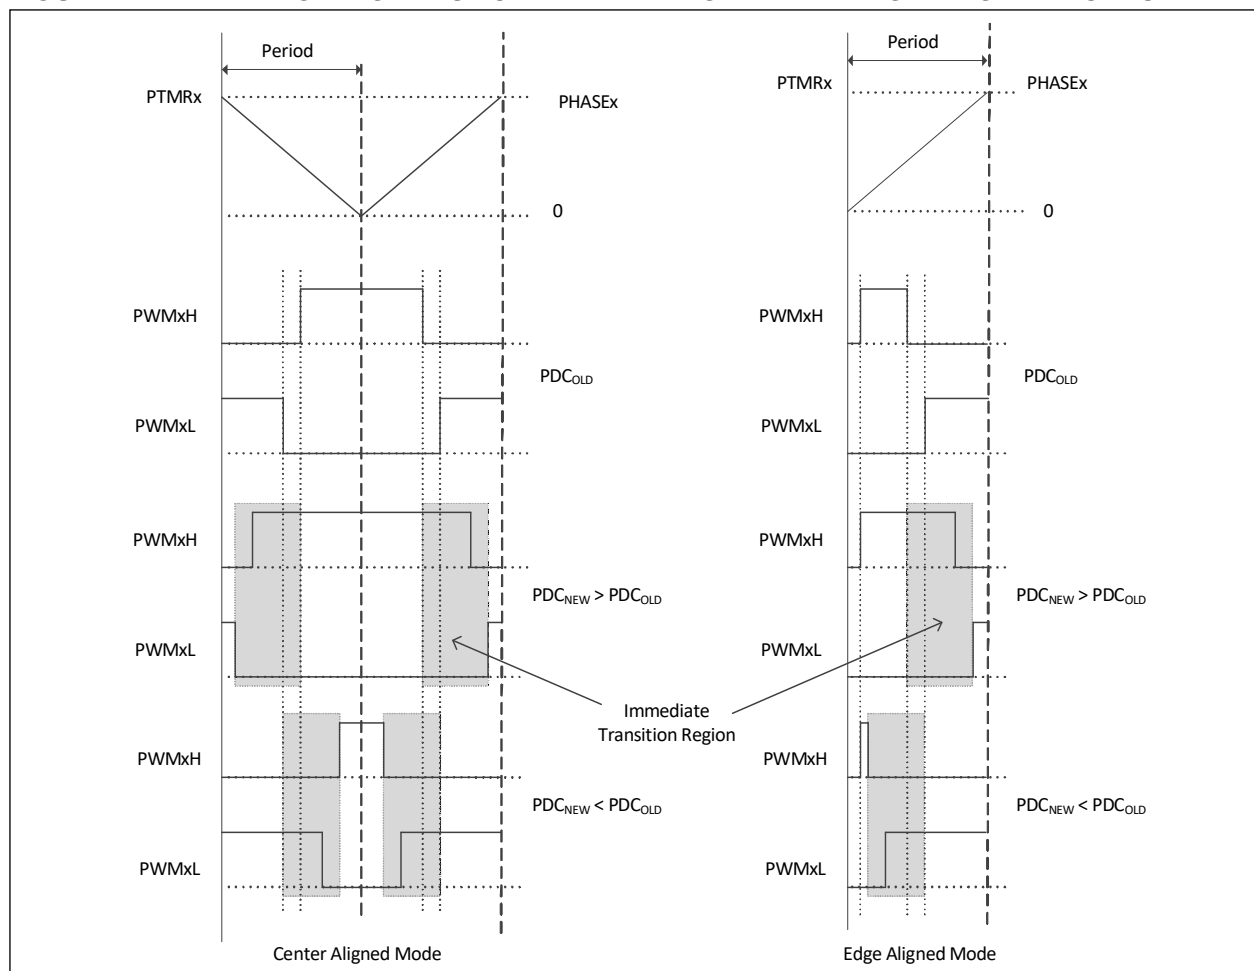
**FIGURE 1: TIMING DIAGRAMS FOR CENTER-ALIGNED AND EDGE-ALIGNED MODES**

The PWM generator may not assert dead time on the edges of transitions. This has been observed when all of the following conditions are present:

In Figure 1, if the duty cycle write occurred in the shaded box, then PWMxH and PWMxL will make an immediate transition without dead time.

None.

However, in most applications the duty cycle update timing can be controlled using the TRIGx trigger or Special Event Trigger, such that the above mentioned conditions are avoided altogether.

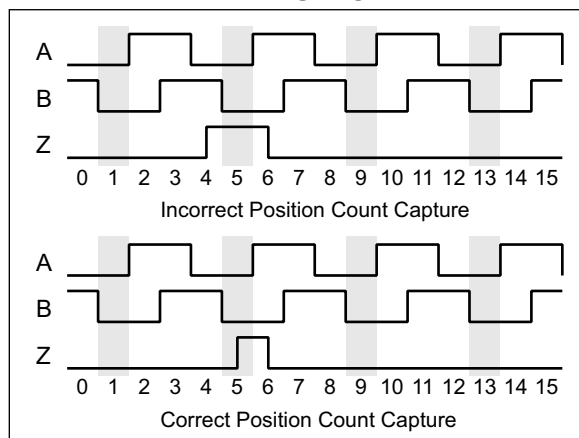
**FIGURE 3: CORRECT AND INCORRECT POSITION COUNT CAPTURES**

This is only observed when the leading edge of the index pulse occurs prior to the leading edge of the index match event. When the index pulse starts after the leading edge of the index match event, the position count is captured correctly.

Figure 3 shows how this occurs. In these cases, Encoder Signals A, B and (index) Z are shown, with the module being configured for index match when A and B are '0'. The effects of a correct and incorrect capture are shown side by side (shaded areas indicate the index match event); the position count is shown along the bottom.

There are two different work arounds depending on the encoder type.

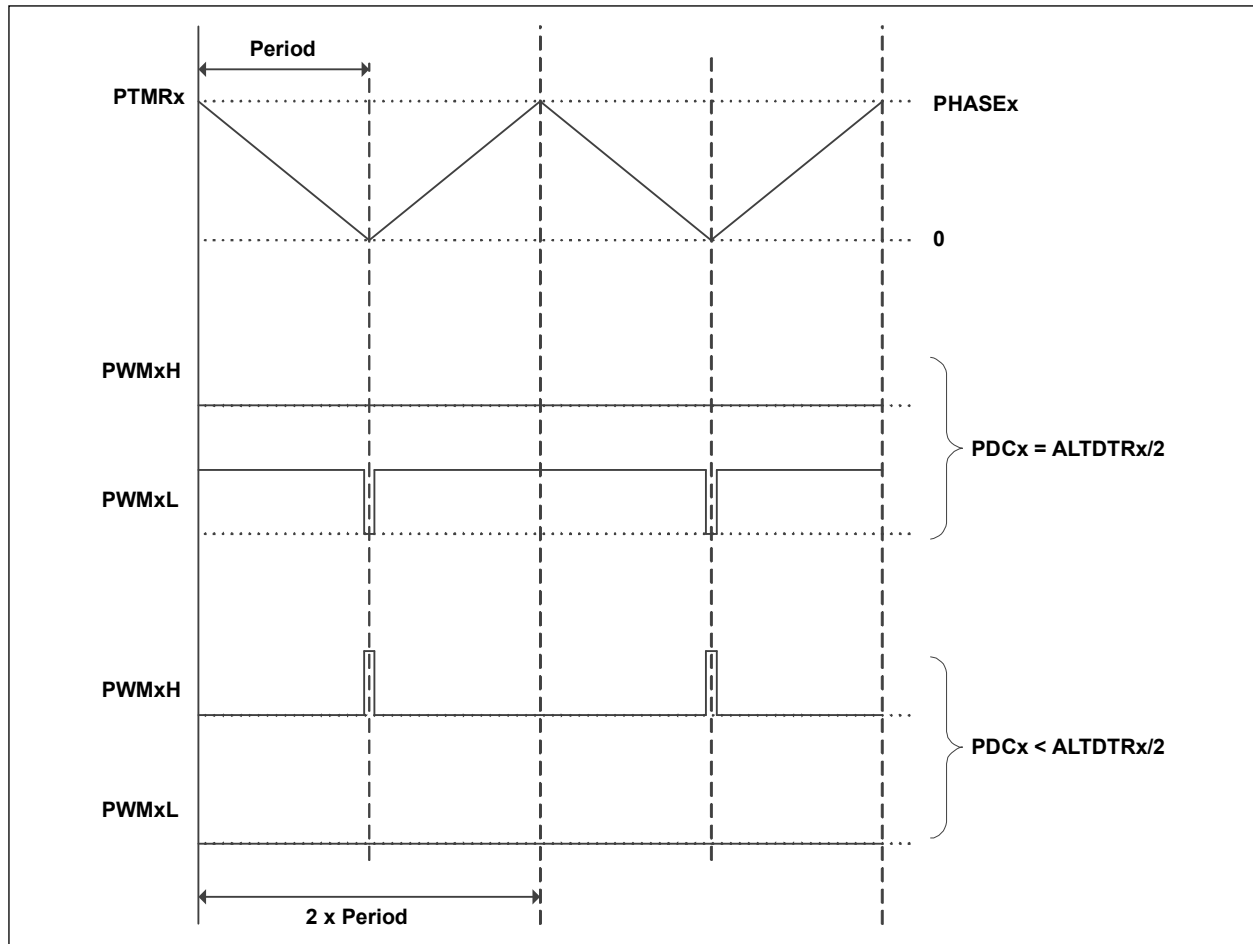
**FIGURE 4: PWM GENERATOR TIMING DIAGRAM**

In Center-Aligned Complementary mode with Independent Time Base, if the value in the PDCx register is less than one-half the value in the ALTDTRx register, the PWM generator will force the PWMxL to low, and on the PWMxH, generate pulses of width less than twice the dead time, as shown in Figure 4.

### Work around

Include a software routine to ensure that the duty cycle value written to the PDCx register is always at least one-half of the value in ALTDTRx. [Example 3](#) shows one method, with PDCtemp representing the variable which has the value to be written to the PDCx register. Alternatively, for duty cycle values less than half the desired dead-time value, zero out the ALTDTRx register or dynamically reduce the value in the ALTDTRx register, such that ALTDTRx is always equal to 2 \* PDCx, as shown in [Example 4](#).

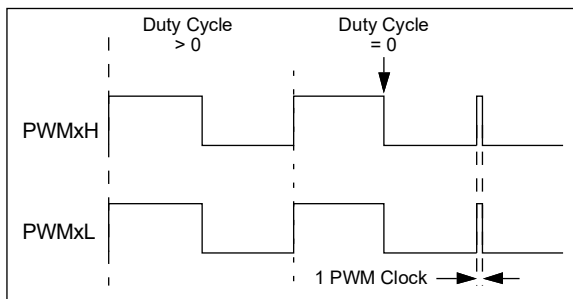
**FIGURE 6:**

In certain output modes, the PWMx module produces a pulse glitch of one PWM clock in width (Figure 6). This has been observed only when all of the following are true:

The pulse glitch has been observed to occur at the beginning of the following PWM boundary period.

##### **Work around**

If the application requires a duty cycle of zero, two possible work arounds are available.

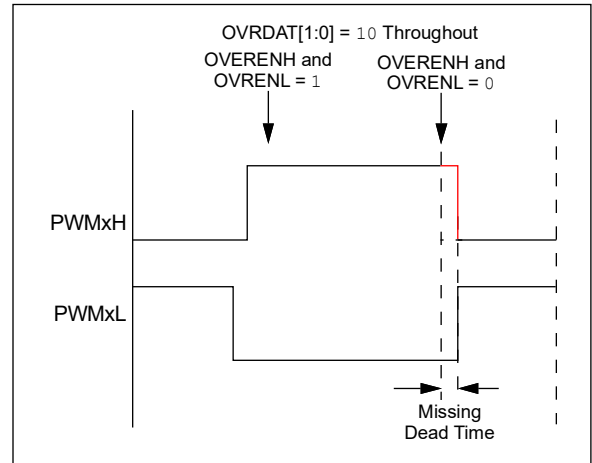
**FIGURE 7:**

This has been observed in both Center-Aligned and Edge-Aligned modes.

None.

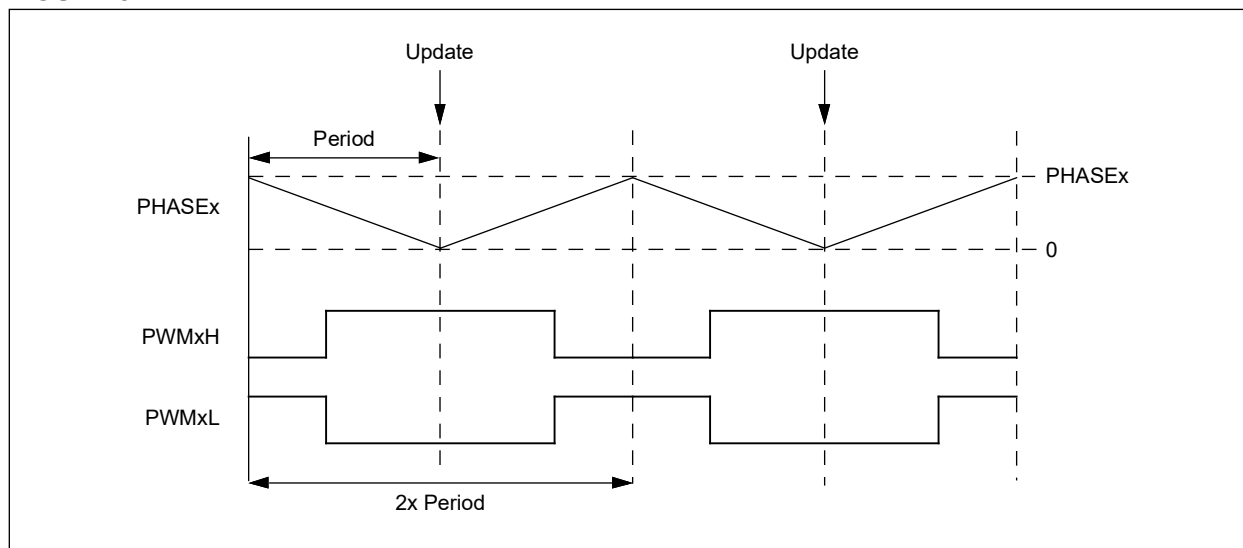
**FIGURE 8:**

In Center-Aligned Complementary mode with Independent Time Base, the expected dead time between transitions of the PWMxH and PWMxL outputs may not be asserted when SWAP is disabled under the following conditions:

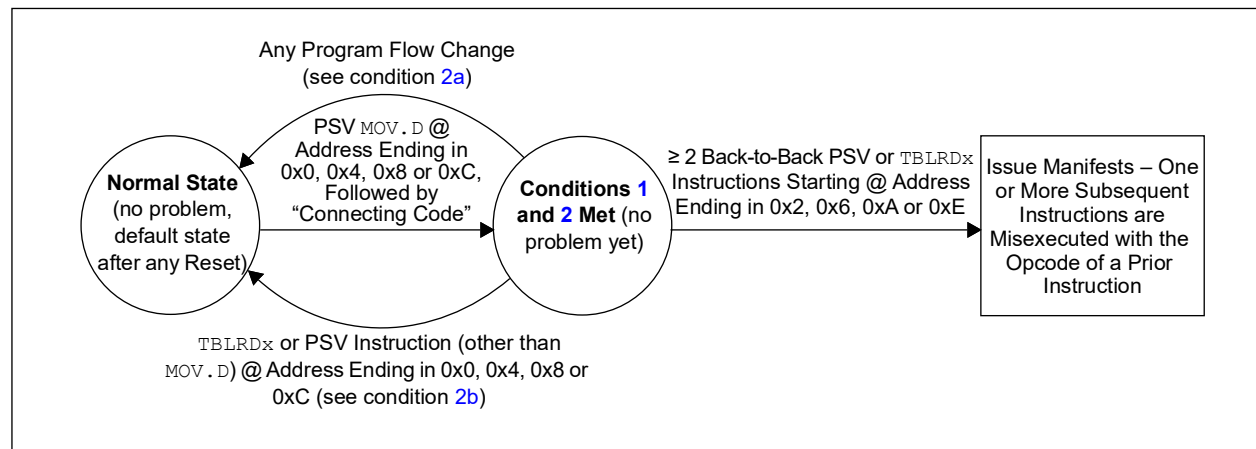
**FIGURE 9: SIMPLIFIED BEHAVIOR**

When two or more data Flash read instructions (via Program Space Visibility (PSV) read or table read) are executed back-to-back, one or more subsequent instructions can be misexecuted when all of the conditions in [Table 6](#) occur.

| 3. | ≥ 2 back-to-back PSV or <code>TBLRDx</code> instructions are executed (following the code of condition 2), where the first of the back-to-back instructions is located at an address ending in 0x2, 0x6, 0xA or 0xE. |

[Figure 9](#) provides an example of the effective behavior.

**Work around**

The issue can be avoided by ensuring any one or more of the requirements are not met. For example:

1. All instances of PSV `MOV.D` can be replaced with two PSV `MOV` instructions instead. Non-PSV `MOV.D` instructions acting on RAM/SFRs do not need to be modified; or
2. If not already present, a program flow change instruction (such as `BRA $+2`) can be inserted above back-to-back data Flash read sequences; or
3. Back-to-back data Flash read instruction sequences can be broken up by inserting a non-Flash read instruction (such as a `NOB`) in between the Flash read instructions; or
4. The alignment of the code can be shifted to avoid the required opcode location addresses.
