[Polymer Testing](#)
Polymer Testing, Polymer Analysis, Plastic Testing, and Plastic Analysis by ExcelPlas
Call Us: 03 9532 2207

Filled polypropylene – Furniture

Title	FAILURE ANALYSIS OF POLYMER FURNITURE COMPONENTS
Date	2013
Objective	To determine the cause of failure of a polymer furniture component.
Photo	<div>

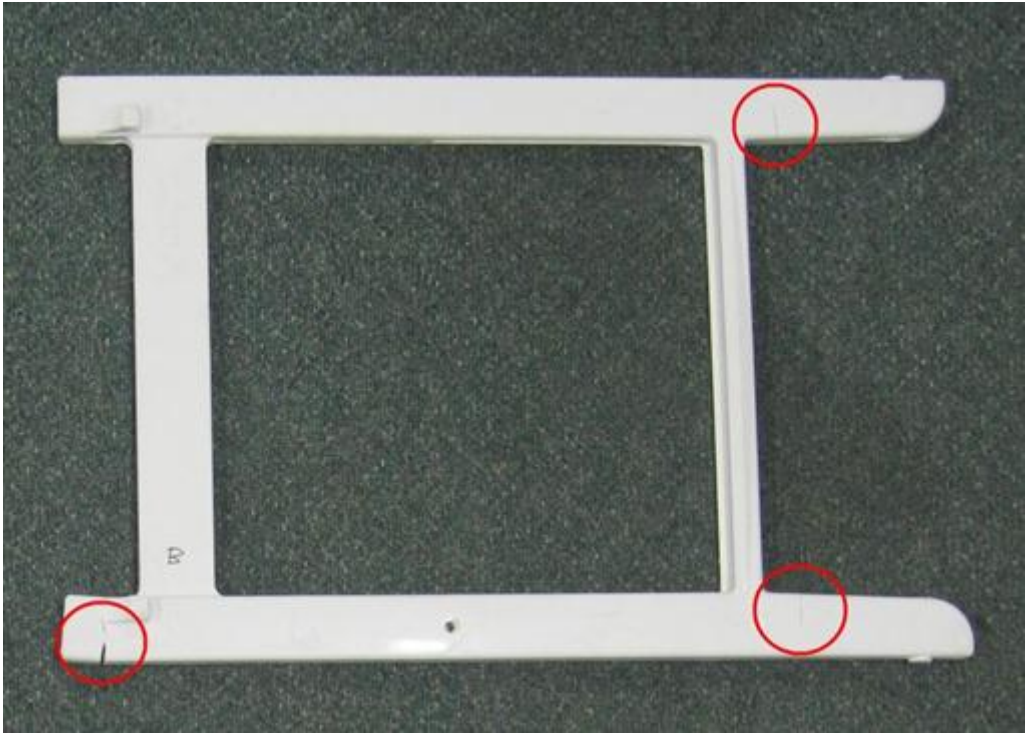
</div> <p>Figure 1. Close-up of Sample B – failed sample (cracks circled).</p>

Testing Undertaken	<p>FT-IR analysis according to ASTM E 573, using an Alpha Measurement Module byBrukerOptik</p> <p>Thermal analysis by DSC according to ASTM D 3418, using a DSC Q20 by TA instruments</p> <p>Ash testing according to the residue on ashing procedure described in ASTM D 2584.</p>
Failure Mode and Recommendations	<p>The failures are due to shrinkage cracking where the polymer undergoes post-moulding shrinkage but is constrained by the metal insert causing the polymer to be placed in tension. The presence of a high level of filler and the use of PPhomopolymer make the polymer less able to resist these tensile forces so cracking occurs.</p> <p>The internal voids are moulding defects due to volatiles or shrinkage voids and these lower the material strength of the polymer.</p> <p>Mould shrinking can be limited by increasing mould temperature, controlling the moulding variables, the thermal history of the moulding (temperature, cooling rate, part thickness and gate dimensions).</p> <p>Heating the metal inserts close to the mould temperature before moulding removes differences in thermal expansion that can lead to stress build-up at the metal/plastic interface.</p>

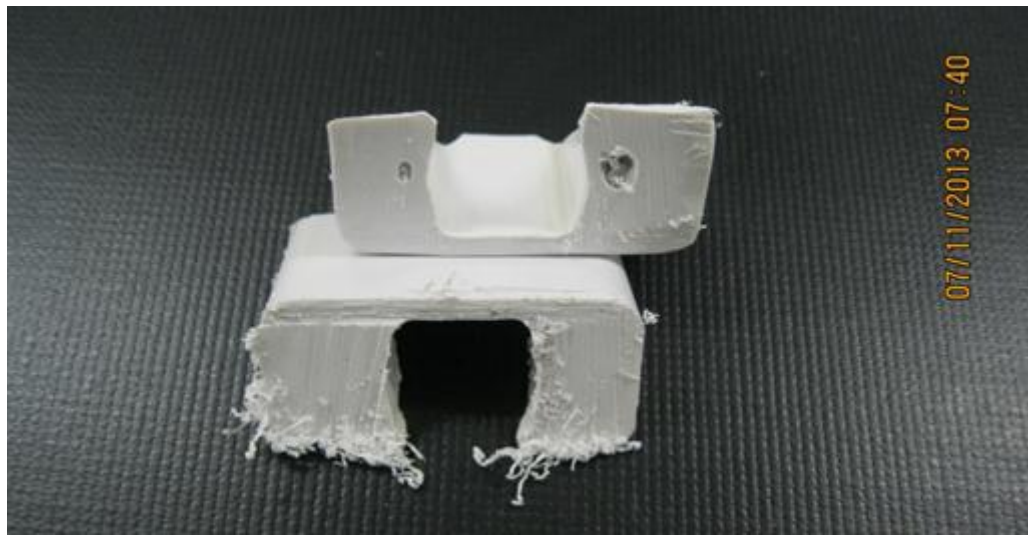
Figure 2. A Specimen showing voids in the material removed from Sample B prior toashing.

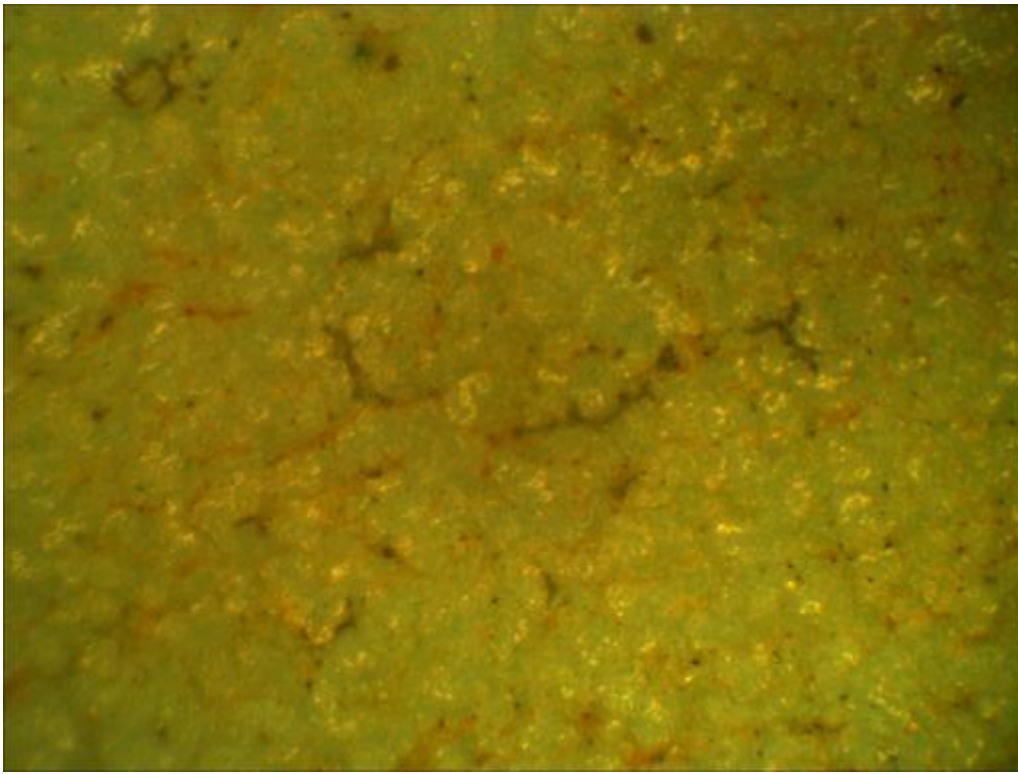
Figure 1. Surface Detail x200 magnification – no surface micro-cracking evident but slight crazing only.

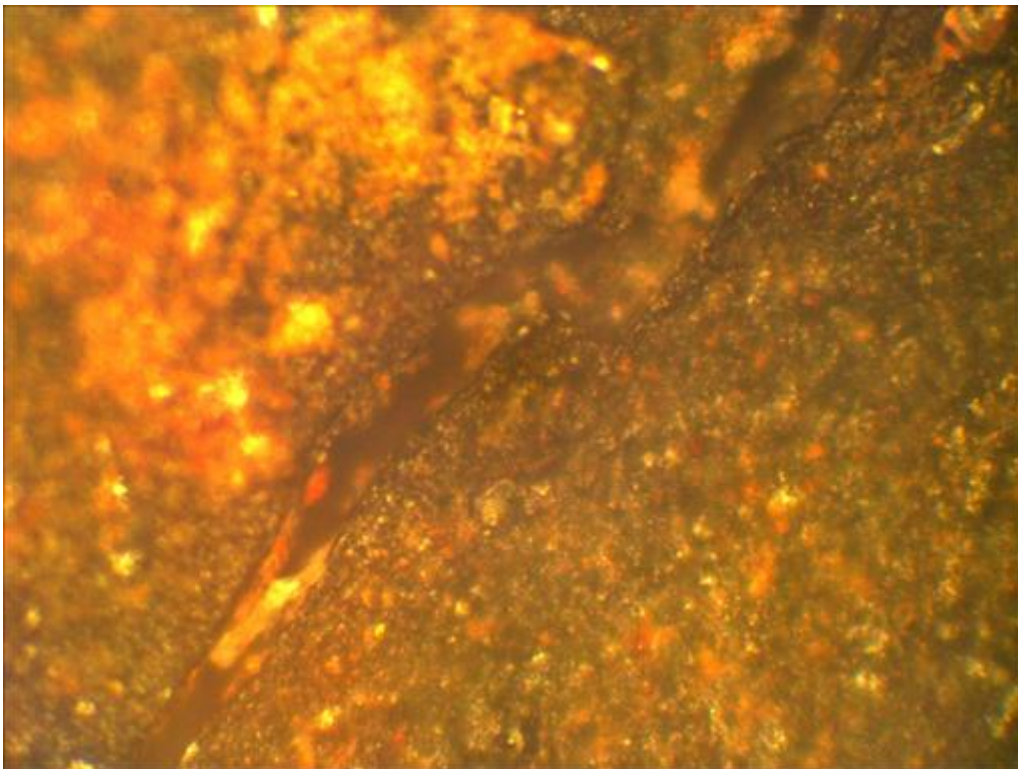
Figure 2. Surface Detail x200 magnification – surface micro-cracking and fissuring evident.

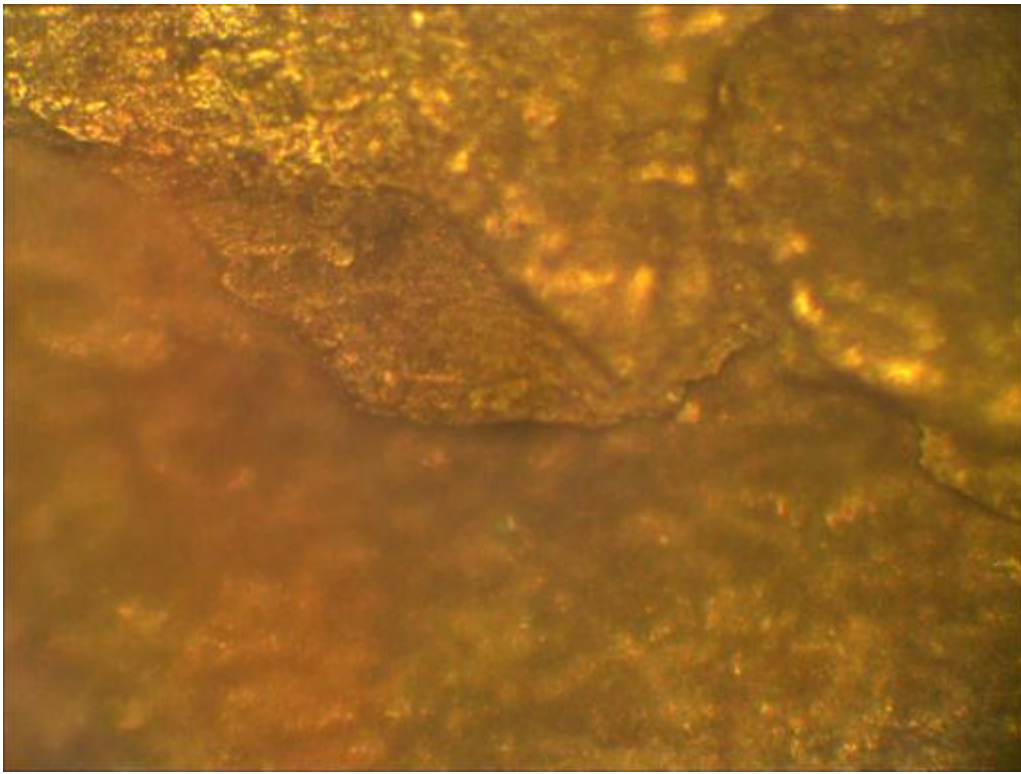
Figure 3. Surface Detail x200 magnification – surface micro-flaking evident.

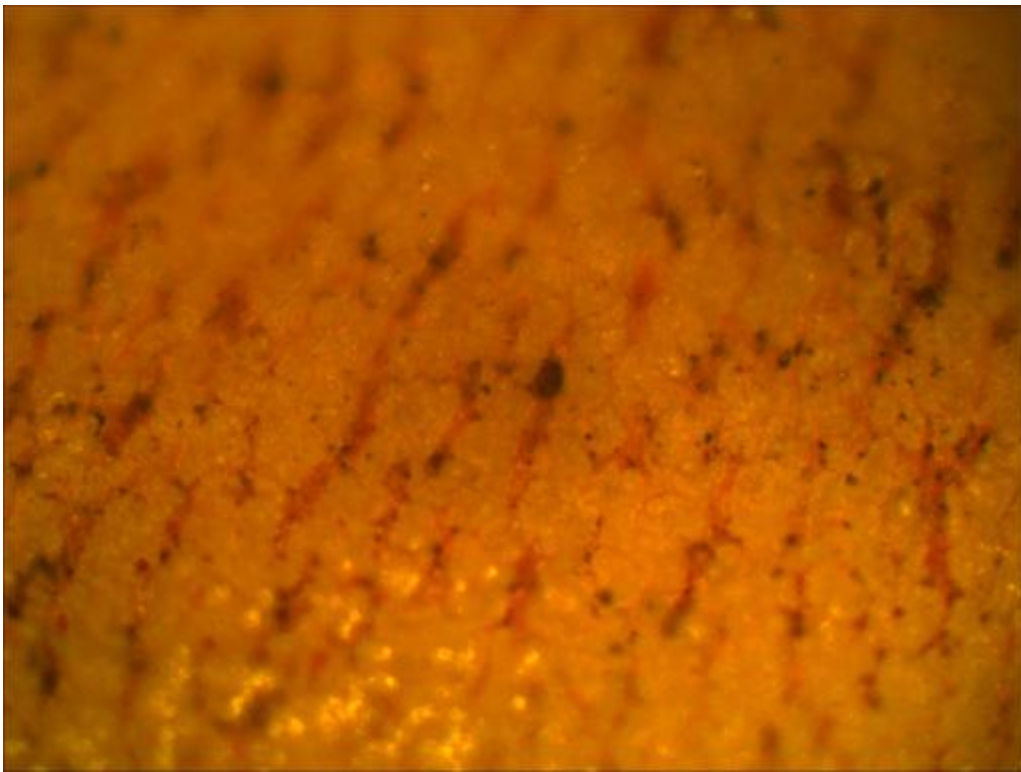
Figure 4. Surface Detail x200 magnification – surface crazing/chalking evident.

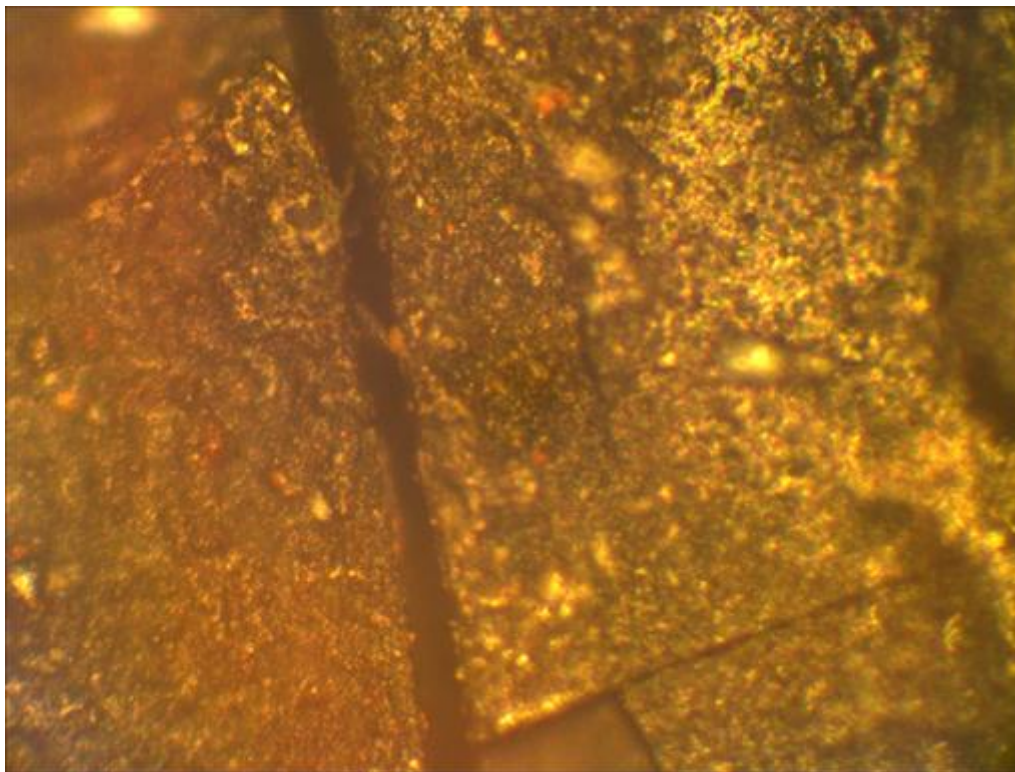
Figure 5. Surface Detail x200 magnification – surface micro-cracking and flaking evident.

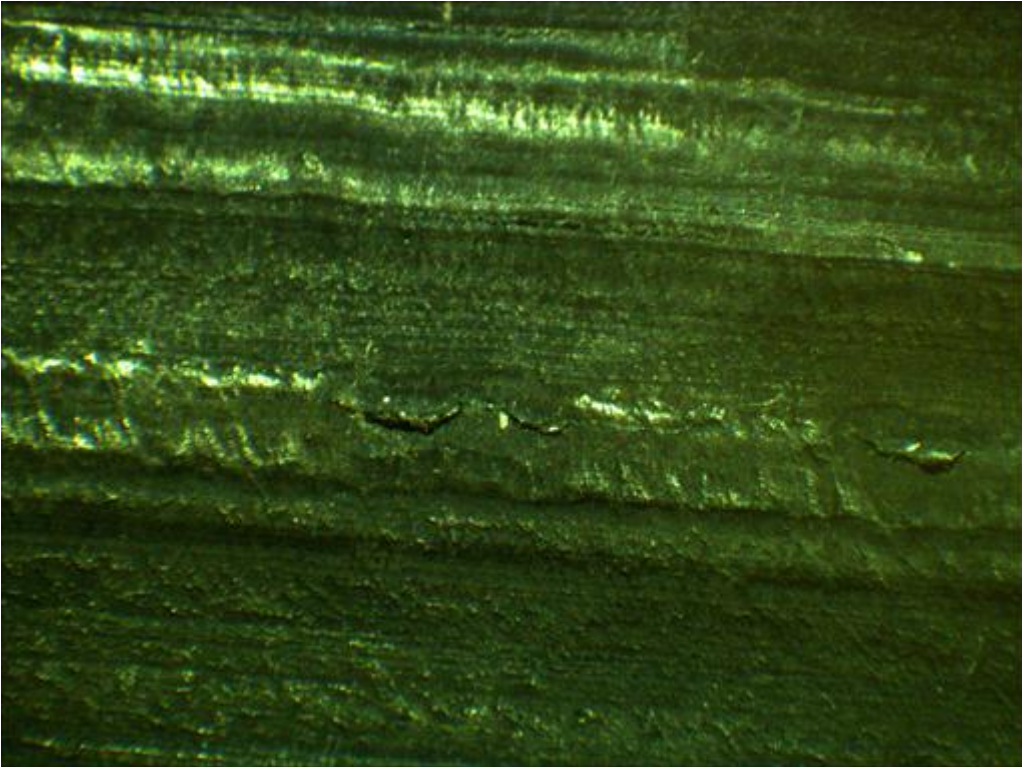
</div> <p>Figure 2. Socket magnified surface</p>

Testing Undertaken	Failure analysis
Failure Analysis	The weld failure was most likely caused by the mating surfaces not being hot enough for the materials to meld together.

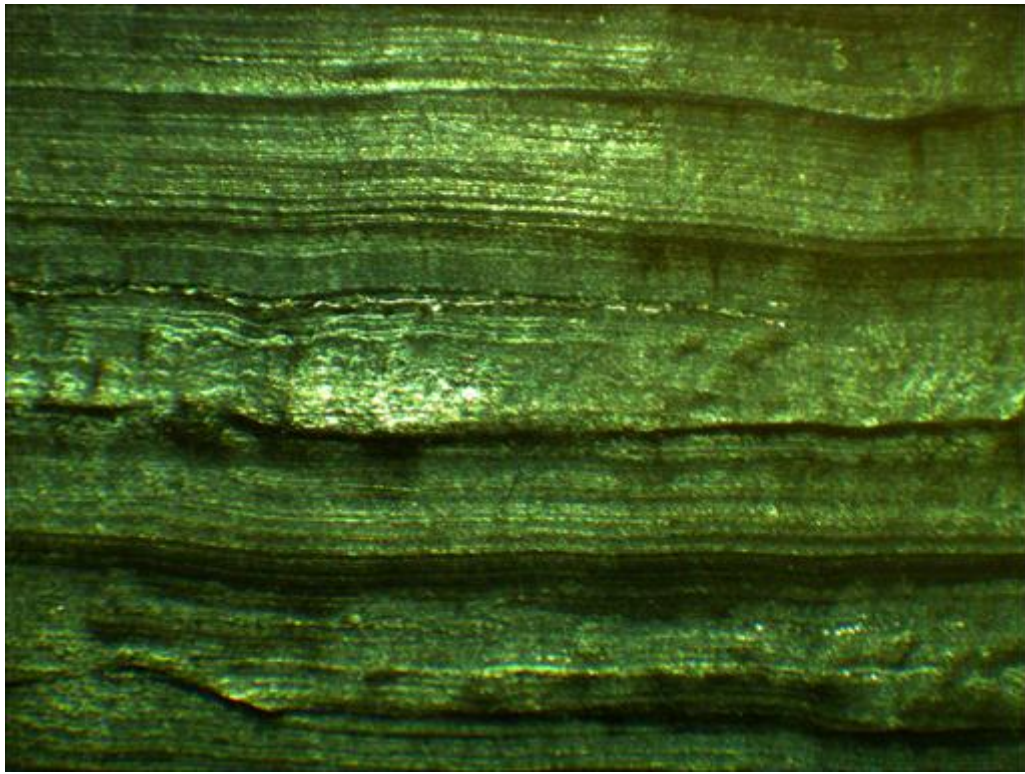
Figure 3. Pipe magnified surface

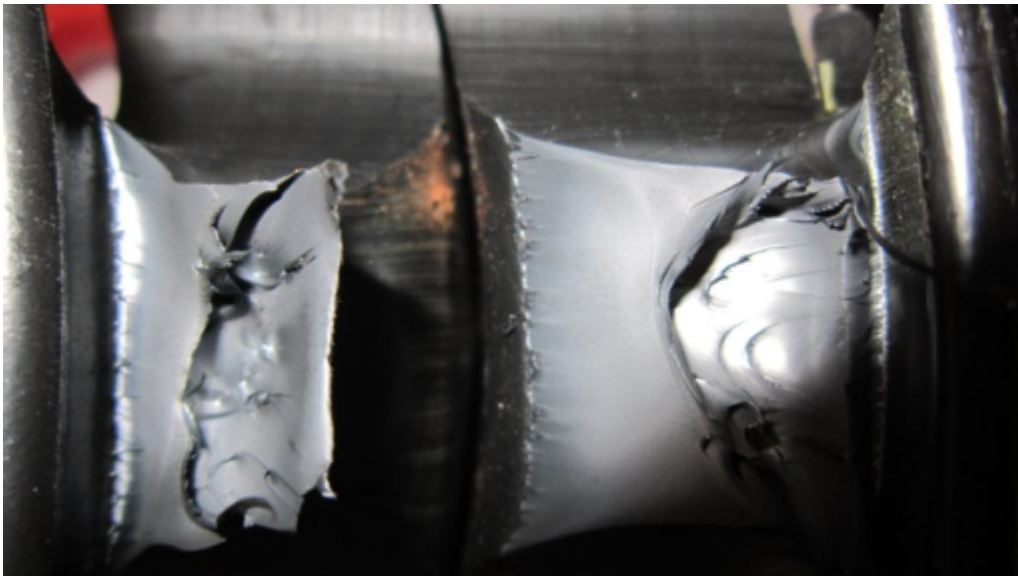
Figure 1. Specimen 1 failure mode (ductile break)

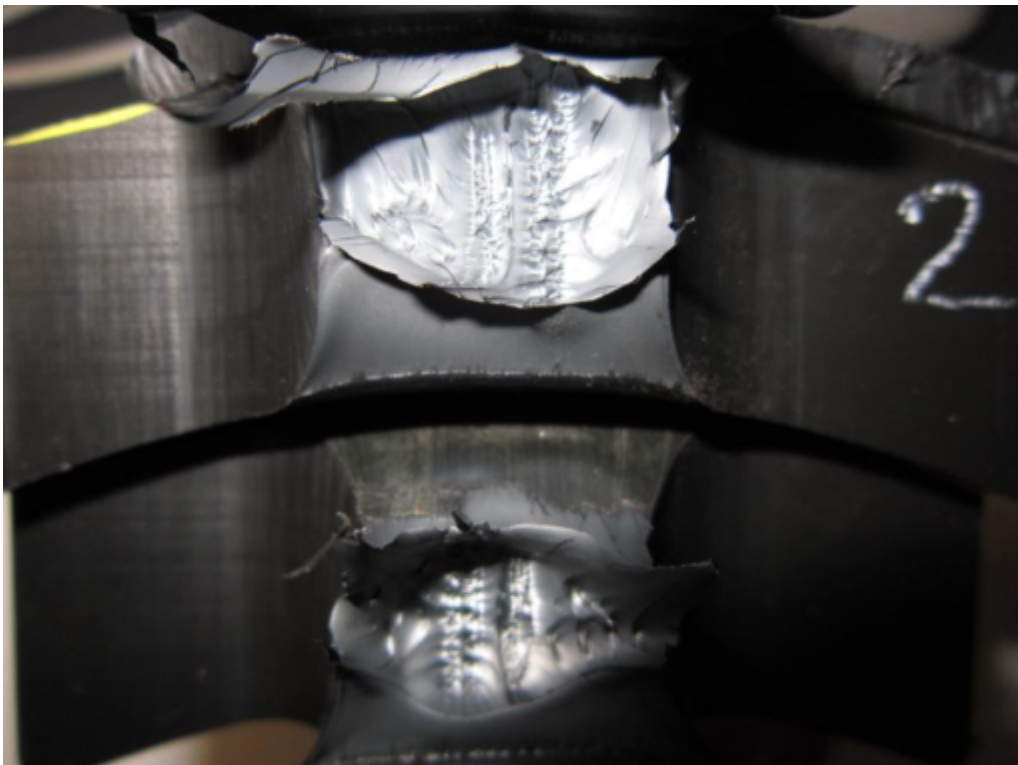
Figure 2. Specimen 2 failure mode (ductile break)

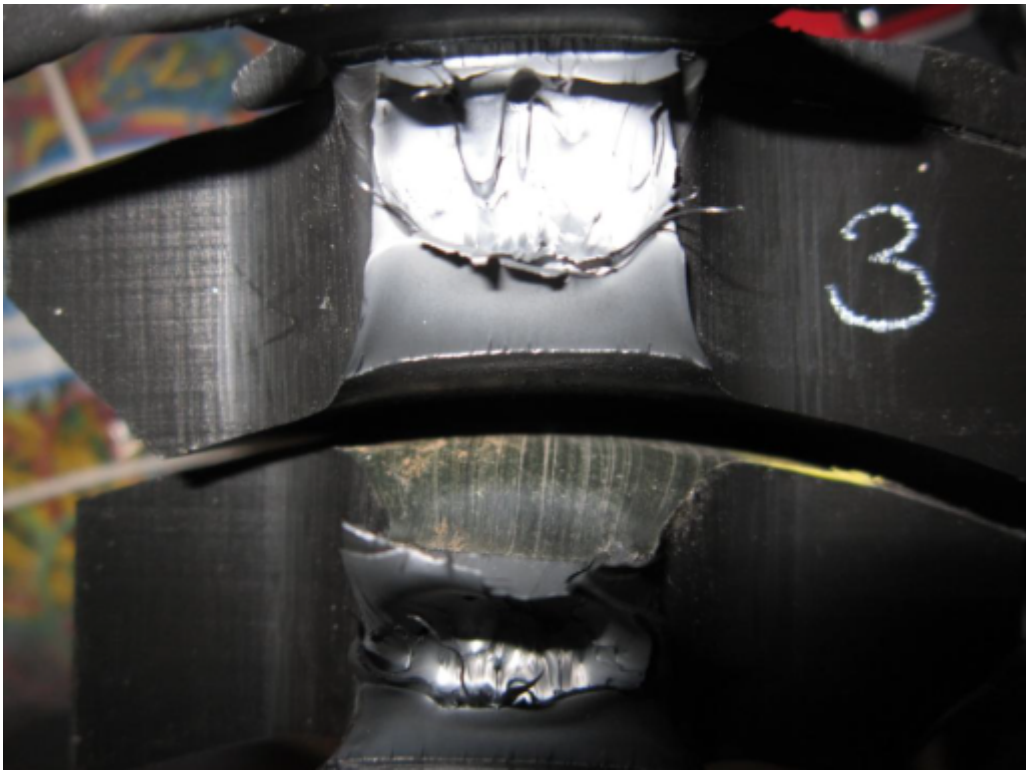
Figure 3. Specimen 3 failure mode (ductile break)

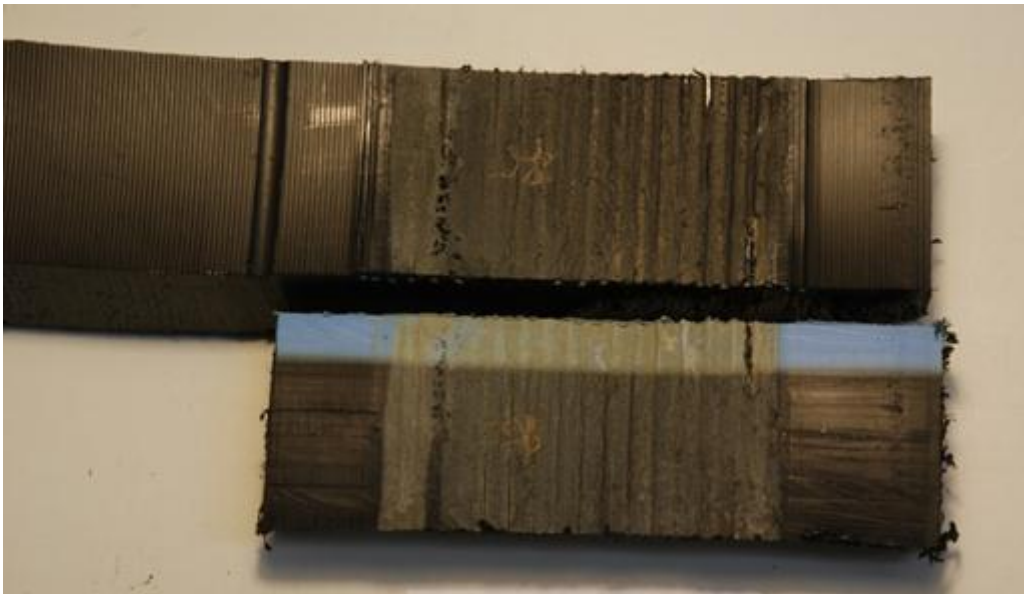
Figure 1. Pipe weld section after extensive cleaning. Some mud remained in weld. Long thin contaminant noticed that had mirror image on the fitting surface.

Testing Undertaken	Failure analysis under microscope
Failure Mode	Although the pipe and fitting were hot enough to melt the polymer, the surfaces were never close enough or clean enough for a proper joint to form.

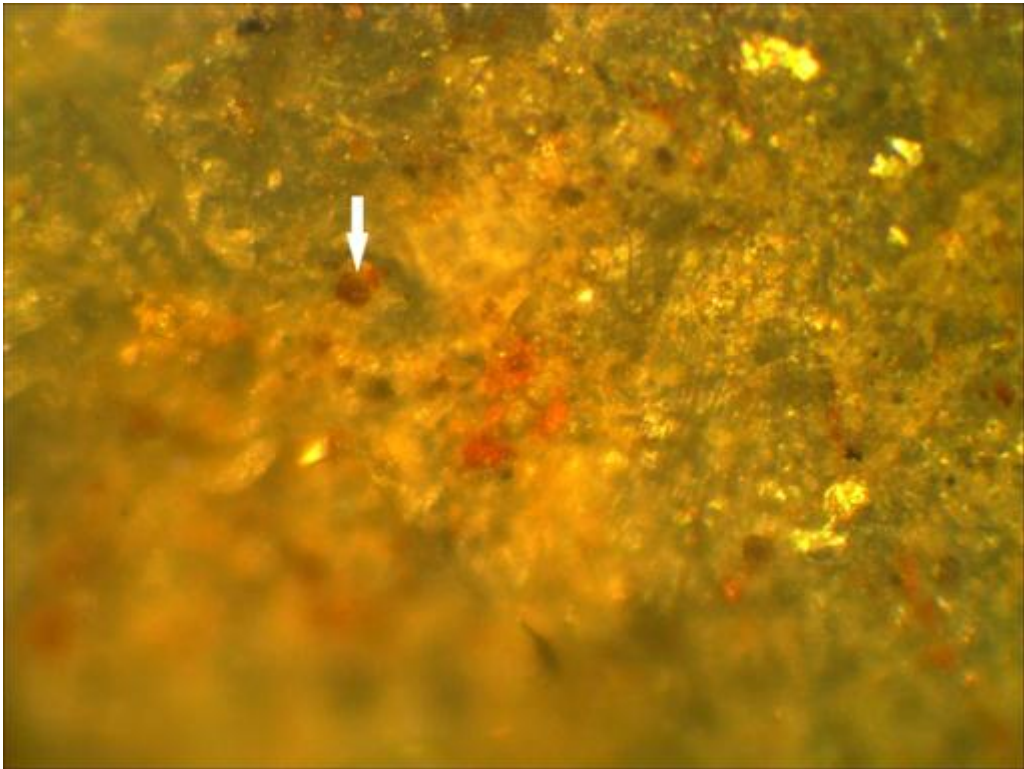
Figure 2. Weld Area at x200 magnification revealing dirt particles melted into surface of specimen

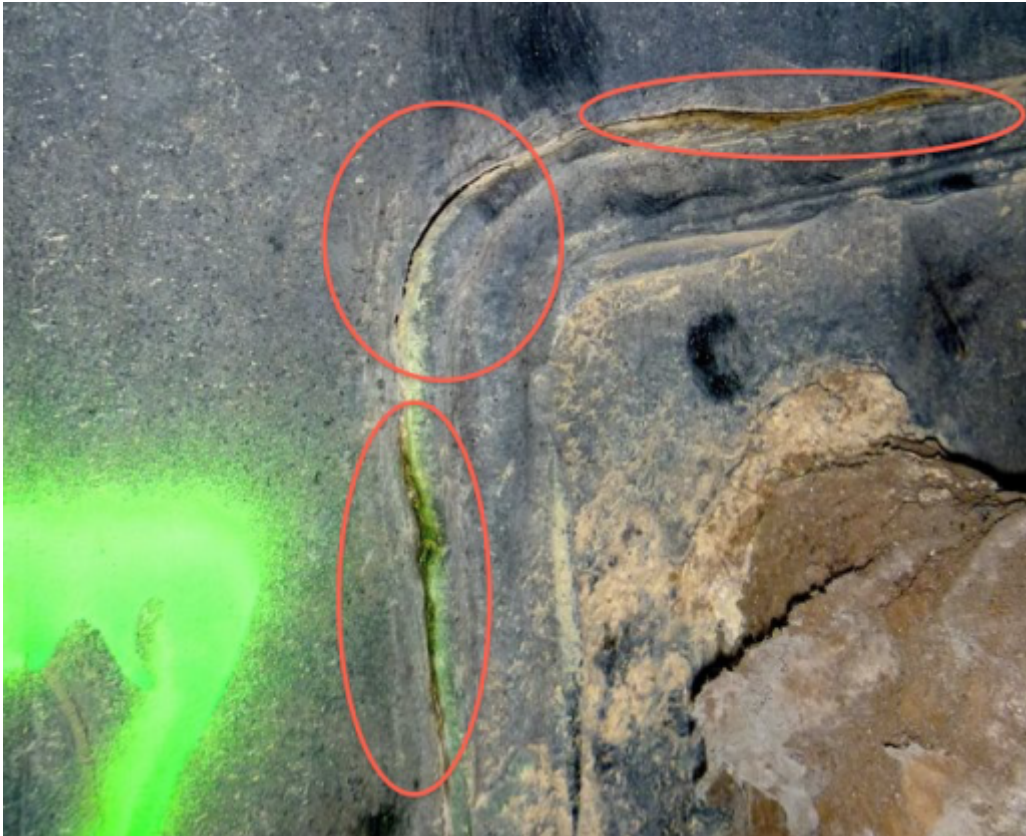
<p>Figure 1. Observed cracking</p>
Testing Undertaken	<p>DSC Thermal analysis</p> <p>OIT</p> <p>Melt flow index</p> <p>Density determination</p> <p>Microscopy</p> <p>Peel testing</p>
Failure Analysis	<p>The 5mm HDPE sheet failed by brittle stress cracking (environmental stress cracking).</p> <p>The root cause of the cracking was poor material selection as the grade of HDPE used was a homopolymer grade which has excessively high density and high %crystallinity and a marked propensity to undergo stress cracking.</p>

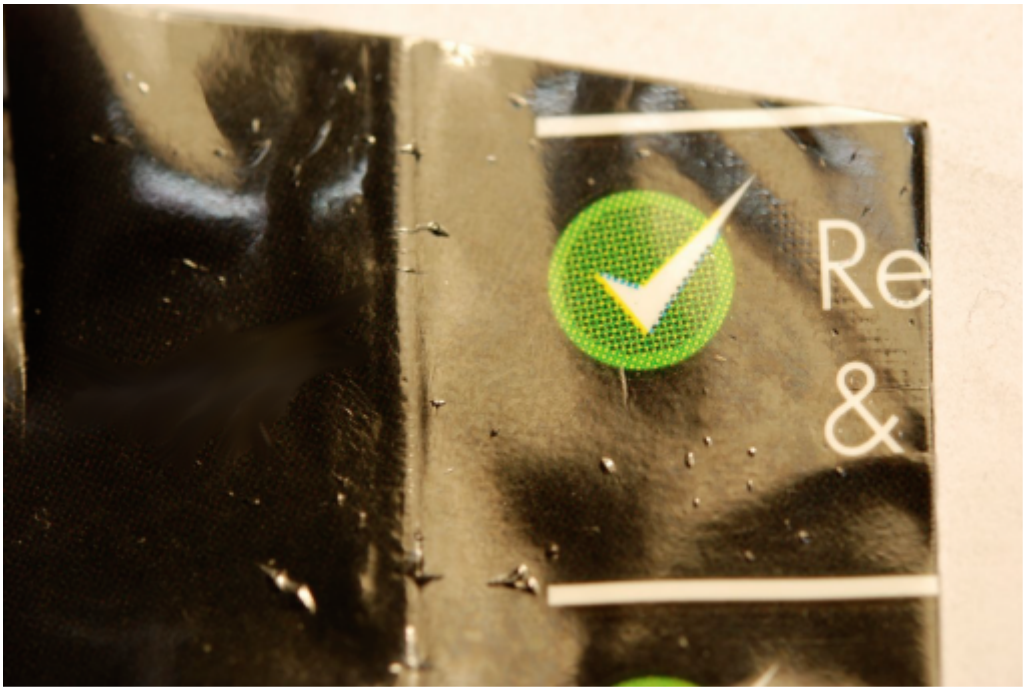
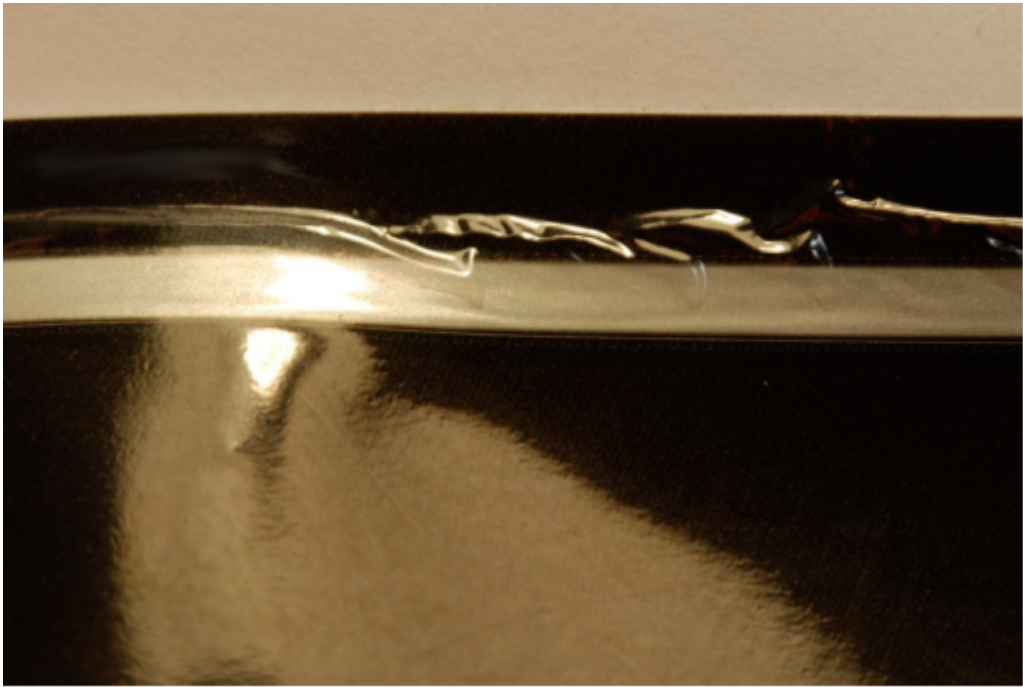
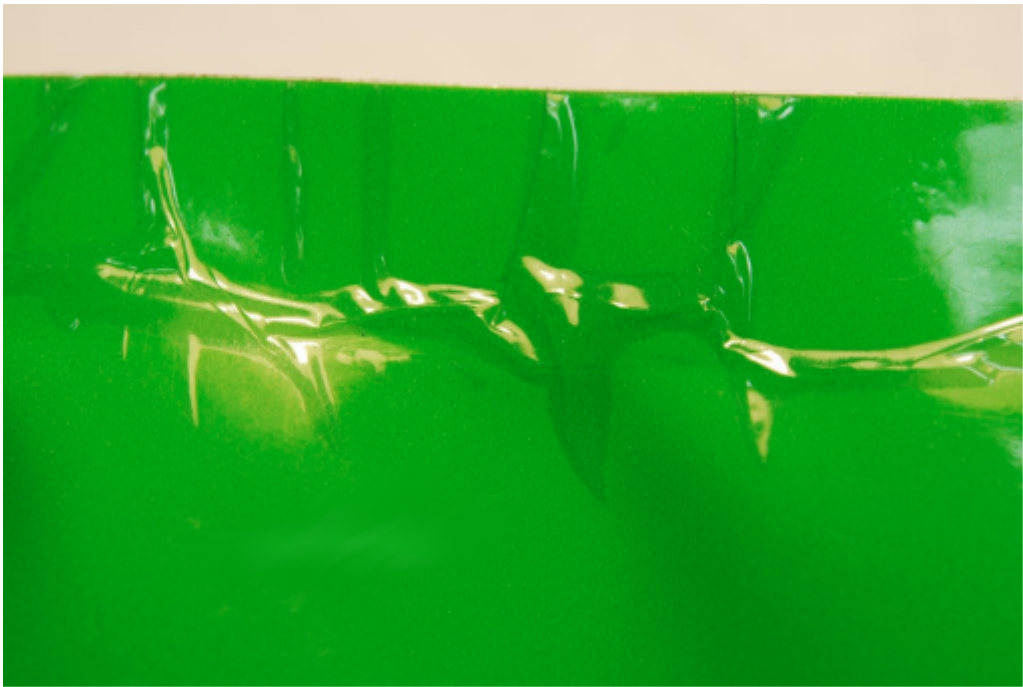
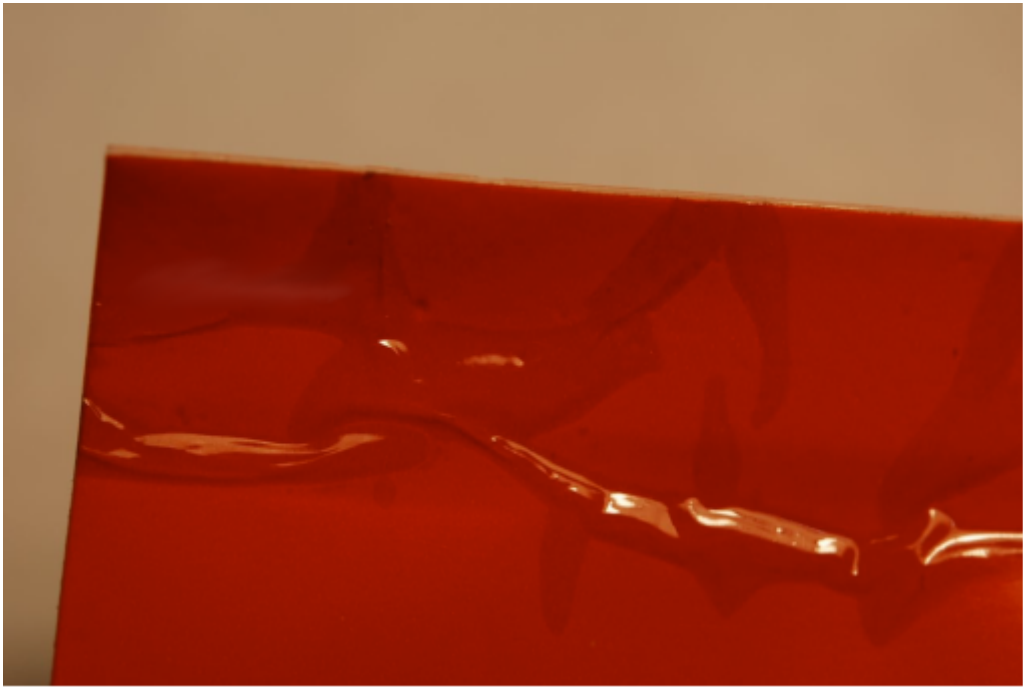
Figure 1a, 1b, 1c, 1d. Photomicroscopy of samples 1, 2, 3 and 4.

Testing Undertaken	Photomicroscopy FTIR TOF-SIMS
Failure Analysis	Delamination was associated with the presence of areas of silicone contamination.
