An Investigation of the Therac-25 Accidents

Nancy G. Leveson, University of Washington

Clark S. Turner, University of California, Irvine

A thorough account of the Therac-25 medical electron accelerator accidents reveals previously unknown details and suggests ways to reduce risk in the future.

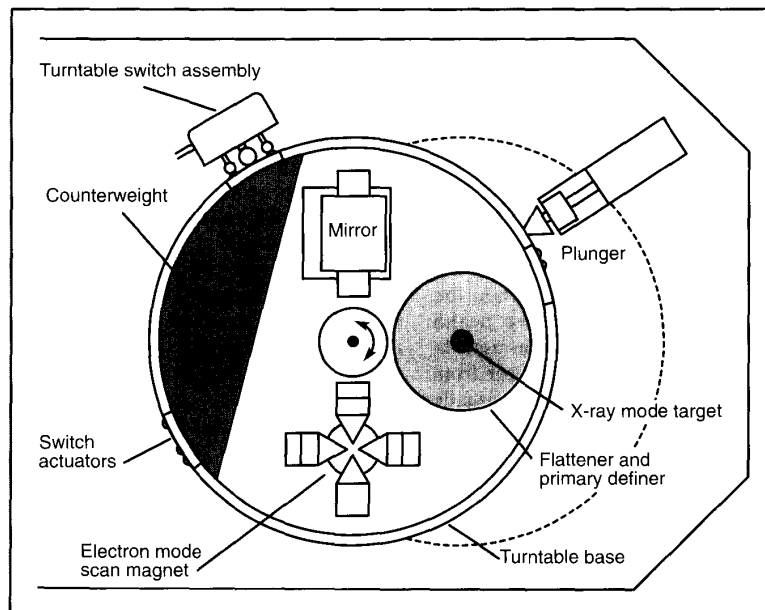
Figure B. Upper turntable assembly.

hazard of dual-mode machines: If the turntable is in the wrong position, the beam flattener will not be in place.

No accelerator beam is expected in the field-light position. A stainless steel mirror is placed in the beam path and a light simulates the beam. This lets the operator see precisely where the beam will strike the patient and make necessary adjustments before treatment starts. There is no ion chamber in place at this turntable position, since no beam is expected.

cate turntable position that tolerated a 1-bit error: The code would still unambiguously reveal correct position with any one microswitch failure.

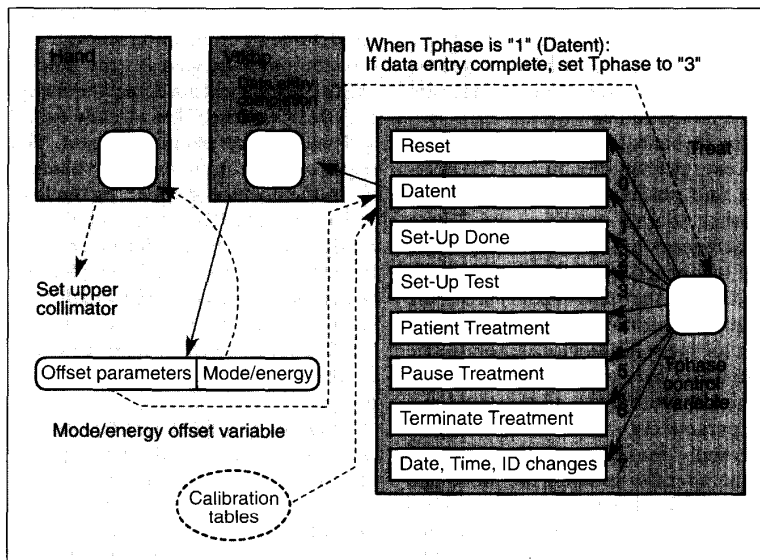
Figure 2. Tasks and subroutines in the code blamed for the Tyler accidents.

As described in the sidebar on Therac-25 software development and design, the treatment monitor task (Treat) controls the various phases of treatment by executing its eight subroutines (see Figure 2). The treatment phase indicator variable (Tphase) is used to determine which subroutine should be executed. Following the execution of a particular subroutine, Treat reschedules itself.

One of Treat's subroutines, called Datent (data entry), communicates with the keyboard handler task (a task that runs concurrently with Treat) via a

shared variable (Data-entry completion flag) to determine whether the prescription data has been entered. The keyboard handler recognizes the completion of data entry and changes the Data-entry completion variable to denote this. Once the Data-entry completion variable is set, the Datent subroutine detects the variable's change in status and changes the value of Tphase from 1 (Data Entry) to 3 (Set-Up Test). In this case, the Datent subroutine exits back to the Treat subroutine, which will reschedule itself and begin execution of the Set-Up Test subroutine. If the Data-entry completion variable has not been set, Datent leaves the value of Tphase unchanged and exits back to Treat's main line. Treat will then reschedule itself, essentially rescheduling the Datent subroutine.

Upon exit from the Magnet subroutine, the data-entry subroutine (Datent) checks the data-entry completion variable. If it indicates that data entry is complete, Datent sets Tphase to 3 and Datent is not entered again. If it is not set, Datent leaves Tphase unchanged, which means it will eventually be rescheduled. But the data-entry completion variable only indicates that the cursor has been down to the command line, not that it is still there. A potential race condition is set up. To fix this, AECL introduced another shared variable controlled by the keyboard handler task that indicates the cursor is not positioned on the command line. If this variable is set, then prescription entry is still in progress and the value of Tphase is left unchanged.

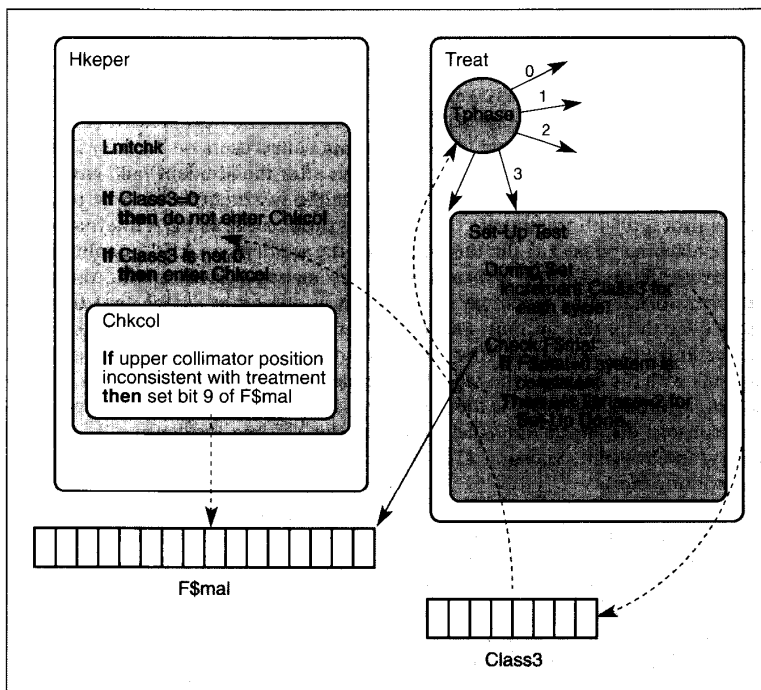
Figure 4. Yakima software flaw.

This situation probably occurred in the Hamilton, Ontario, accident a couple of years ago. It was not discovered at that time and the cause was attributed to intermittent interlock failure. The subsequent recall of the multiple microswitch logic network did not really solve the problem.

The second Yakima accident was again attributed to a type of race condition in the software — this one allowed the device to be activated in an error setting (a "failure" of a software interlock). The Tyler accidents were related to prob-

lems in the data-entry routines that allowed the code to proceed to Set-Up Test before the full prescription had been entered and acted upon. The Yakima accident involves problems encountered later in the logic after the treatment monitor Treat reaches Set-Up Test.
