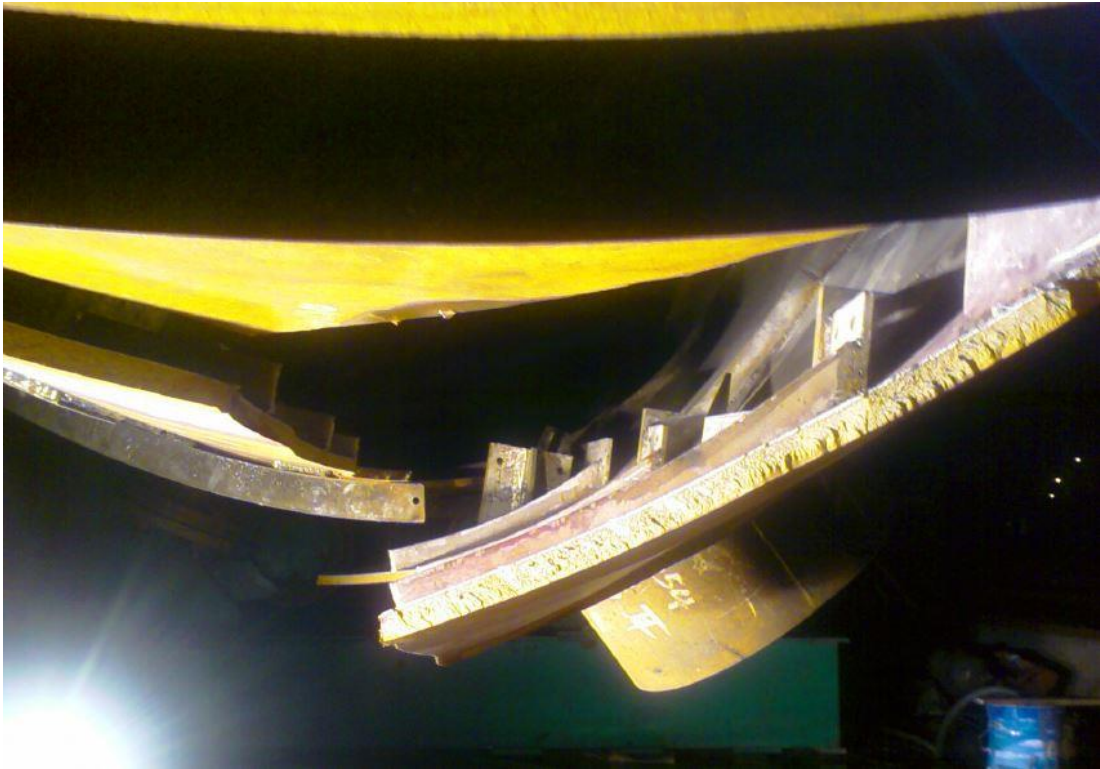
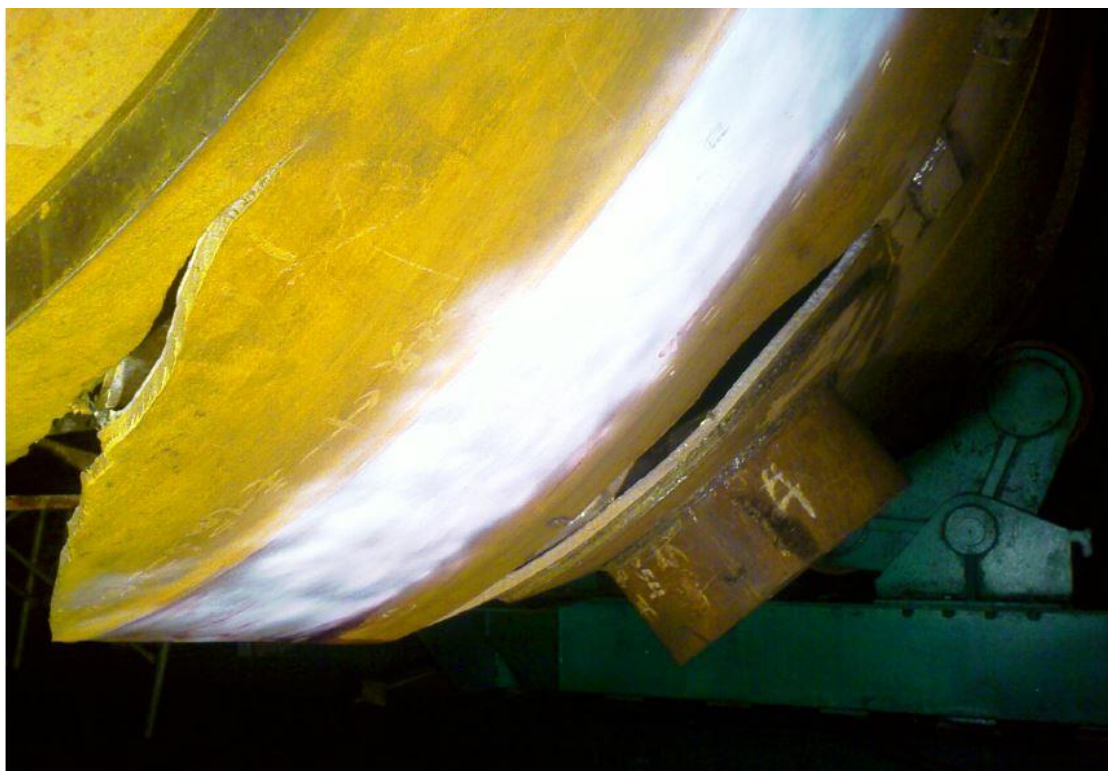
The following photos show the failure that a recently restored vessel suffered during hydraulic testing. The photos show undermining and lack of fusion in welds; as well as laminations in the material that were probably the causes of this failure. This demonstrates the importance of properly carrying out the tests so that this type of breakage does not occur during the service of the equipment.
