This accident occurred during the filling of a 2000 m<sup>3</sup> LPG sphere, resulting in the death of one worker and leaving another seriously injured.

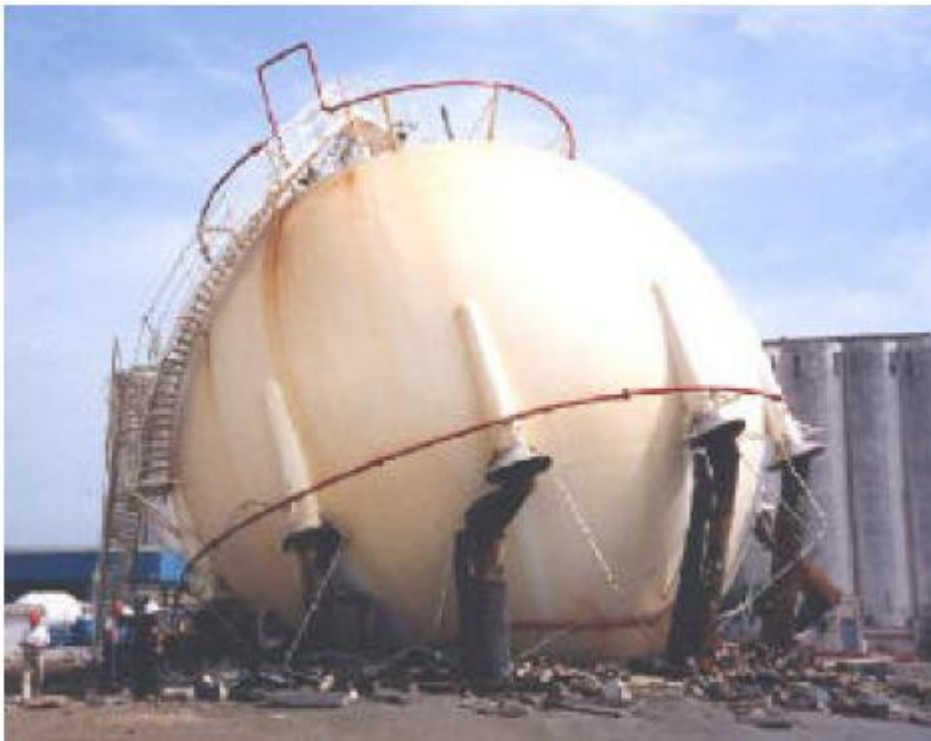
The sphere was 80% filled with water and at that moment the legs collapsed.

After the accident, it was verified that the steel had been reduced by 8 mm, with holes of up to 10 cm<sup>2</sup>.

After the analysis and testing of the steel beams and the concrete, it was concluded that the severe corrosion of the legs and the concrete was caused by water seepage through the fireproof protection.
